# INVESTIGATION OF GROUND-WATER CONDITIONS AT GORETOWN, IN EASTERN HORRY COUNTY, SOUTH CAROLINA

by Brenda L. Hockensmith

South Carolina Water Resources Commission Open-File Report OF-31

August 1989

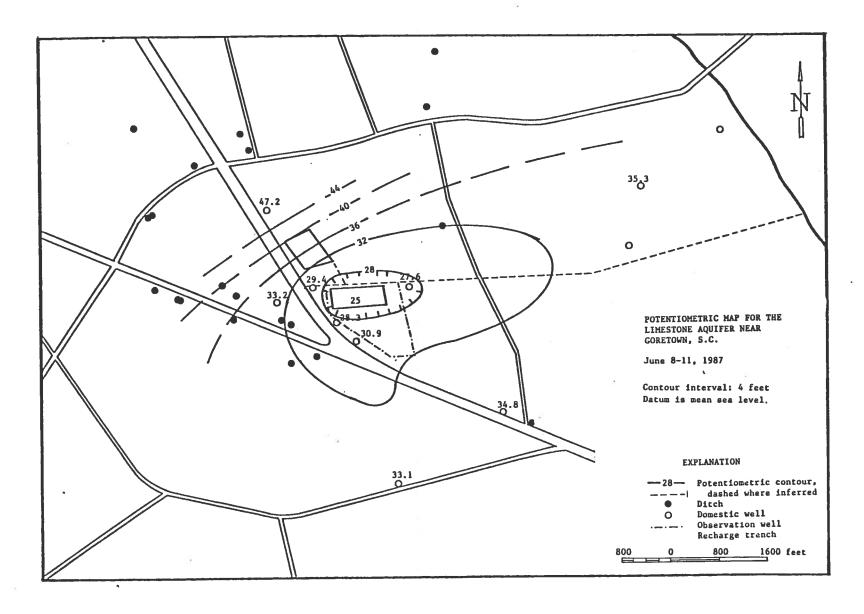
Figure 7. Potentiometric surface of the limestone aquifer, June 8-11, 1987.

Figure 7 represents water levels in the study area following a period of several weeks when the No. 9 Mine had been pumping water at a rate of 3,000 gpm (Soil & Material Engineers, 1987). The total volume of ground water displaced is not known, since pumpage was not reported to the SCWRC for this period. During this time, the water level was near the working surface of the pit, estimated at 25 feet msl. Analysis of this map shows that the hydraulic gradient was steepest, at 1.3 percent, from the northwest toward the mine. The gradient was less east, west, and south of the mine, with the lowest gradient, 0.2 percent, being from the east.

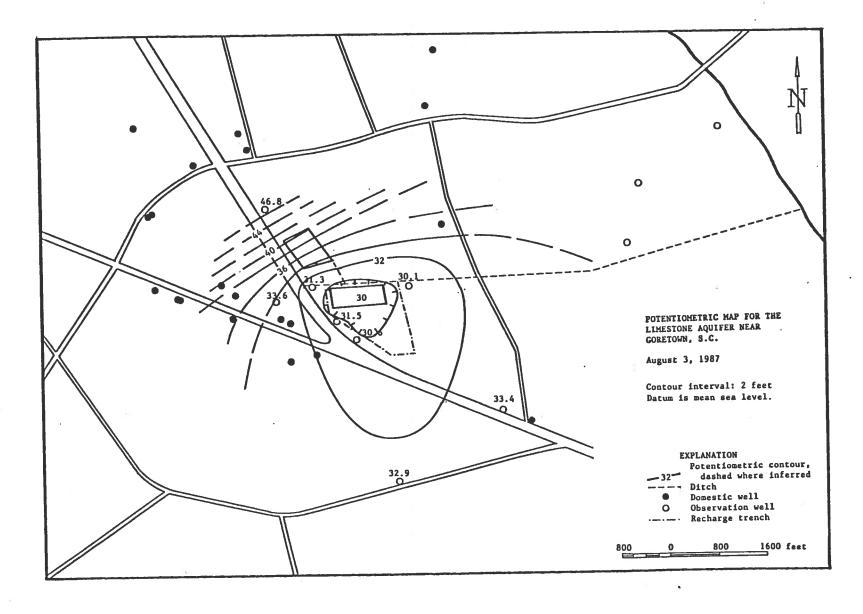
Figure 8. Potentiometric surface of the limestone aquifer, August 3, 1987.

Figure 8 shows the potentiometric surface following a two-week period of no pumping by the No. 9 Mine, although the quantity of ground water withdrawn by the Horry County Mine is not known. Again the steepest hydraulic gradient was in the northwest. Water levels in observation

wells in the immediate vicinity of the No. 9 Mine rose slightly, but in wells farther away the levels dropped by as much as 1.4 feet. A rise in water level of 5 feet had been estimated within the mine.

An anomaly appears to exist in the potentiometric surface shown in Figures 8, 9, and 10 between IW-9 and CW-2. IW-9 is nearer to the No. 9 Mine than CW-2 but shows a higher water level than CW-2. This difference was least during February 1988 (0.1 foot) but increased to 1.7 feet during June 1988. A possible explanation is that the recharge trench may have been more effective in the vicinity of IW-9 than at CW-2, provided water was being discharged into the trench and circulated to the southwest side. Figure 11 for late August 1988 shows a lower water level in IW-9 than in CW-2, which is reasonable, considering the distance of the wells from the pumping center, particularly if recharge effects were minimal or altered during the recharge trench modifications. Further investigation is needed to determine the rate at which water is discharged into the trench and how effective the trench is at maintaining ground-water levels beyond the perimeter of the mine.

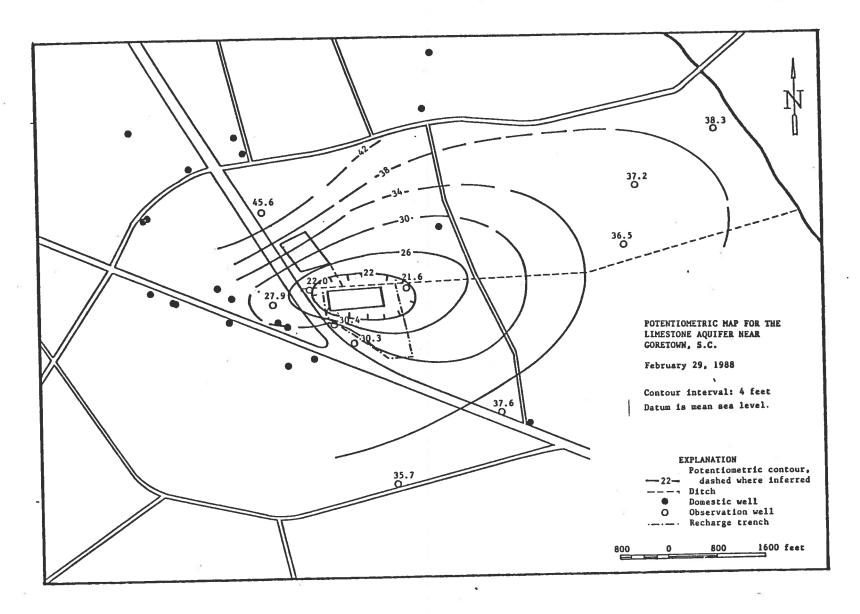
Figure 9. Potentiometric surface of the limestone aquifer, February 29, 1988.

In Figures 9, 10, and 11, the water levels within the mines were unknown. Water level elevations of 22 feet msl or lower have been noted in at least one of the observation wells in the immediate vicinity of the No. 9 Mine for two of these maps, therefore it is likely that the water level within this mine was below 22 feet msl. Figure 9 represents ground-water levels in February 1988 following withdrawals of nearly 500 million gallons over a two-month period. Monthly water-use figures reported for the No. 9 Mine in 1988 are listed in Table 2. Roughly 300 million gallons were pumped during the two months prior to June 30, 1988 (Fig. 10). Ground-water withdrawals for July and August exceeded 430 million gallons. Withdrawals by the Horry County Mine for these periods These most recent maps are similar to the previously are not known. discussed maps in that the cone of depression was centered around the No. 9 Mine and the hydraulic gradient was generally steepest on the northwest. The steepest gradient of all five maps (approximately 3.6 percent) occurred from observation wells OW-2 and IW-9 toward the No. 9 Mine in February 1988 (Fig. 9). At that time the lowest gradients were south of OW-2 toward the mine and in the east at 0.2 and 0.4 percent, respectively. By June 1988, the lowest gradient, at 0.3 percent, occurred in the south and is only slightly less than the gradient in the east (Fig. 10). Northwest of the No. 9 Mine the gradient decreased to 1.2 percent. The gradient steepened slightly to 1.3 percent in August 1988 on the northwest (between observation wells OW-1 and LW-7) and the low gradient had shifted back to the east (Fig. 11).

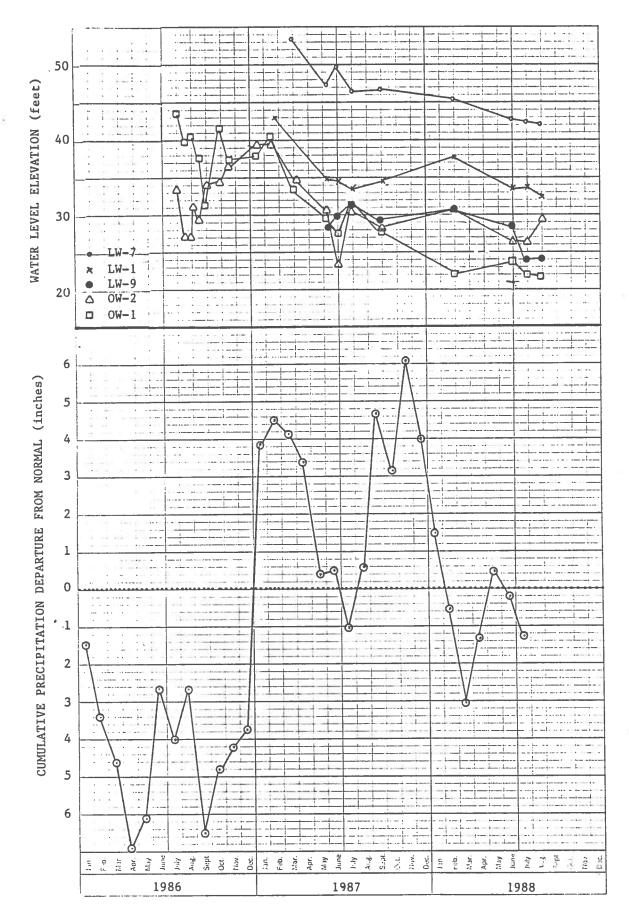
Figure 12. Hydrographs of selected observation wells and the cumulative departure from normal for precipitation at the Loris Station.

Hydrographs of selected observation wells and the cumulative departure from normal for precipitation at the Ioris Station are shown in Figure 12. Water-level trends were consistent, with only minor variations among most of the observation wells. OW-1 differed noticeably from the other wells during late February 1988 and again in late June 1988. The low water level in OW-1 for February 1988 may have been a result of the well's proximity to the two mines and thus subject to pumping effects to a larger extent than other wells. The second discrepancy may have been a result of recharge from either the recharge trench or the ditch between the mines.

The hydrographs of the observation wells were similar to the plot of the precipitation data prior to July 1987. During the last six months of 1987, however, the water levels in the wells continued to drop or rose only slightly, while the precipitation departure was up to 6 inches above normal. The water-level trends also differed from the precipitation data during the first five months of 1988. Comparisons of the hydrographs with the monthly pumpage figures during 1988 for the No. 9 Mine indicated that the wells were greatly affected by the mine pumpage. These data tend to indicate that the effects of pumping mask the effects of precipitation.
