SC DEPARTMENT of  
**ENVIRONMENTAL  
SERVICES**

The South Carolina Department of Environmental Services (the Department/SCDES) inspected your dam on April 22, 2026 and the report of that inspection is enclosed. Please review it closely. Dam Safety Program staff are available to discuss the results of the inspection with you. A summary of the inspection report is as follows:

# UPPER SUNNY HILL POND DAM

## Dams Preliminary Inspection Form

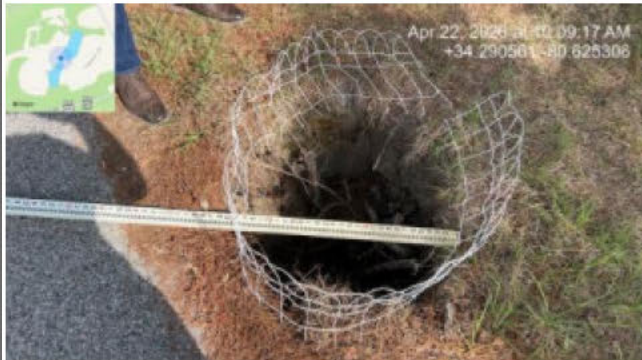
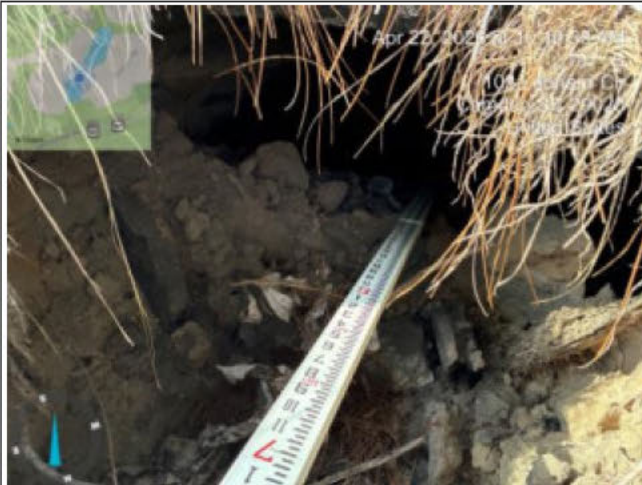
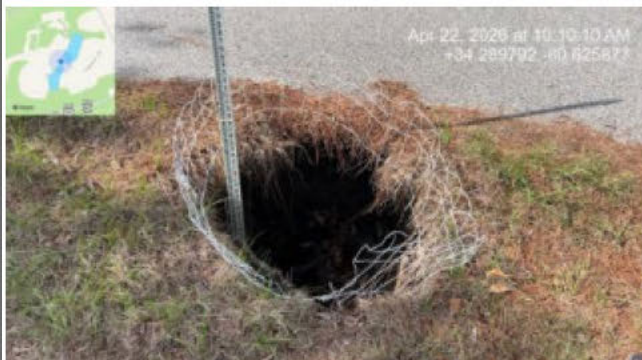
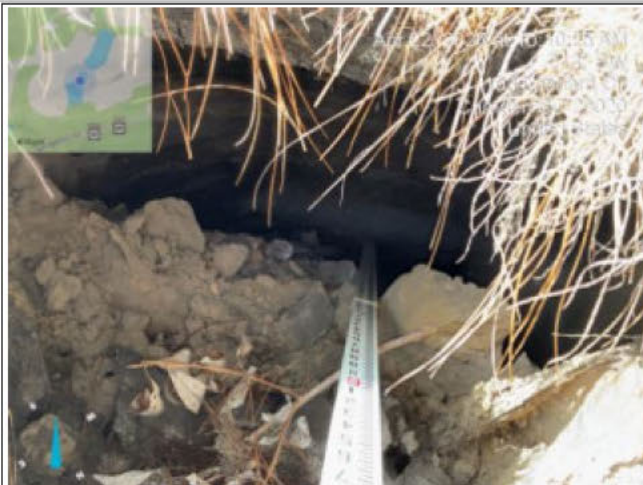
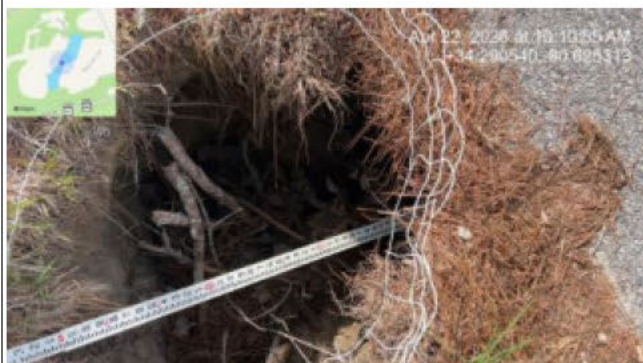
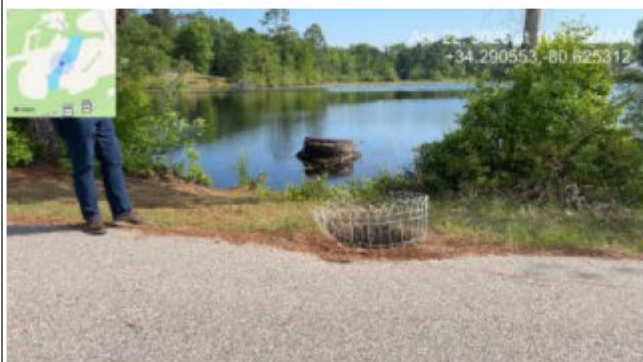
| Observation & Instrumentation | |
|---|---|
| ► Comments:<br>Road is closed due to sinkholes in the embankment. | |
| Comments:<br>Large sinkhole at the upstream edge of the road above the primary conduit. Sinkhole is about 3ft wide and 4ft deep. Sinkhole extends 6-7ft horizontally beneath the roadway. | |

- Evaluate and repair the sinkholes and voids on the crest and upstream slope.
- Evaluate and repair the primary spillway and conduit.
- Repair the erosion on the downstream slope.
- Develop and implement a tree management plan for trees (and decaying stumps) greater than 4" in diameter.

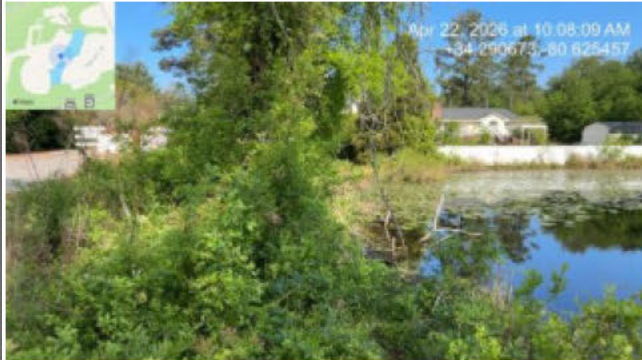
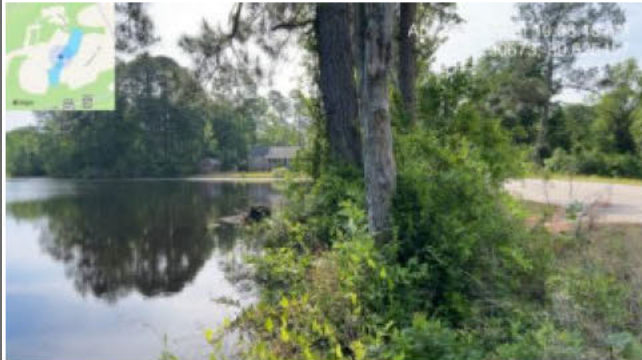
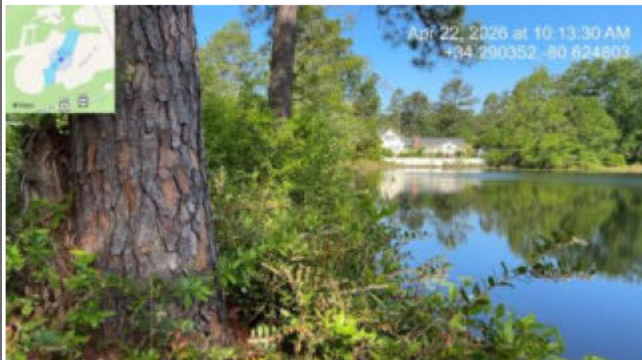
Grass cover limited by brush and woody vegetation.

- Remove debris from the blocked riser structure.
- Brush, woody vegetation, and trees less than 4" in diameter should be cut and removed.
- Grass cover should be established on the upstream and downstream slopes.

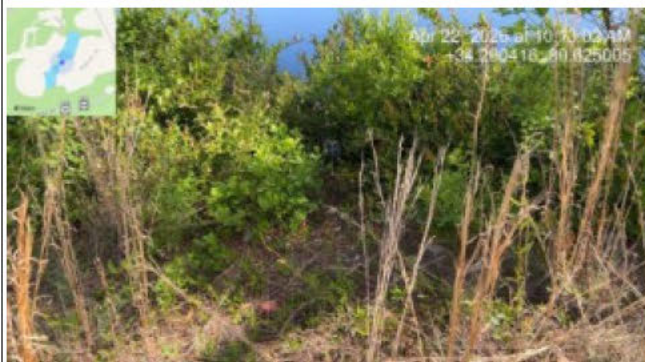
Dense brush and woody vegetation on the upstream slope.

Large trees greater than 4" in diameter observed on the upstream slope.

Animal paths and activity observed on the upstream slope.

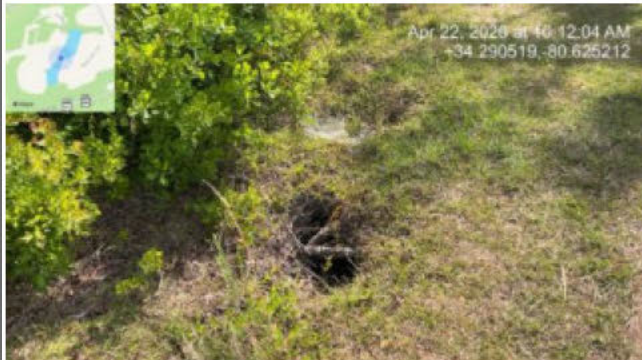
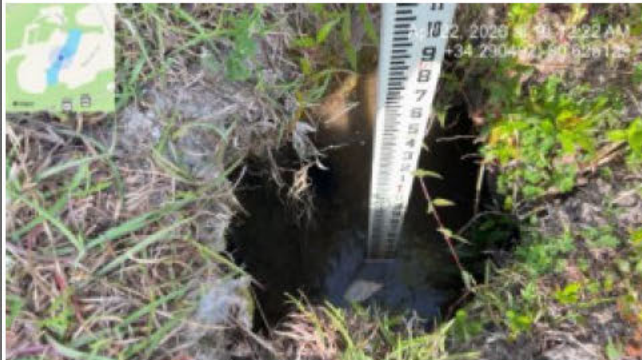
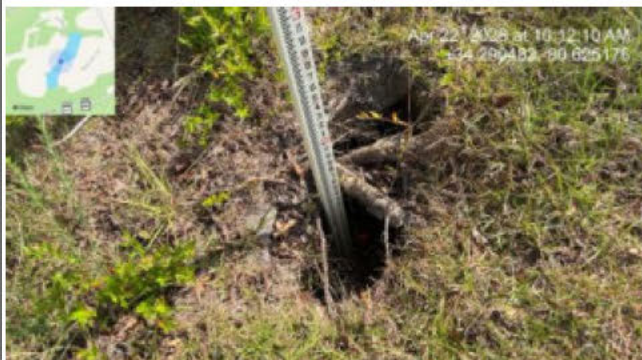
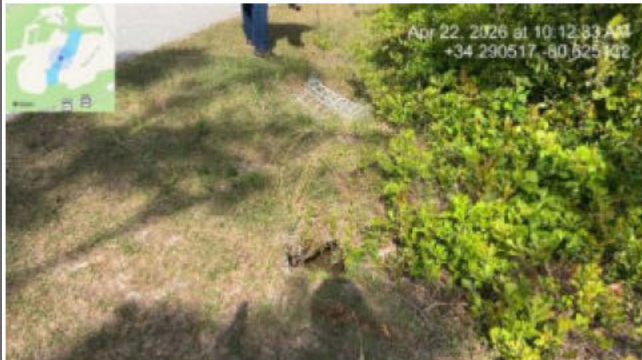
Several voids observed on the upstream slope. All are greater than 12" in depth and one has standing water within it.

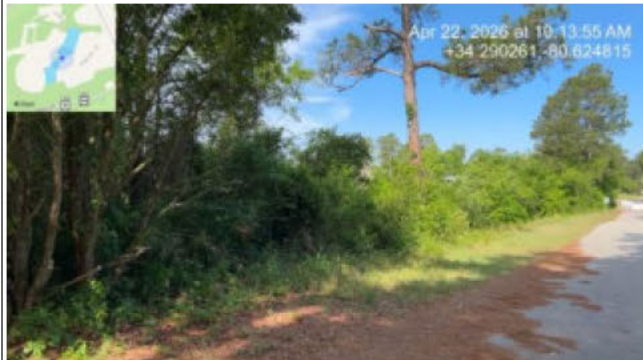
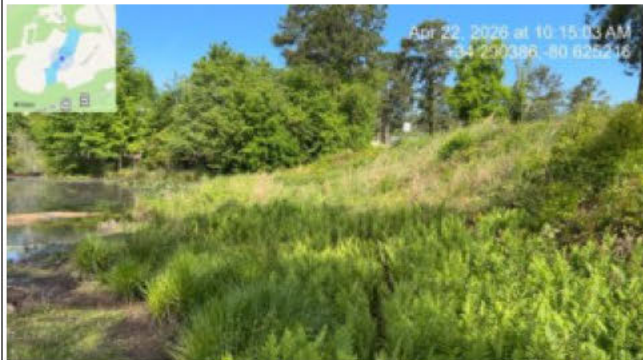
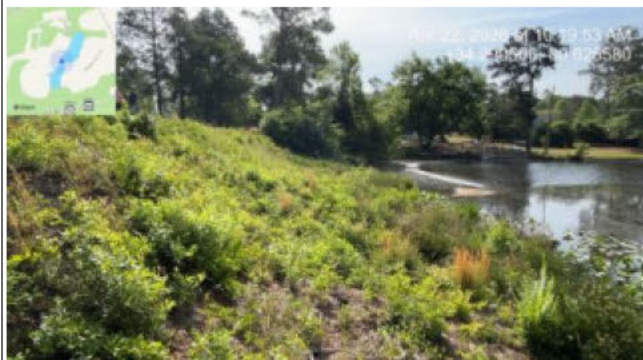
Grass cover limited by brush and woody vegetation.

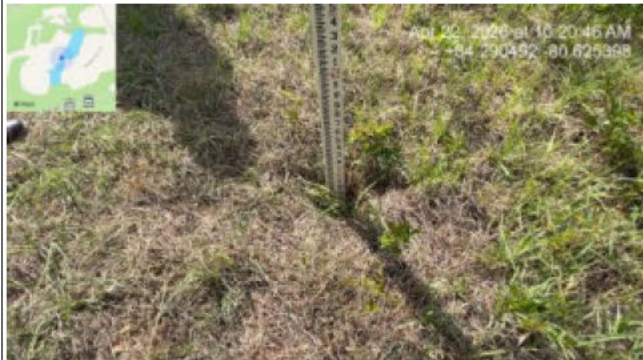
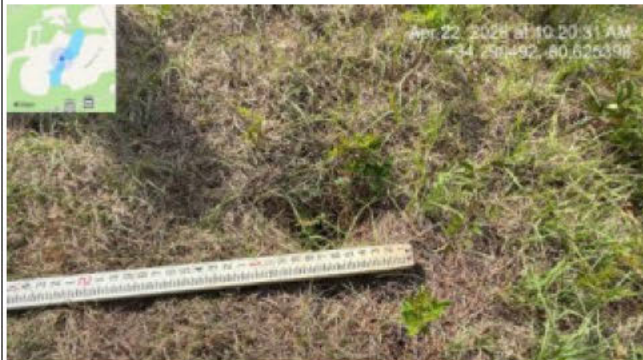
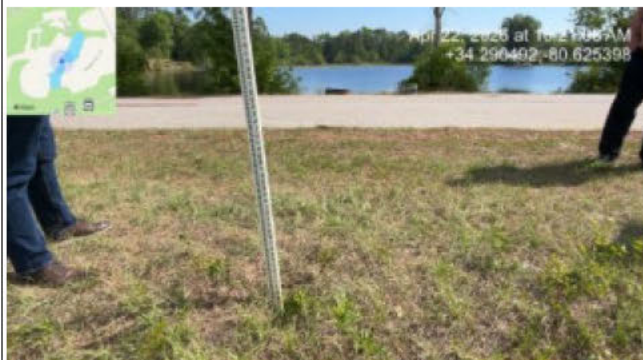
Another smaller sinkhole in line with the conduit at the edge of the downstream slope.

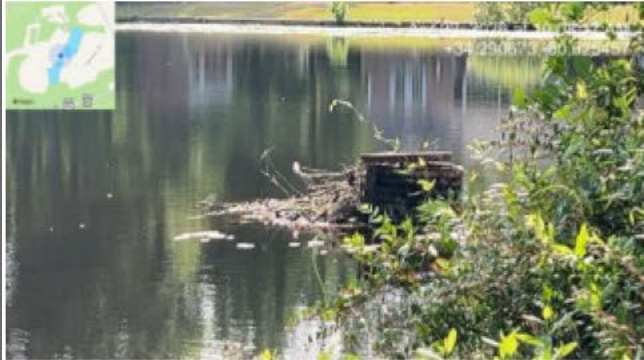
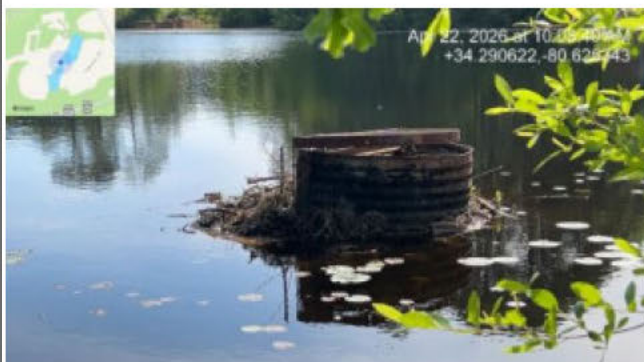
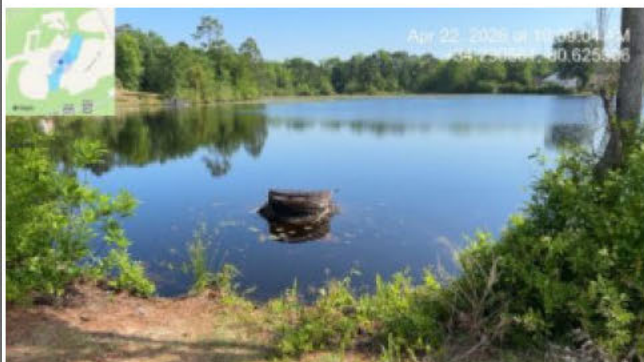
| <b>3. Condition of Trashrack</b><br>Monitor,Investigate,Action Required | |
| <b>7. Intake Structure Condition</b><br>Regular Monitoring Required,Needs Maintenance | |

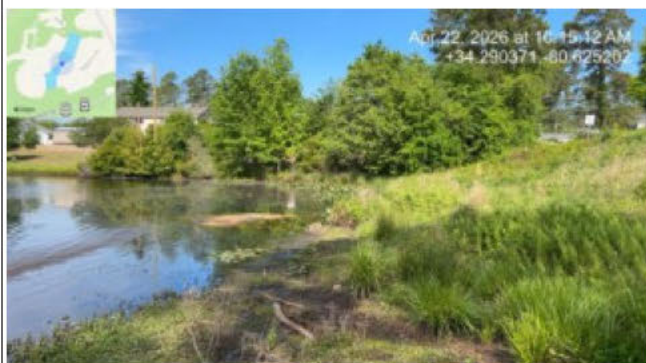
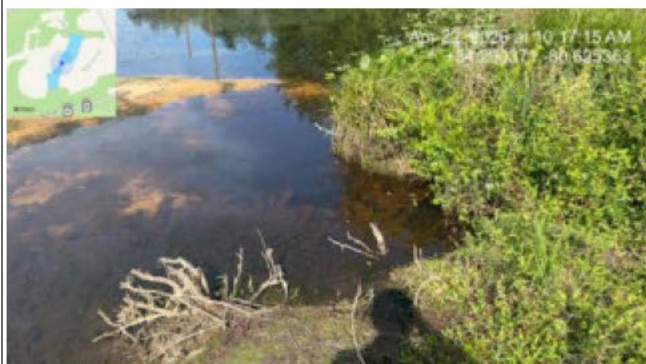
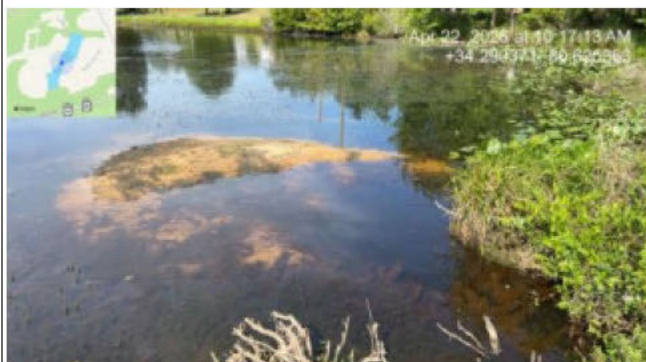
Condition Prevented Full Inspection, Regular Monitoring Required
