SC DEPARTMENT of  
**ENVIRONMENTAL  
SERVICES**

**Subject: Inspection of UPPER SUNNY HILL POND DAM, D2523, Kershaw County, High Hazard Class**

# UPPER SUNNY HILL POND DAM : D2523

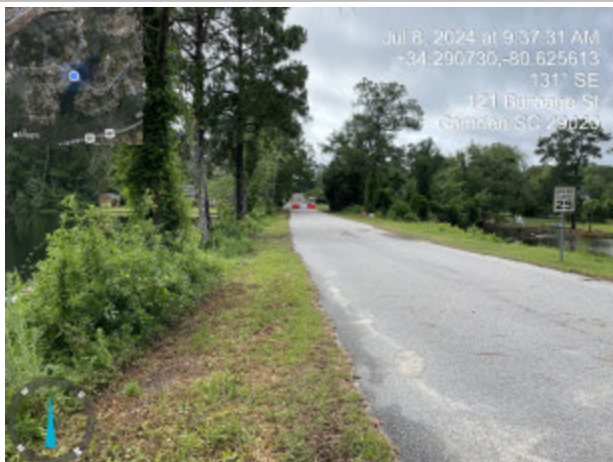
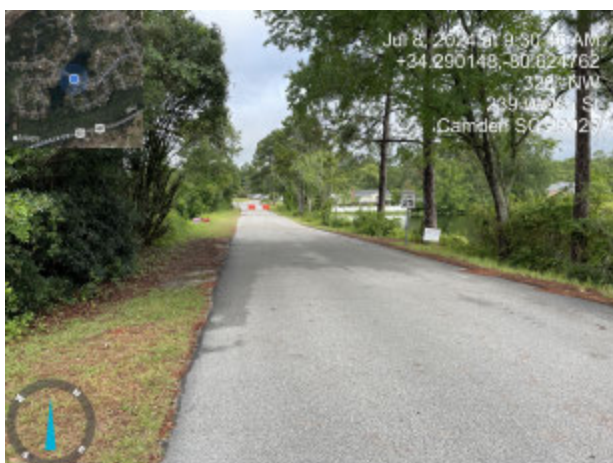
Paved Sunnyhill Drive on the crest of the dam. Shoulders of the crest are mostly grassed, some bare areas or areas with pinestraw coverage observed.

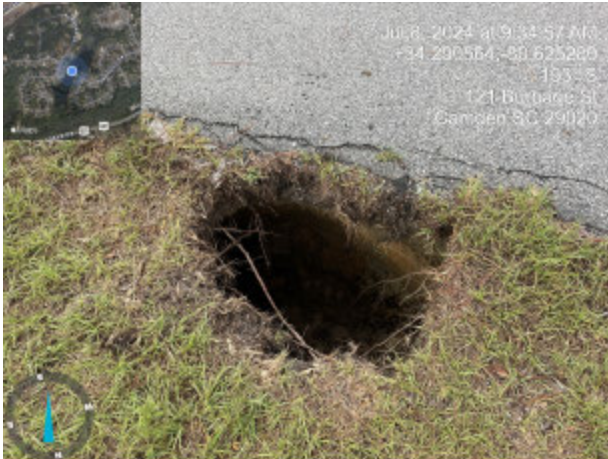
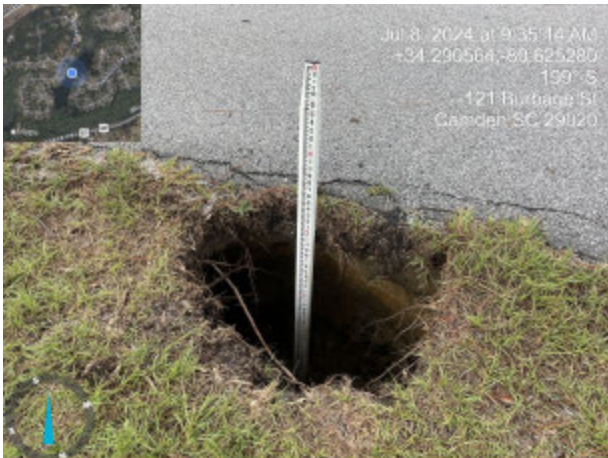
Longitudinal cracking of the pavement observed near the sinkhole.

Sinkhole formed alongside the pavement nearly in-line with the primary spillway structure. Sinkhole is approximately 3.5 feet deep and 3 feet in width.

Engage a Professional Engineer to evaluate the stability of the crest around the sinkhole and develop a permit application for repairs and stabilization of the embankment.

Monitor for worsening cracking along the pavement.

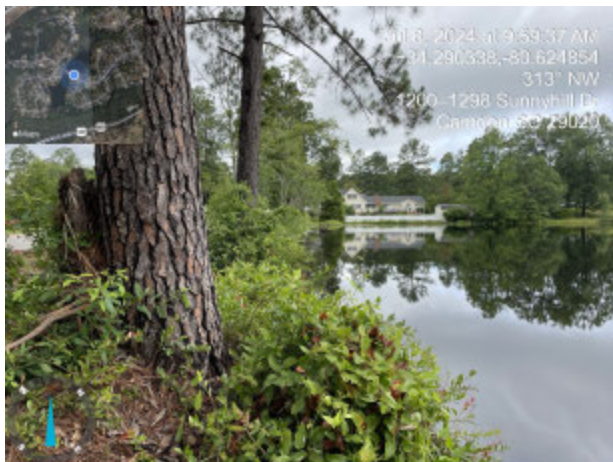
Dense brush and woody vegetation less than 4 inches in diameter observed along the upstream slope, mainly along the water line.

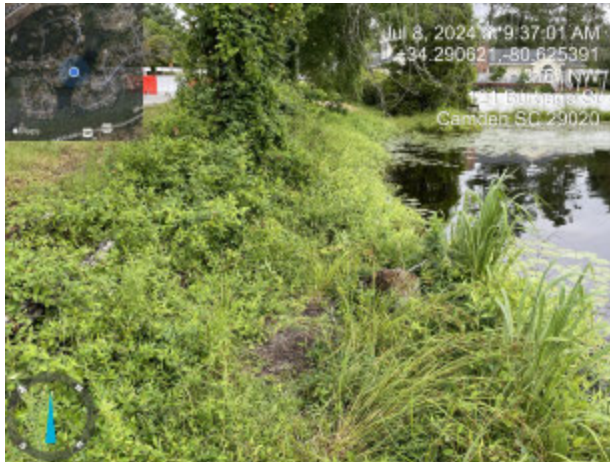
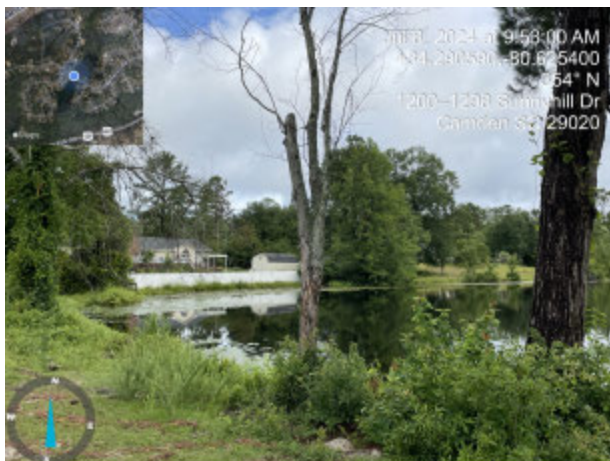
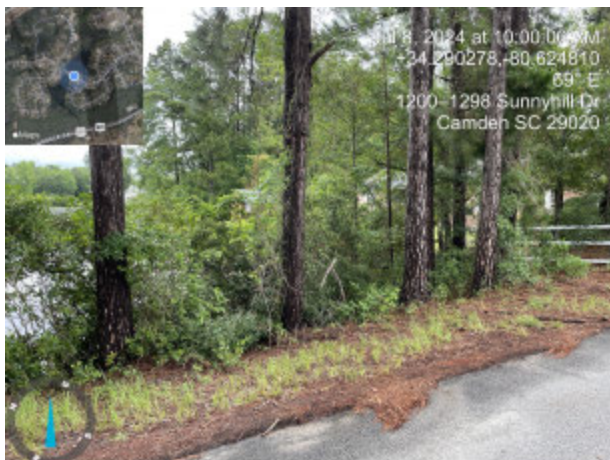
Numerous trees greater than 4 inches in diameter observed, including dead trees and decaying stumps.

- Engage a Professional Engineer to develop a tree management plan to address the trees and stumps greater than 4 inches in diameter.
- The newly formed sinkhole may be a sign of internal erosion within the dam, engage a Professional Engineer to conduct a full investigation into the extent of voids/internal erosion pathways within the dam.

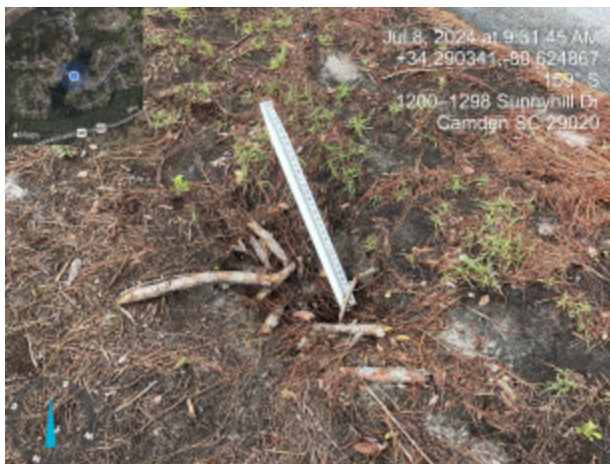
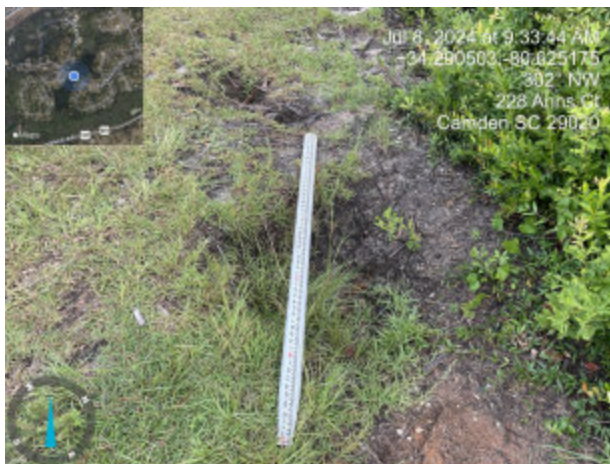
Numerous voids/subsided areas observed within the upstream slope. Depths vary, but all are greater than 12 inches in depth. Standing water was observed within one of the voids. Some of the voids appear to have formed around tree roots.

Engage a Professional Engineer to evaluate the condition and stability of the upstream slope, especially around areas with voids. Engineer should develop a permit application for repairs and stabilization of the upstream slope.

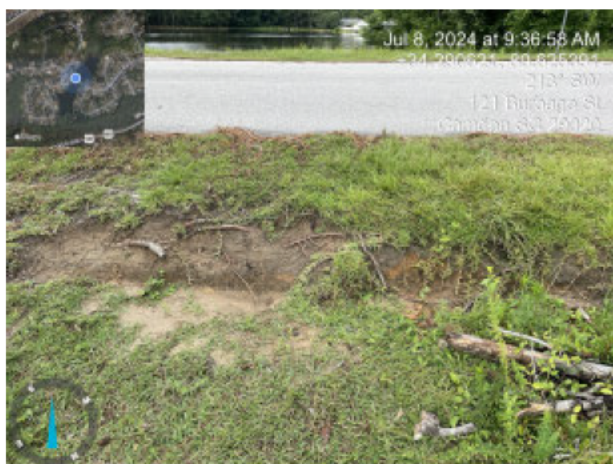
Minor scarping observed on the upstream slope near the right side of the dam. Less than 12 inches.

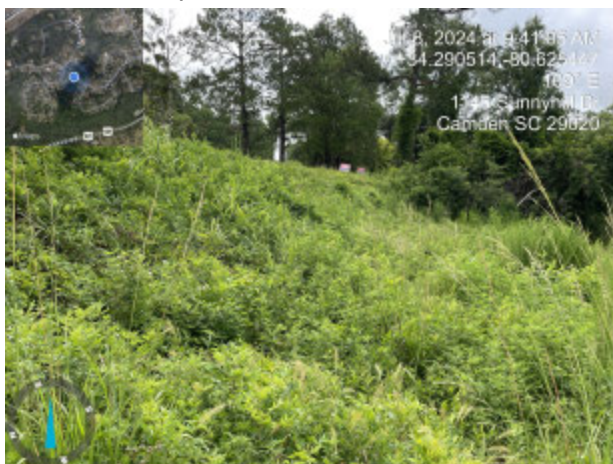
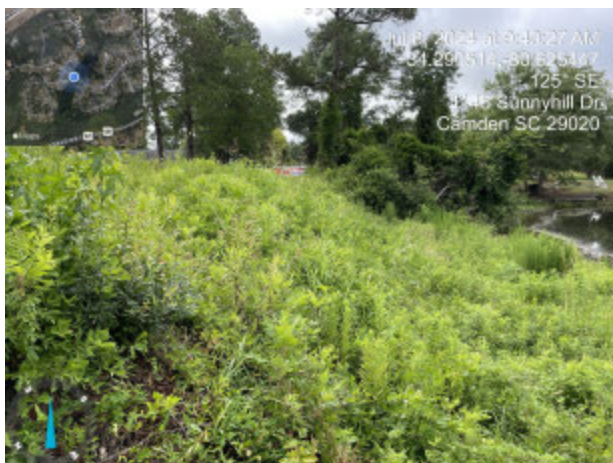
Dense brush and woody vegetation less than 4 inches in diameter prevented full inspection of the downstream slope.

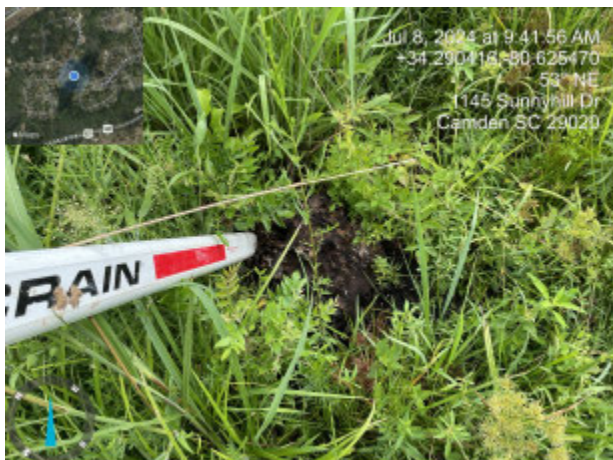
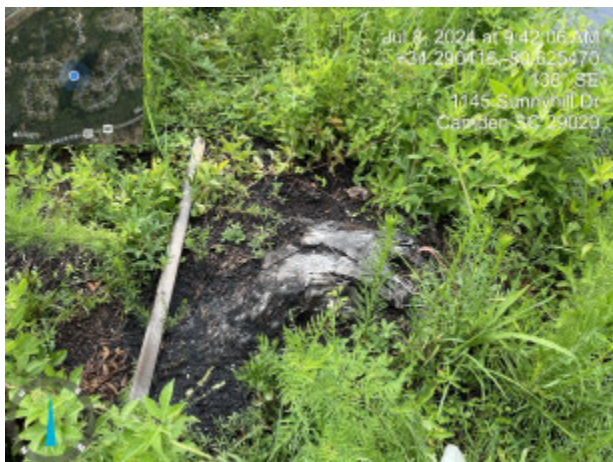
Decaying tree stumps observed.

Engage a Professional Engineer to evaluate the stability and condition of the downstream slope, especially around decaying tree stumps. Engineer should develop a permit application for repairs of the voids and eroded sections of the downstream slope.

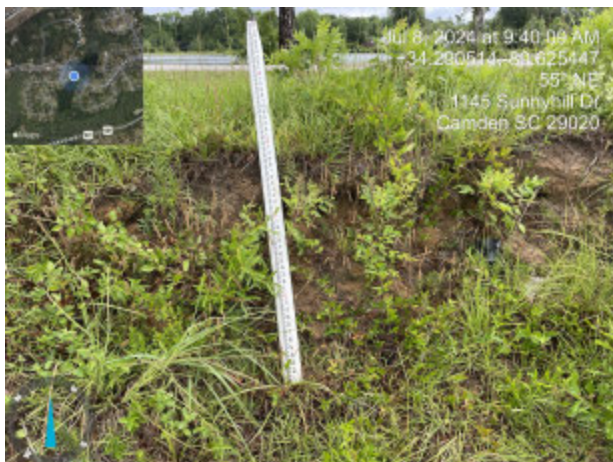
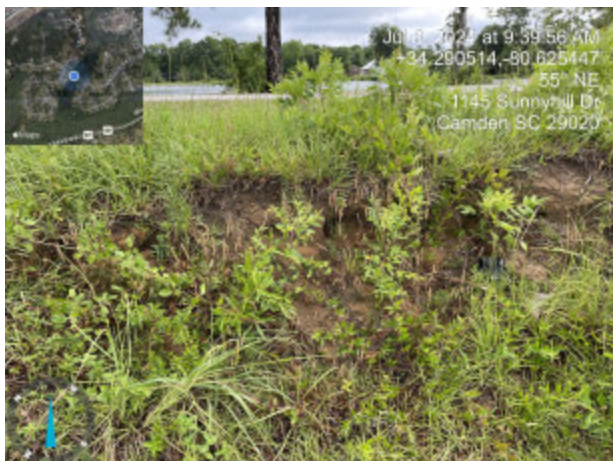
Scarp along the shoulder of the crest and downstream slope. Nearly vertical slope along this section of the downstream slope.

Engage a Professional Engineer to evaluate the area of the downstream slope experiencing scarping and to develop a permit application for slope repair and stabilization.

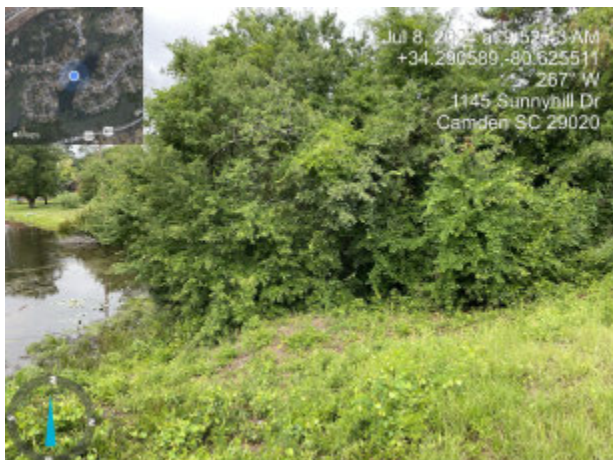
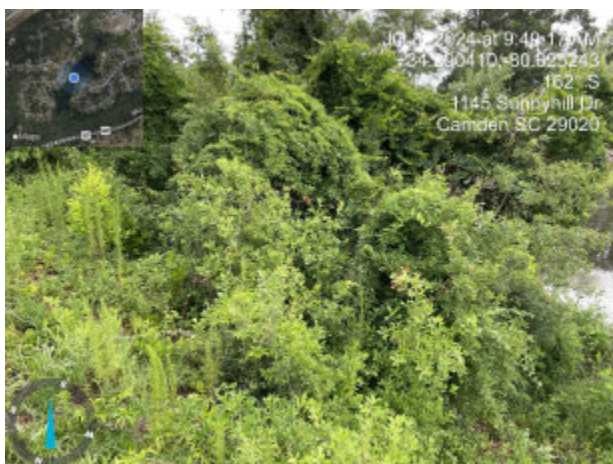
Dense brush and woody vegetation observed in the groins of the downstream slope.

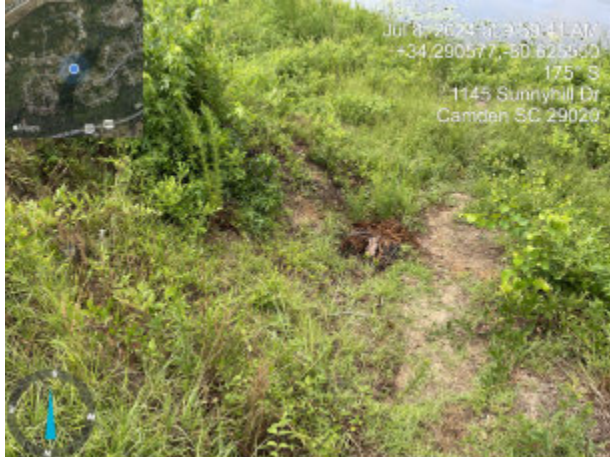
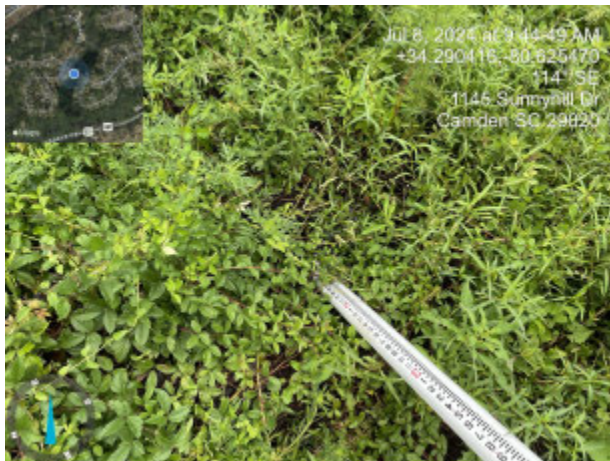
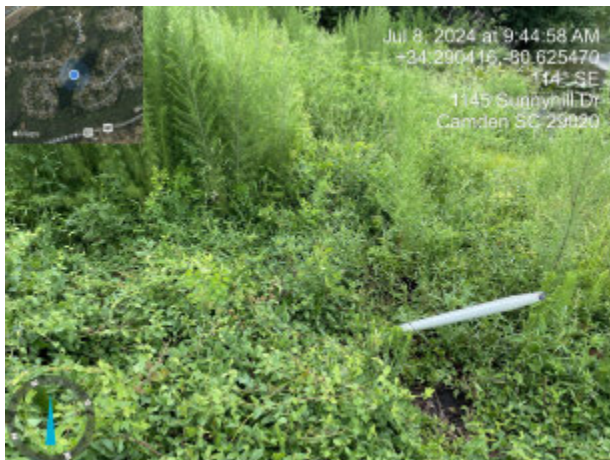
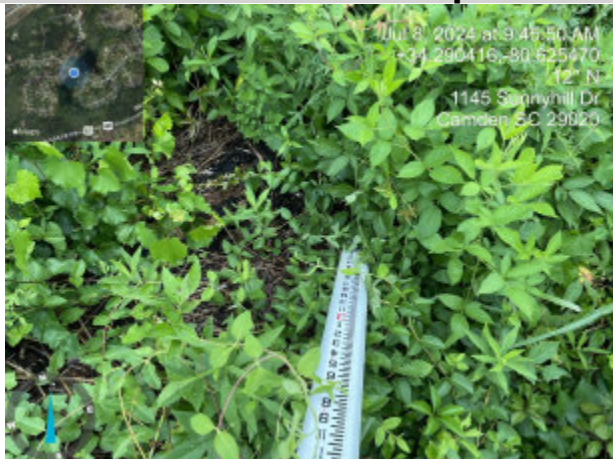
Multiple voids observed within the downstream slope, potentially around tree roots and stumps. Depths greater than 2 feet observed in some areas.

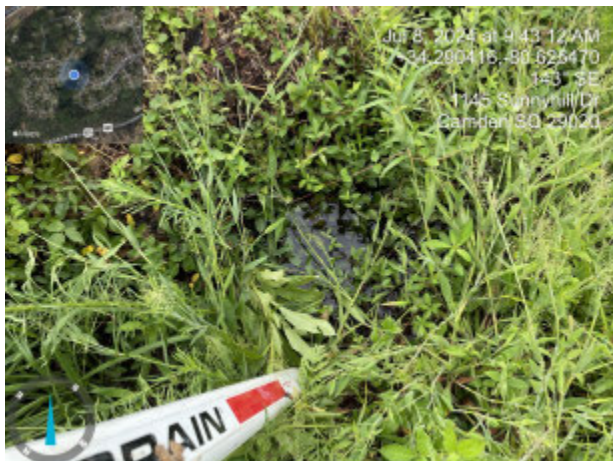
Puddles observed along the downstream slope, potentially due to recent rainfall.

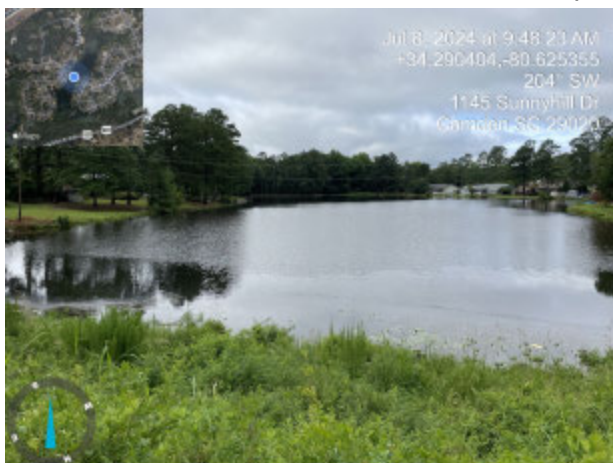
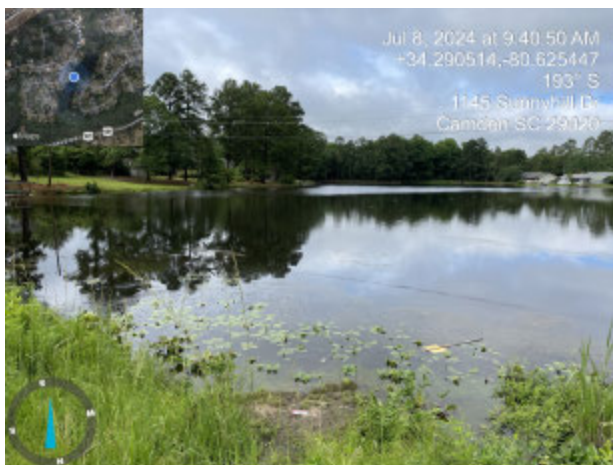
Downstream area is the reservoir for Lower Sunnyhill Pond Dam.

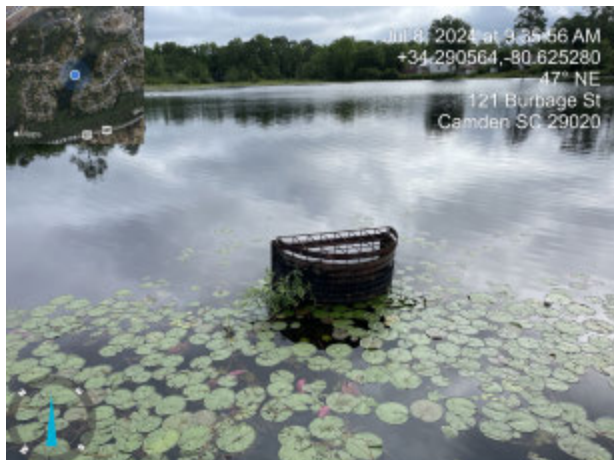
Trashrack is present, but is off-centered.

Monitor for deterioration and rusting of the inlet structure.  
Recommend engaging a Professional Engineer to conduct a camera investigation of the primary spillway to assess the condition of the spillway pipe.

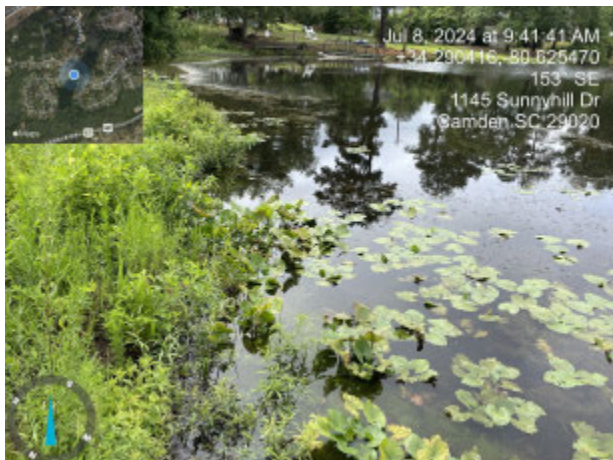
Approximate location of the outlet pipe. Due to water level of lower pond, outlet pipe could not be observed.

Recommend engaging a Professional Engineer to conduct a camera investigation of the primary spillway to assess the condition of the spillway pipe.
