# PRO DISPOSAL USA (BARNWELL RESOURCES) CLASS 2 LANDFILL : P1TJ-QJAP-426

Solid Waste - Class 2 Landfill : SW\_CLS2\_LF

| <b>Date of Inspection</b> | 6/15/2026 |
| <b>Permit #</b> | 072410-1201 |

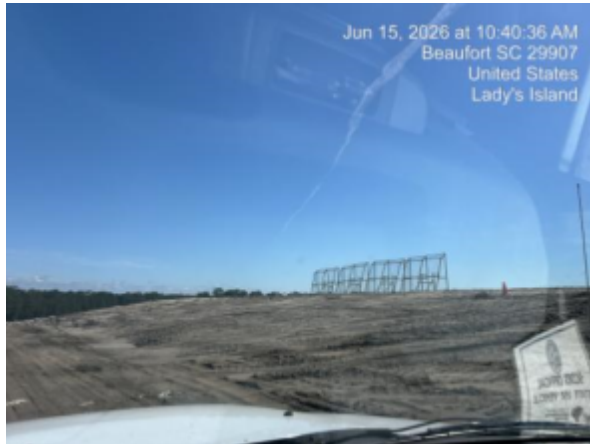
**9. Frequency of cover meets regulatory/ permit requirements** No

A little cover has been added since last inspection, but 30 day full cover requirement has not been met (R.61-107.19 part IV.C.7)

| Inspection Detail | |
|---|---|
| <i>Comments:</i><br>Once compactor is back up, get all waste compacted and covered to meet 30 day cover requirement. Maintain as small a working face as can be safely and efficiently managed. | |

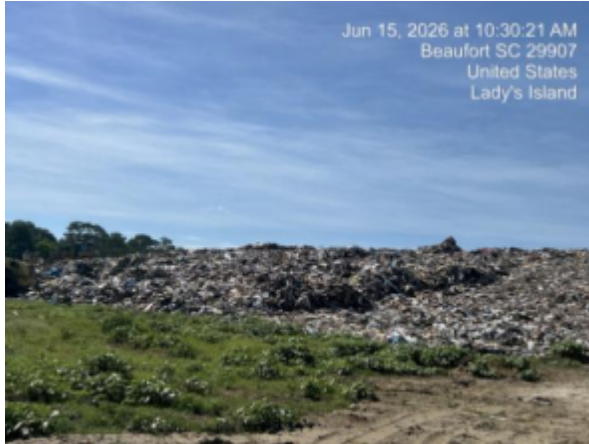
**15. Waste spread in uniform layers and compacted to smallest practical volume**

Some of the working face needs better compaction. Get this done once compactor is back online.

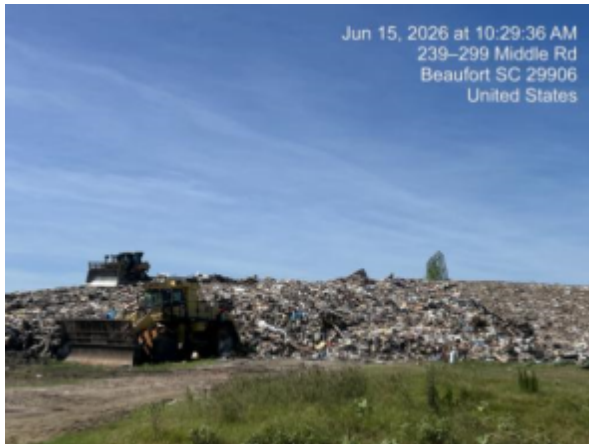
**16. Working face as small as can efficiently and safely be managed**

Working face too large, get this covered up before next inspection.

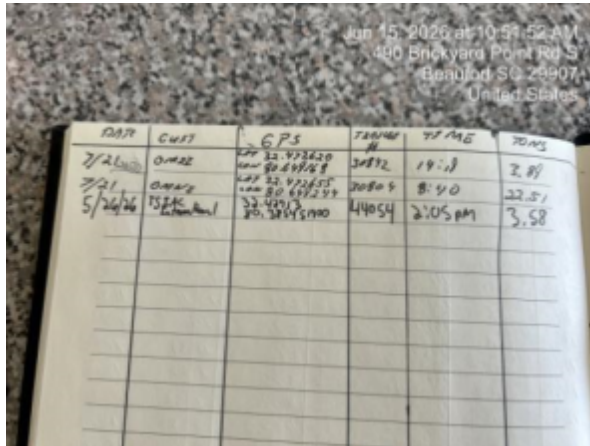
One load of asbestos accepted since last inspection, was immediately covered and logged.

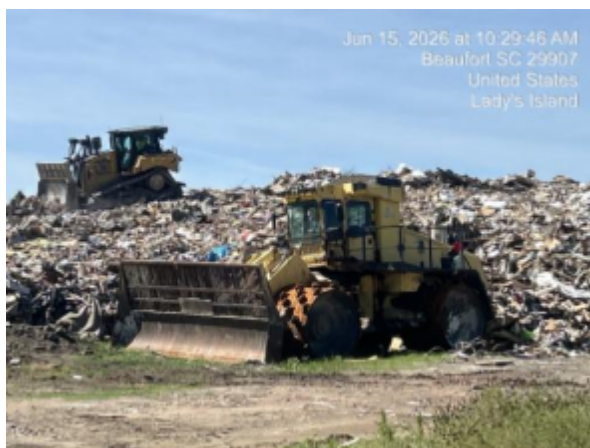
Compactor and backup are down, operator stated one should be back up in a few days.

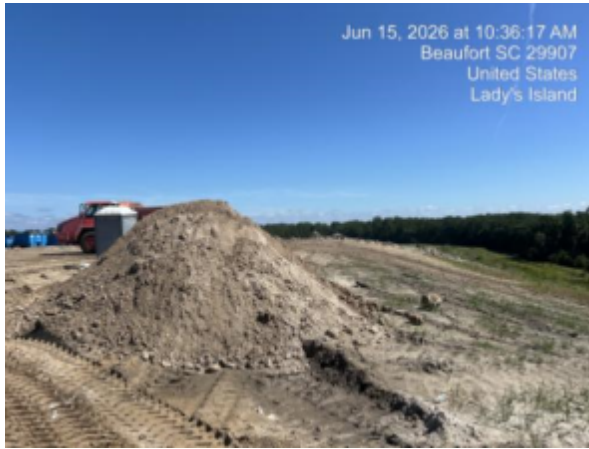
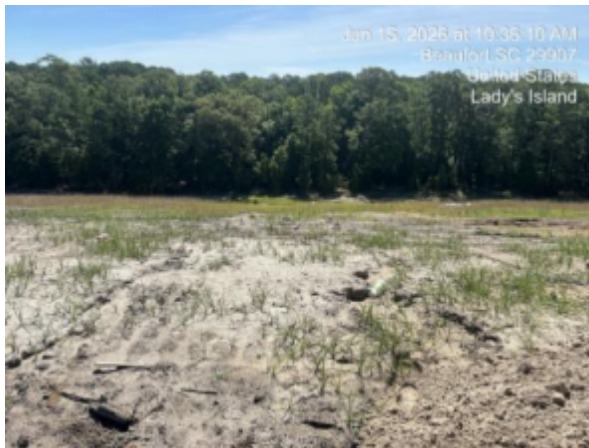
Minor washout from recent rain event. Berm being constructed at landfill peak along eastern slope to prevent future washouts.

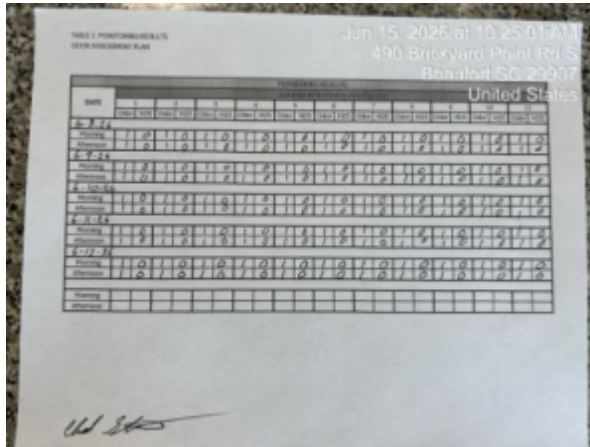
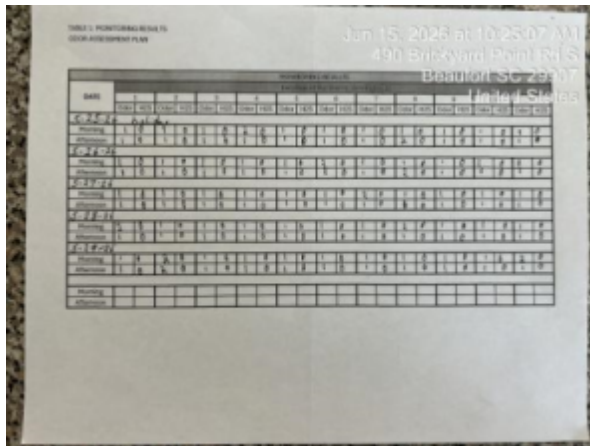
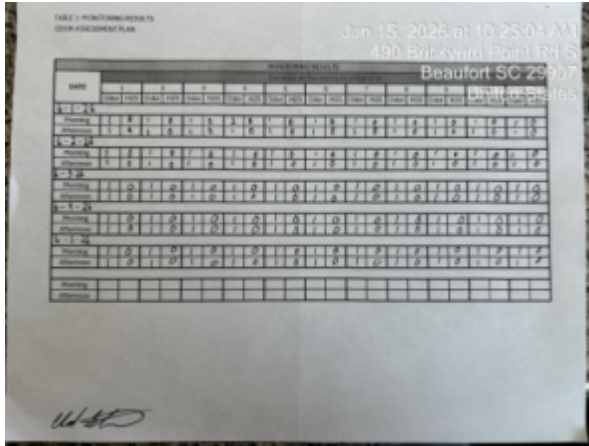
SCS has collected samples and flown drone to look for gas hotspots for the proposed gas collection system. Facility is still documenting daily odor monitoring (photos attached). Eastern slope has had test bores for thickness, areas not at 2' of cover will be capped.
