# PRO DISPOSAL USA (BARNWELL RESOURCES) CLASS 2 LANDFILL

P1TJ-QJAP-426

| <b>Solid Waste - Class 2 Landfill</b> | |
| <b>Date of Inspection</b> | 10/22/2025 |

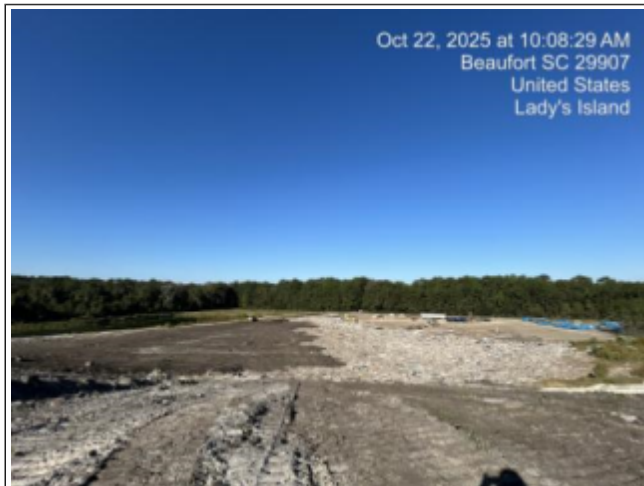
Cover applied over more than half of the working face and more covering occurring during the inspection.

Photo Comment: Working face viewer from above

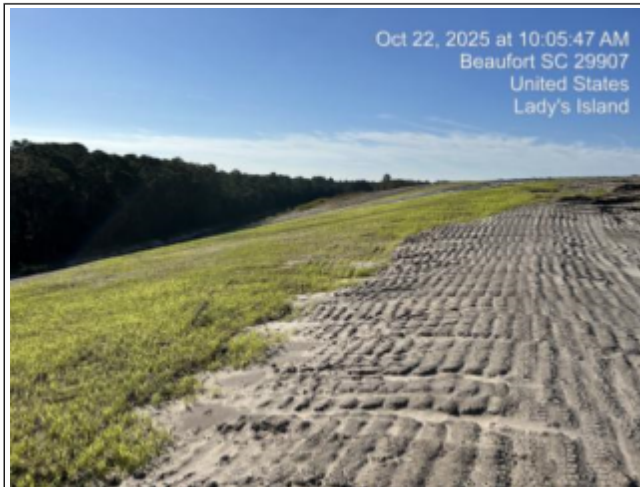
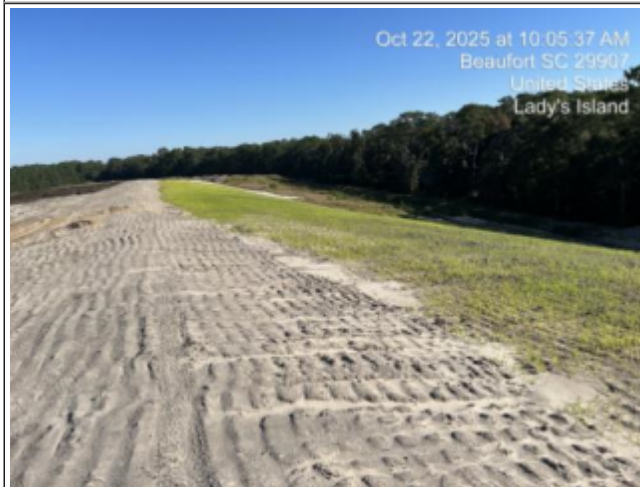
Facility continues to maintain the integrity of the cover on the outer slopes and repaired any erosion rills that occurred during the rain event 10/10-10/12.

Photo Comment: Outside slope facing Middle Rd

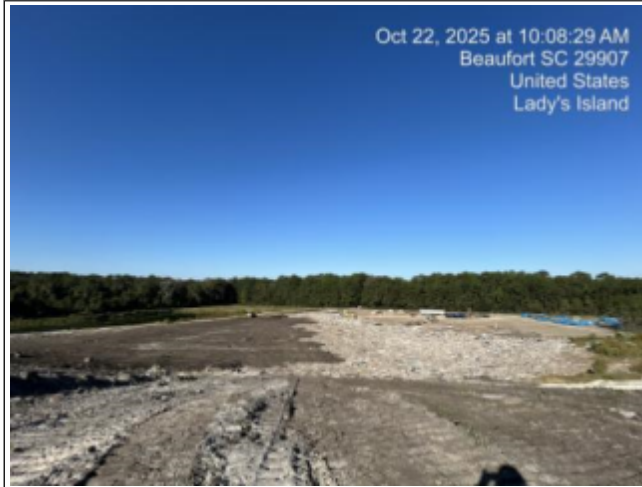
Cover applied to more the half of the open working face since last inspection and more covering occurring during being applied during inspection.

Photo Comment: Working face viewed from above

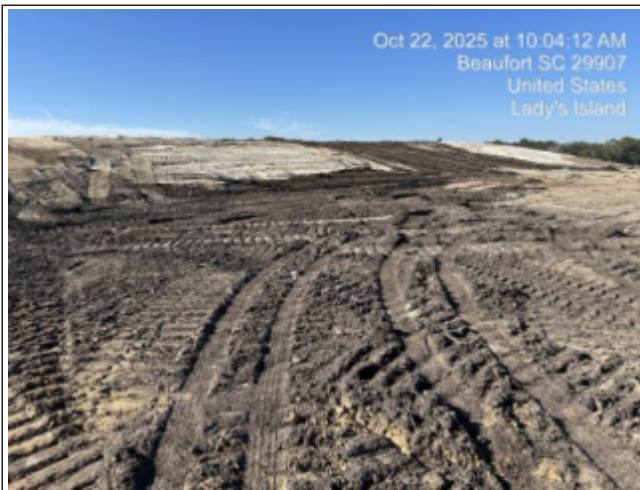
Facility is working to address the low-lying area on the top of the landfill. Fill/cover material has been added to this area to help promote positive drainage of water. The facility is also working on a plan to redirect Stormwater down the old haul road away from fill.

Photo Comment: Fill/cover material applied to low lying area on top of the landfill.

Ensure working face and recently covered area is sloped so that water drains away from the rest of the fill area.

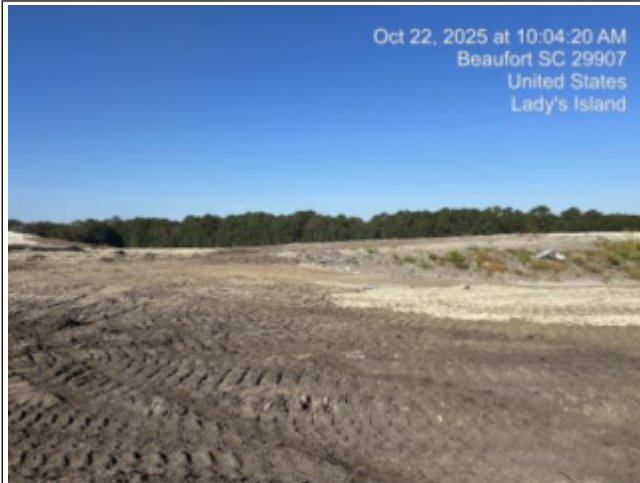
Photo Comment: Previously low lying area now graded so water will flow down the old haul road

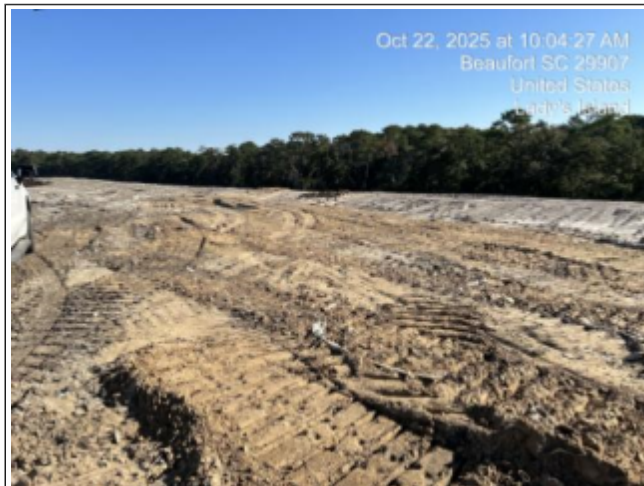
Berm installed at top of outside slope facing Middle Rd to divert water away from slope.

Photo Comment: The berm that has been built above the outer slopes along Middle Rd to divert Stormwater away from that slope
