Preliminary Inspection Report for South Carolina Regulated Dams and Impoundment Structures Regulations R.72-1 through R.72-9

A. Dam Number: D 0005 & Hazard Class c1 B. Name of Dam: Big Creek WCD Dam 2
C. Inspection Date (12/02/2013) & Time: 0930 D. Date of Last Inspection: (12/19/2011)
E. Location-County/City: Anderson / williamston F. EQC Regional Office: Anderson
G. Inspector's Name: Hannah Vinson
H. Owner's Name: Al Rentz (first phone #) and Paul Williams (second phone #)
I. Contact Person (if different from above): Al Rentz, present at time of inspection, phone number below
J. Dam Owner's or Contact Person's Phone Numbers: Home (864) 940 - 7418 Office (864) 847 - 1157 Other () - - - -
K. Dam Owner's or Contact Person's mailing address: Address 1 223 Walton Drive (Rentz) 124 P Williams Road (Williams) Address 2 (optional) City Williamston, State sc Zip Code 29697 - - - -

Re: WS Lee Steam Station Primary Ash Basin (D 4887) Preliminary Inspection Results
High Hazard, Anderson County

February 24, 2014 Preliminary Inspection for WS Lee Primary Ash Basin

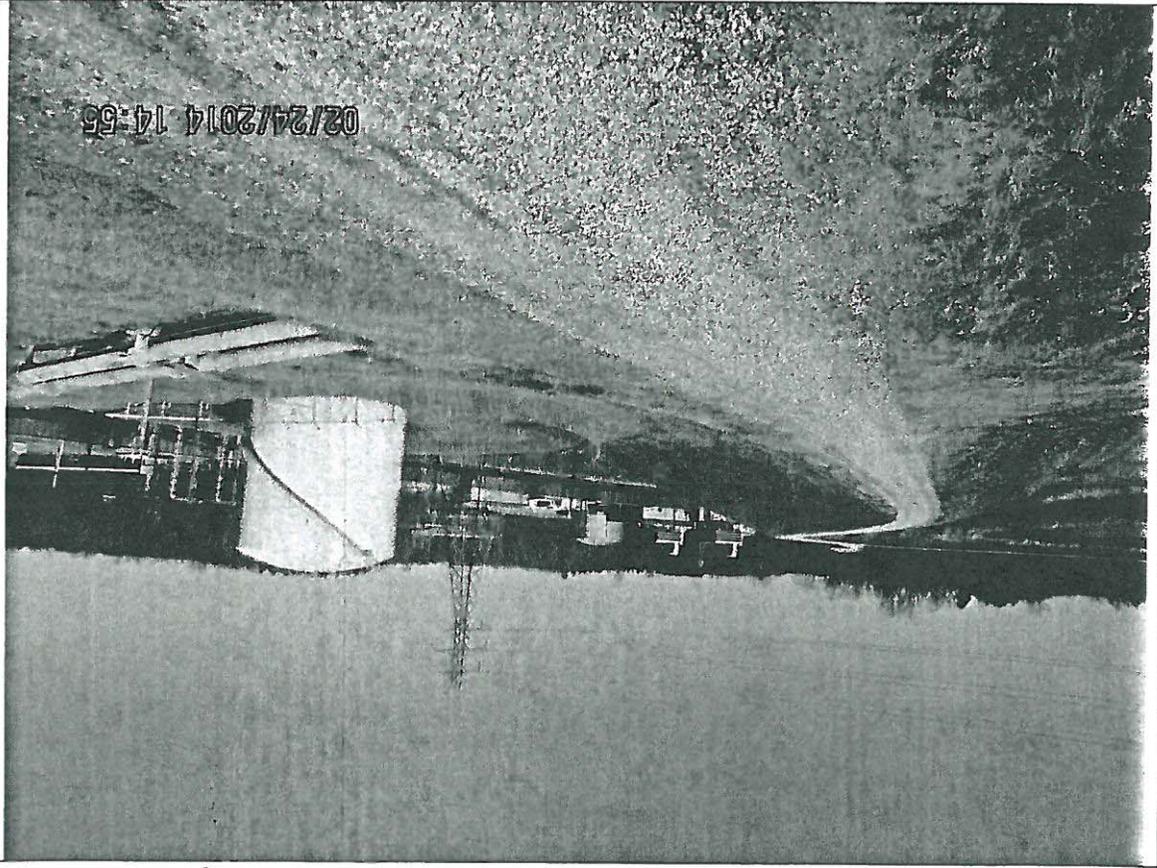
Photo 1-Major utilities, fuel storage, and railroad track shown directly below the southern most embankment for the dam.

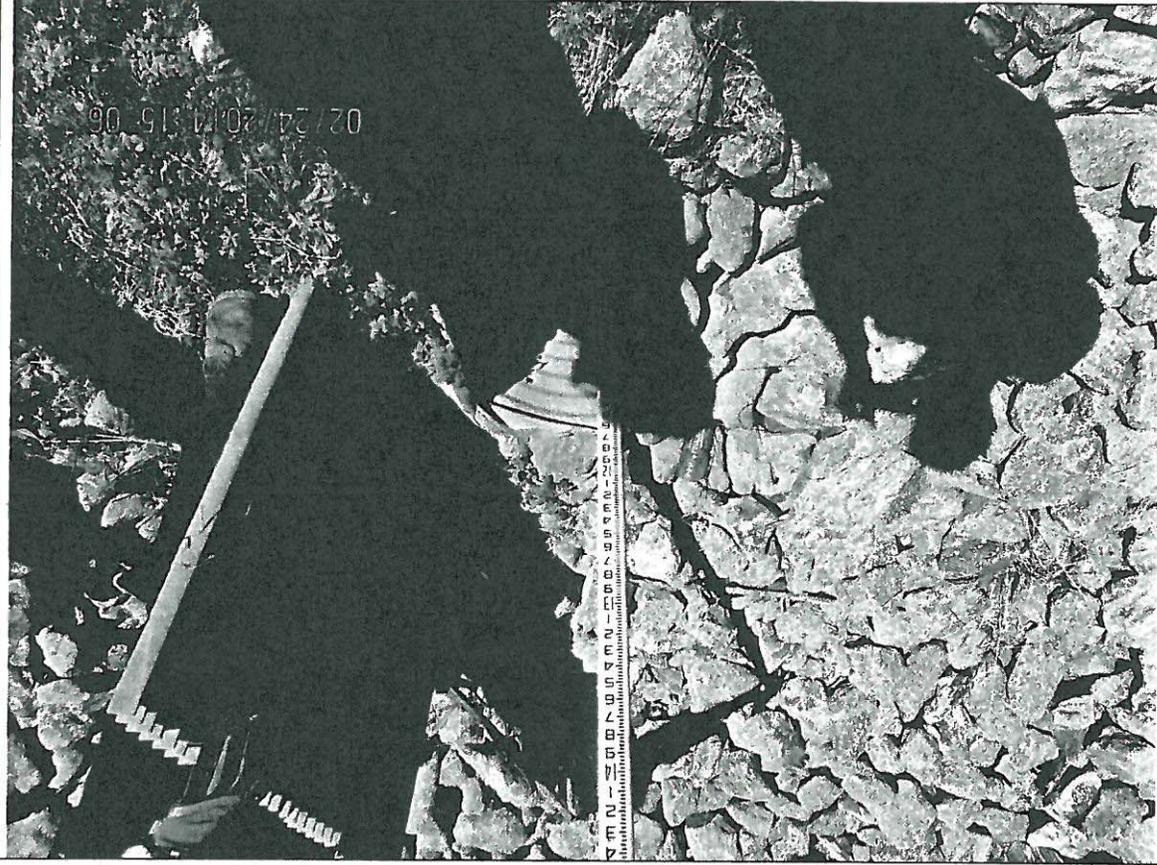
Photo 2-The Toe drain in this location is 11.5 feet deep.

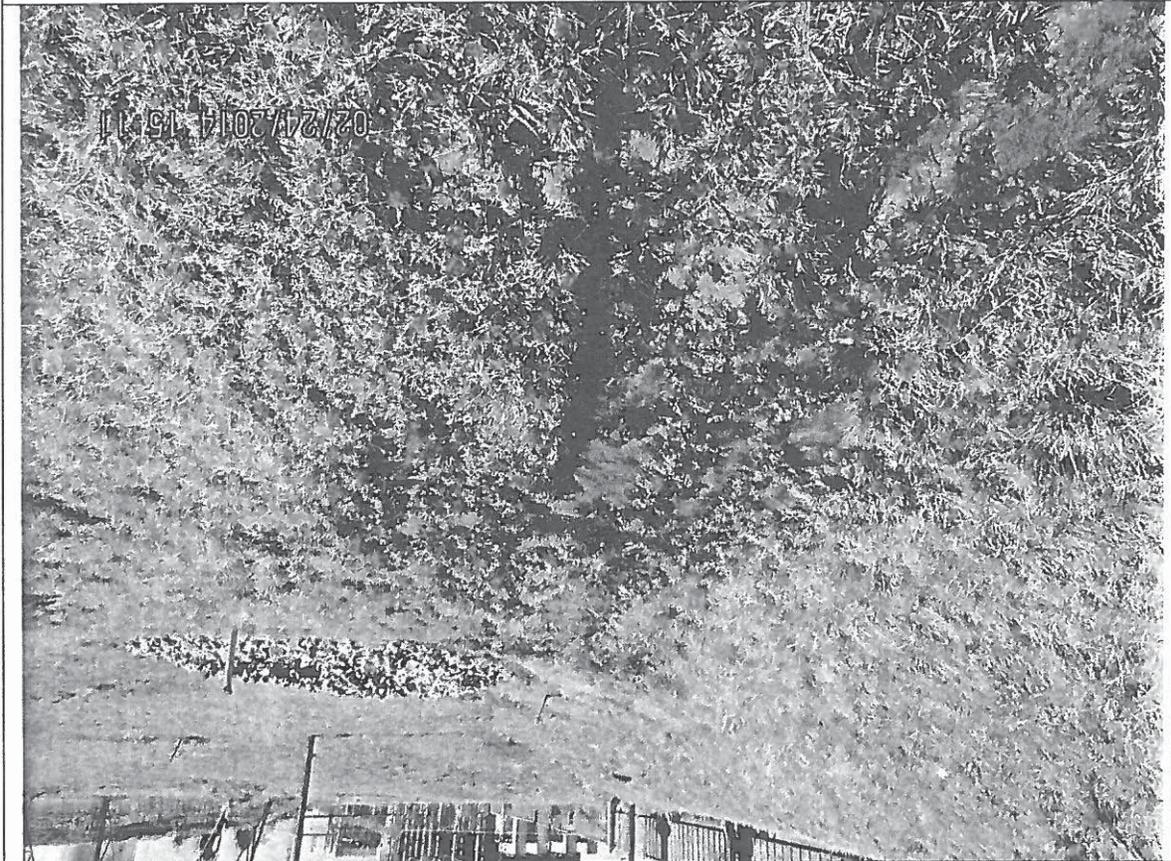
Photo 3 - Standing water is shown in this location left of the drain.

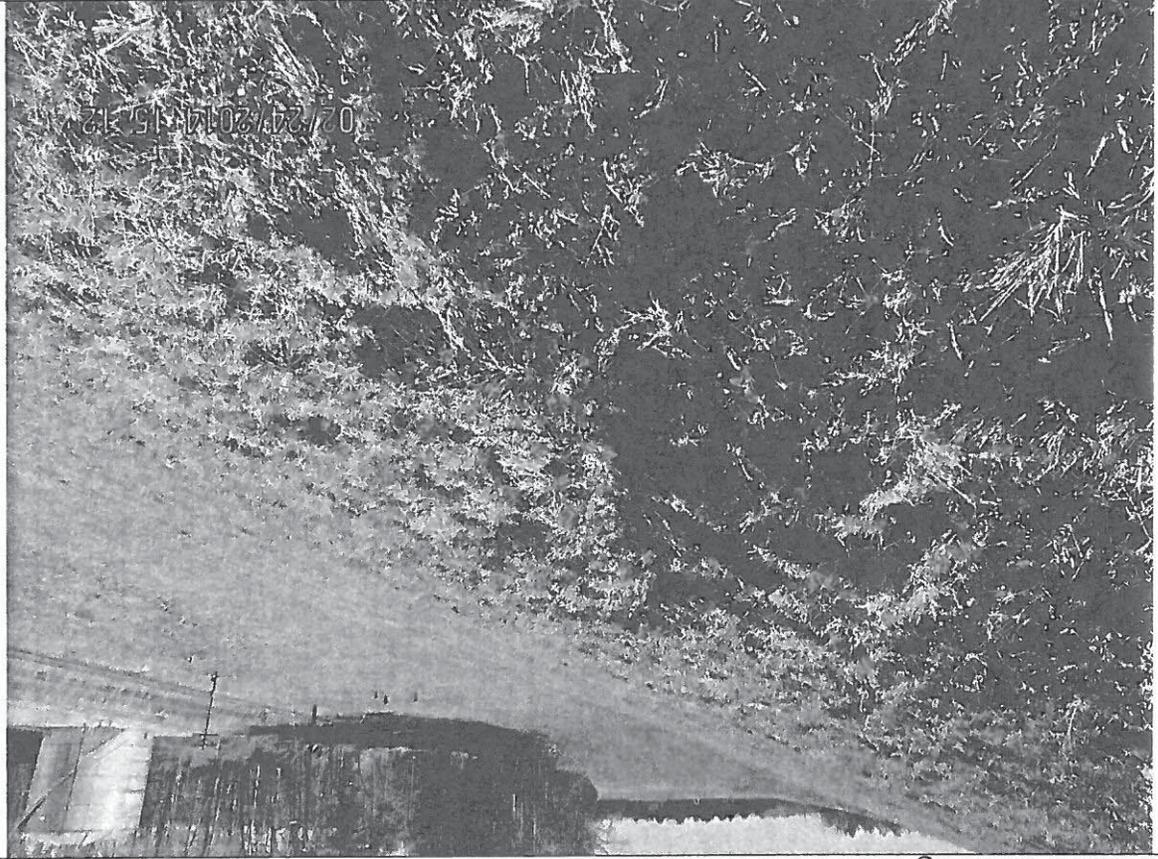
Photo 4 - Minor surface slippage shown on the embankment.

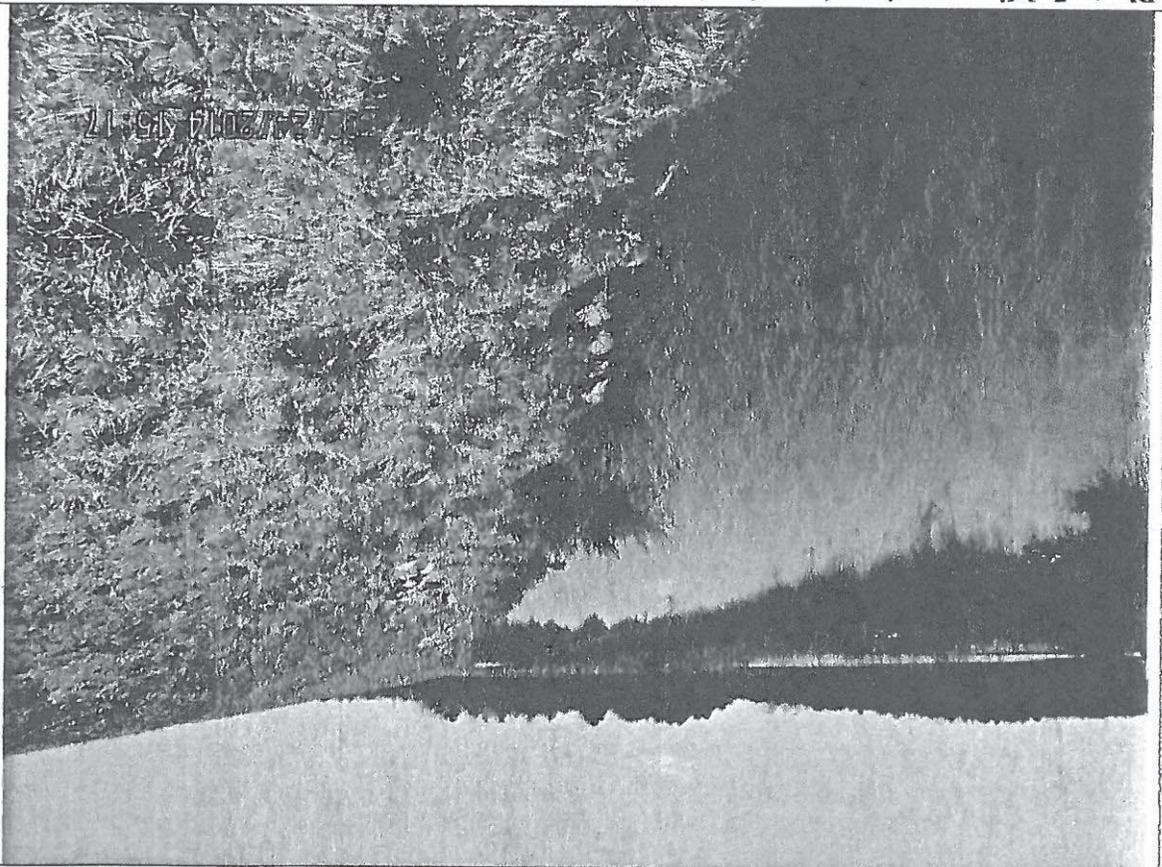
Photo 5 - Minor erosion along the shoreline of the upstream side of the embankment.

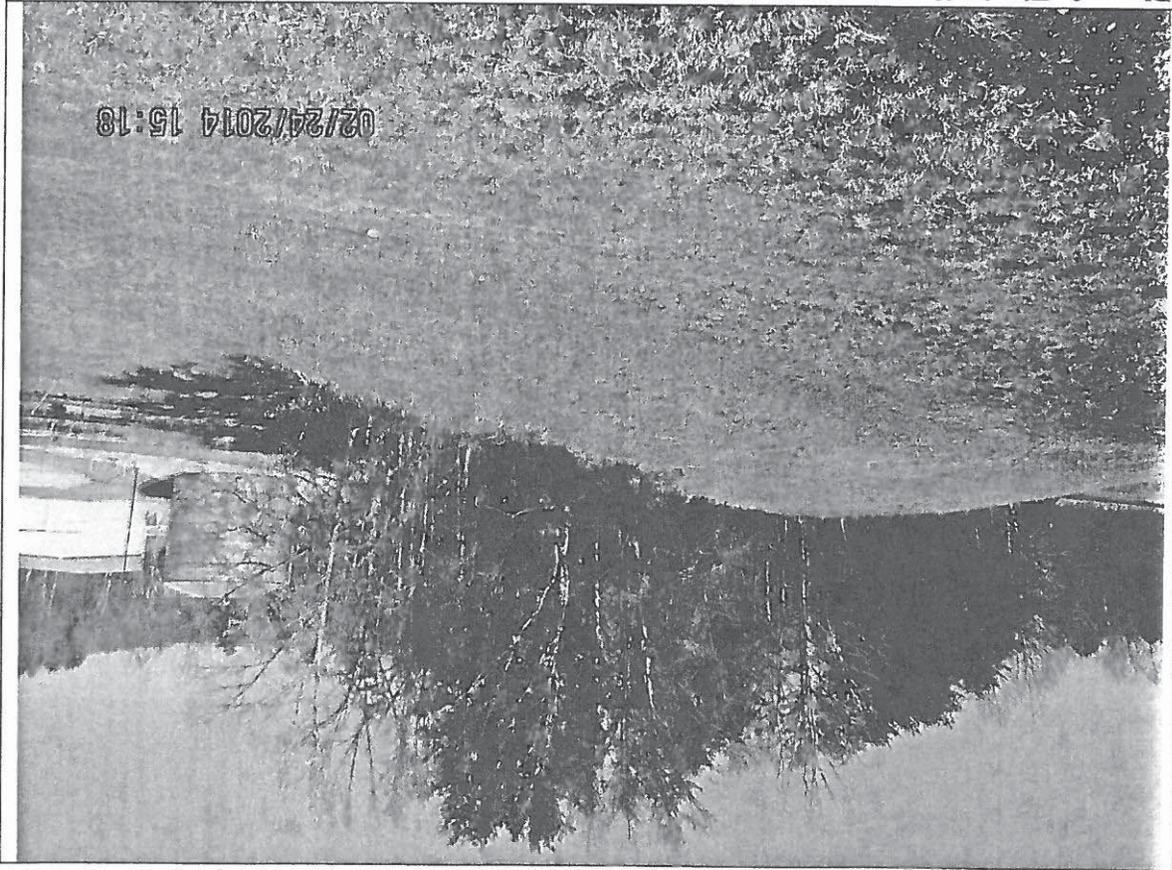
Photo 9- The buffer area along this area is not properly stabilized.

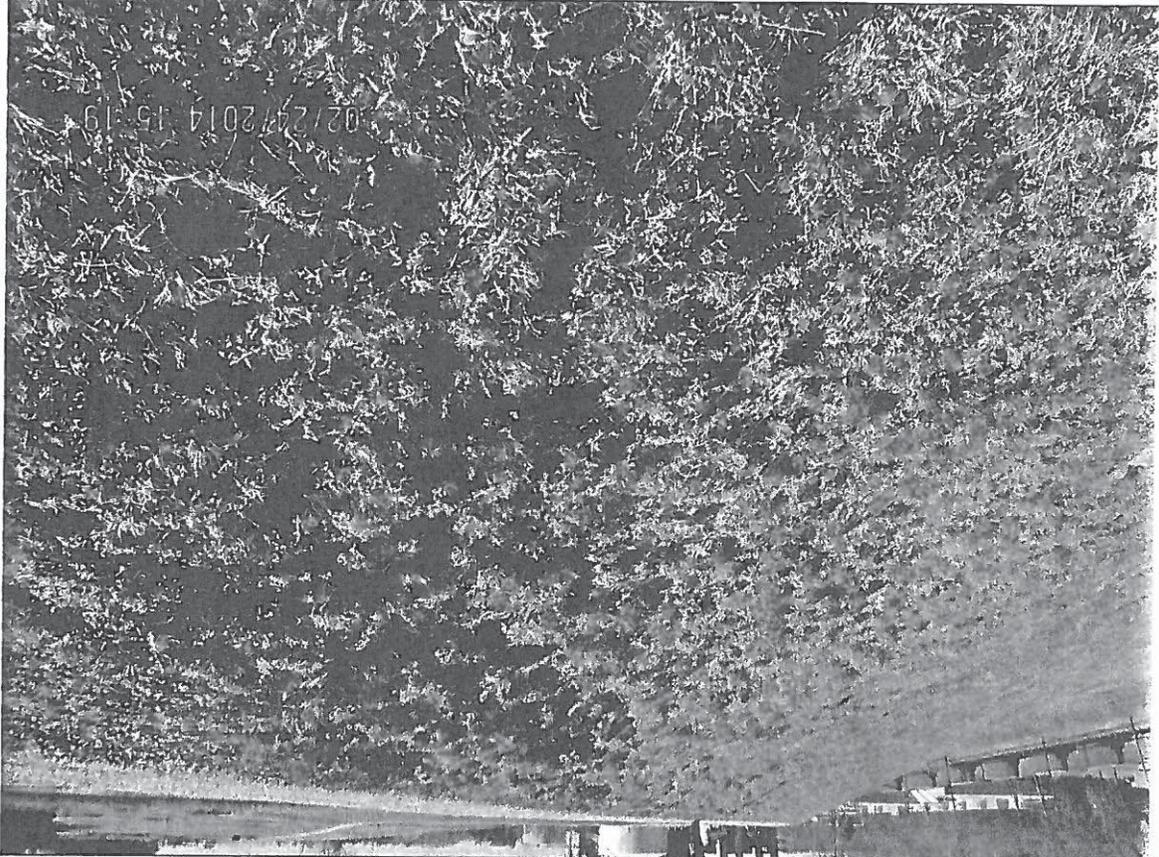
Photo 10- The slopes along the embankment are not uniform and some areas appear to be under high stress.

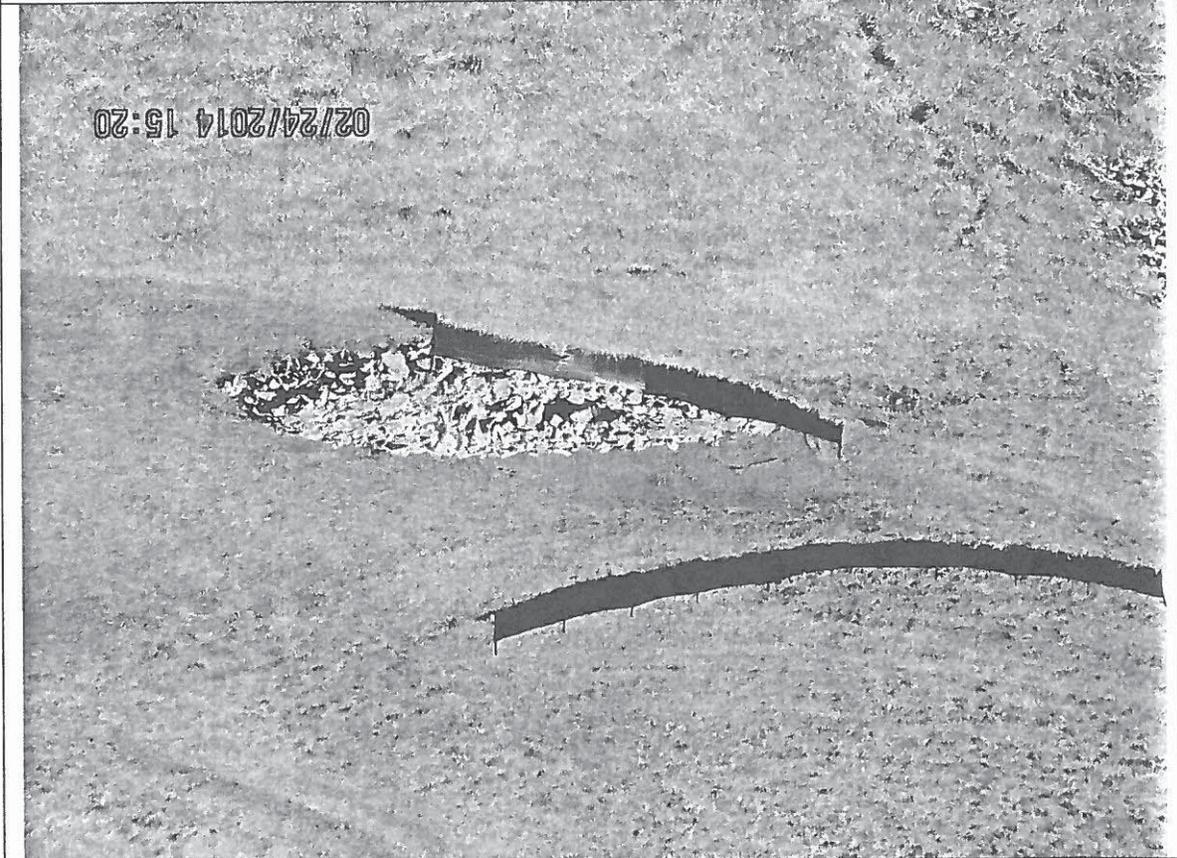
Photo 11 - This area was recently repaired due to sever erosion. Stabilization needs to be established in this area.

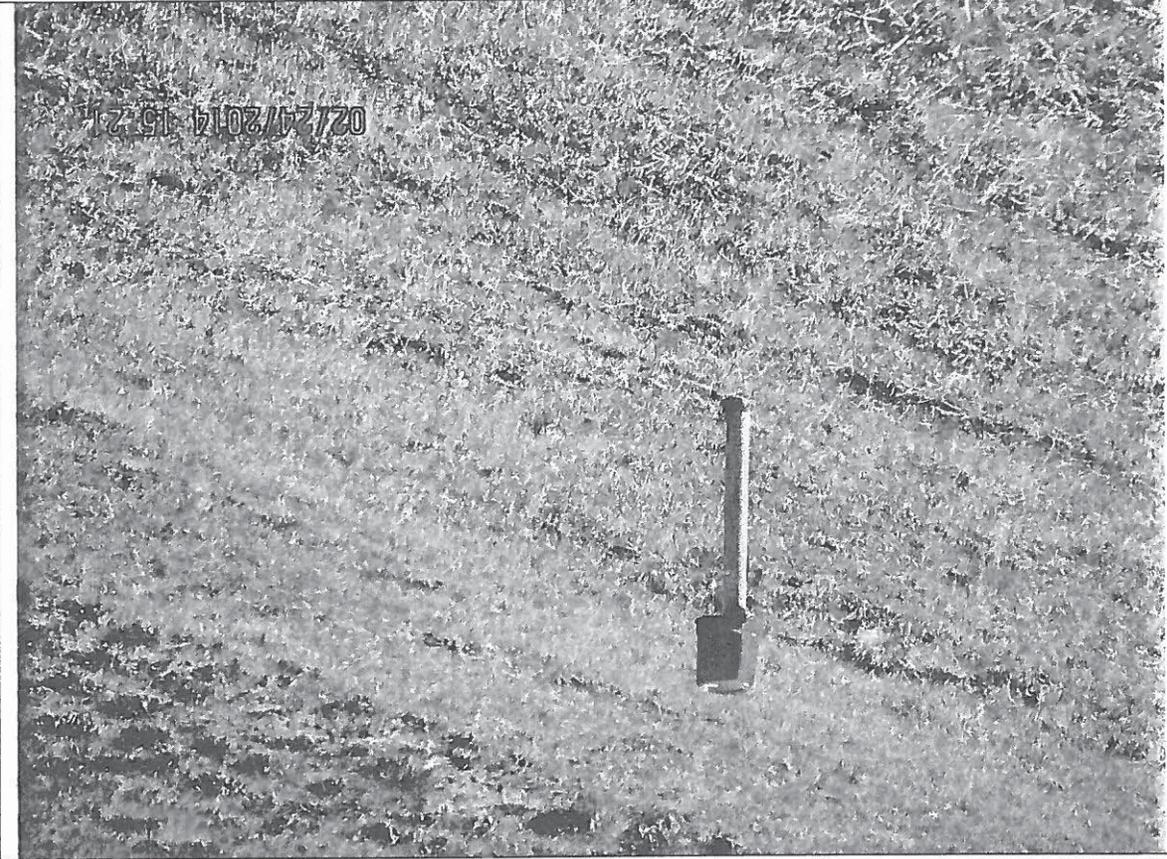
Photo 12 - Ensure all piezometers have locking caps.

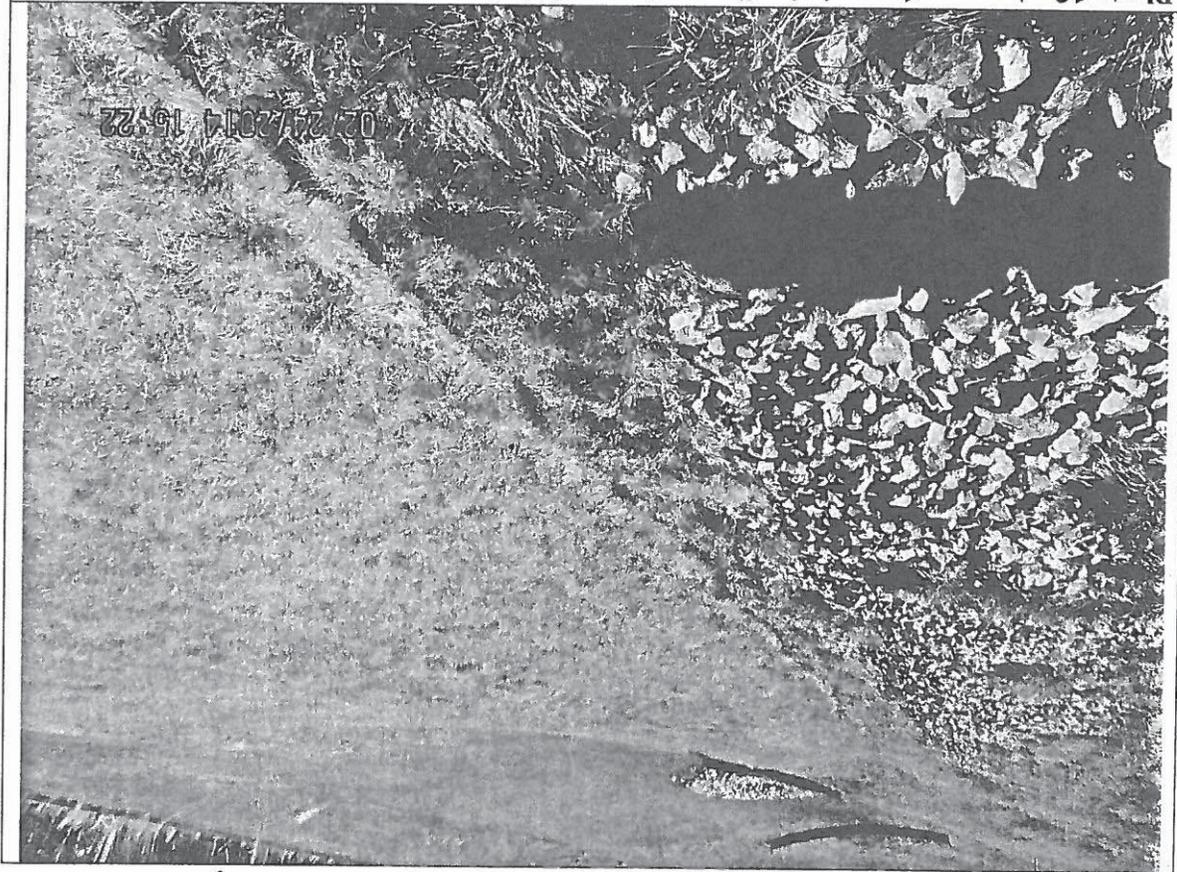
Photo 13- Appears the groin leading to the toe drain has erosion.

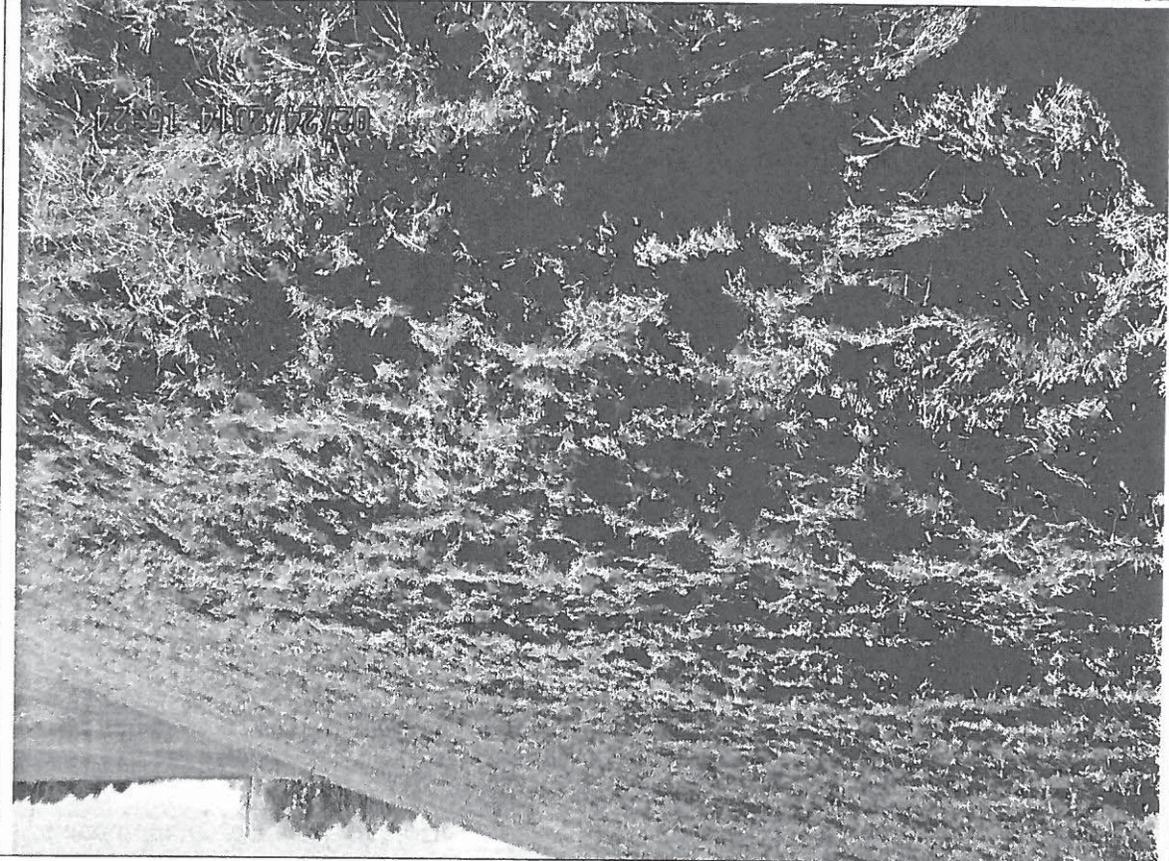
Photo 14- Marked Change in vegetation that may indicate high seepage line.

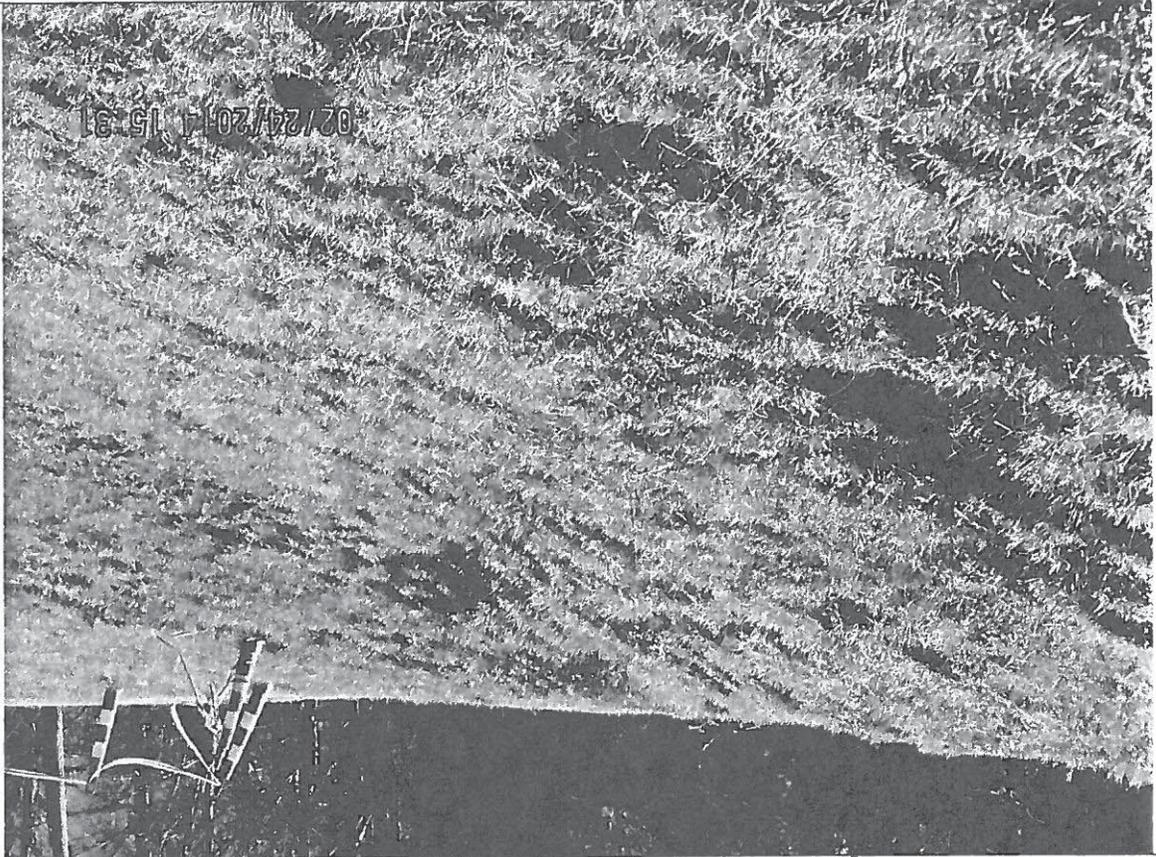
Photo 16- Minor surface slippages near crest on northern end of embankment.

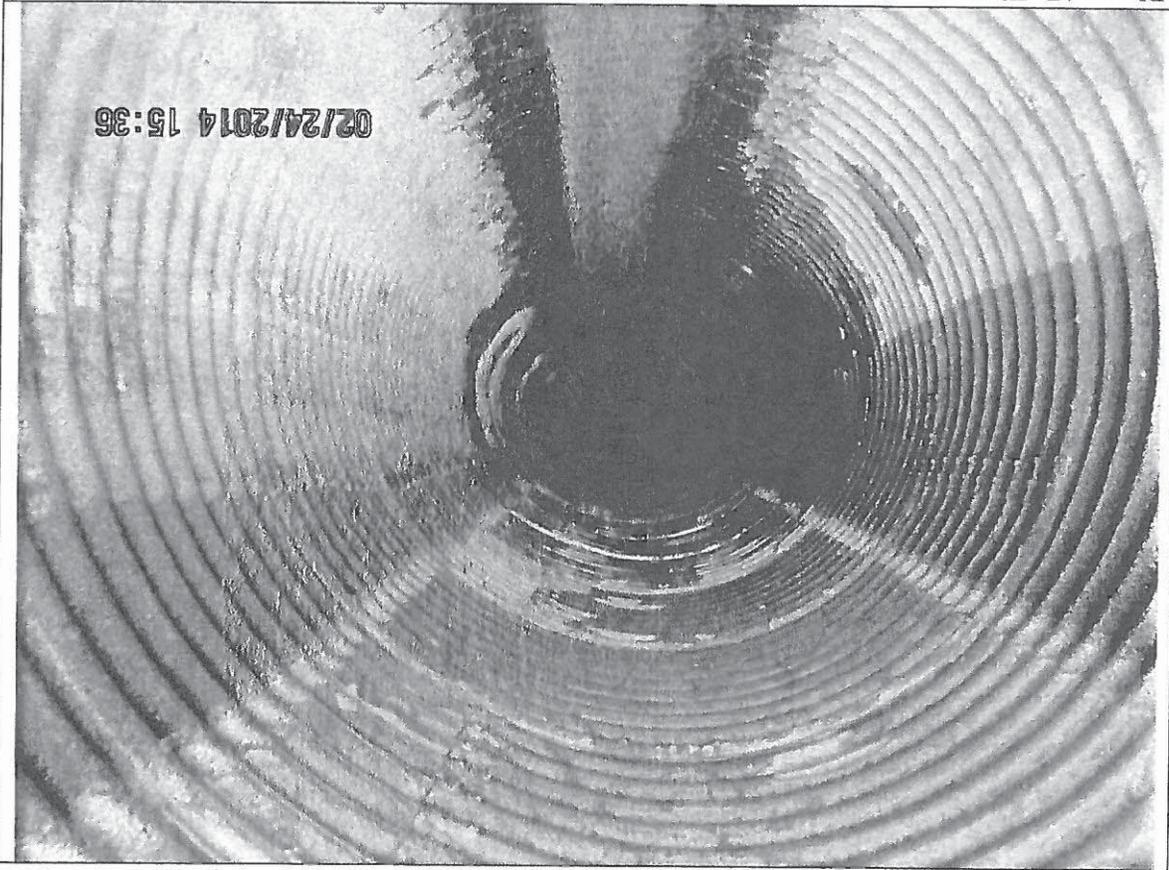
Photo 17- The second toe drain pipe shows a slight elliptical shape. This will need to be monitored.

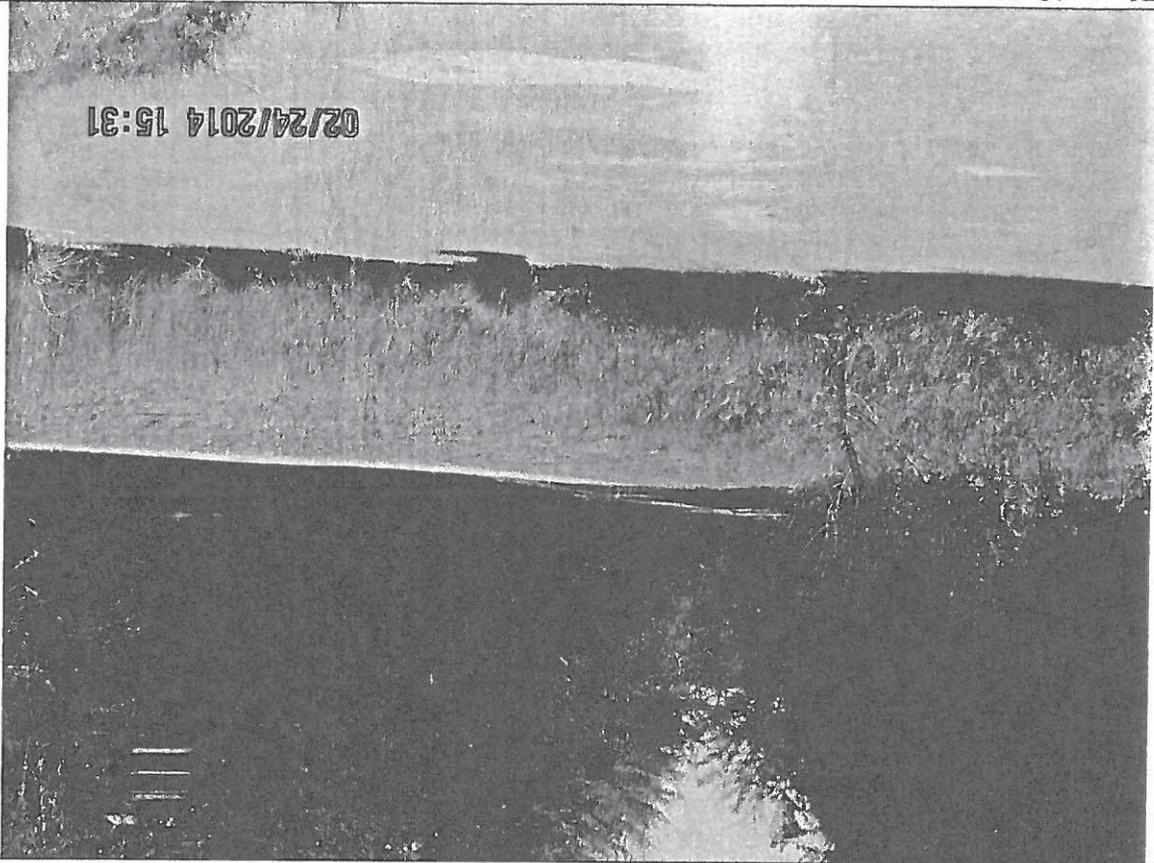
Photo 18- Trees in this location appear to be in natural grade.

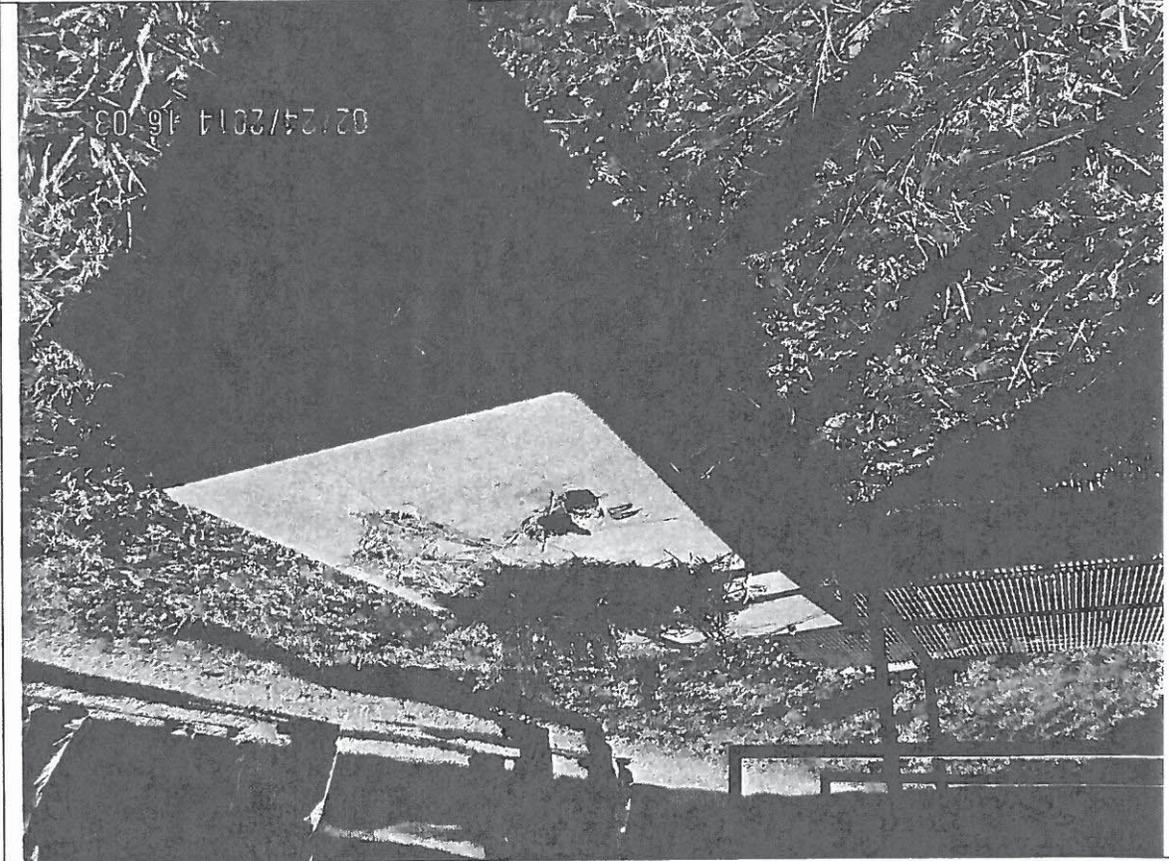
Photo 19- Areas protected from erosion on dike appear visibly higher.

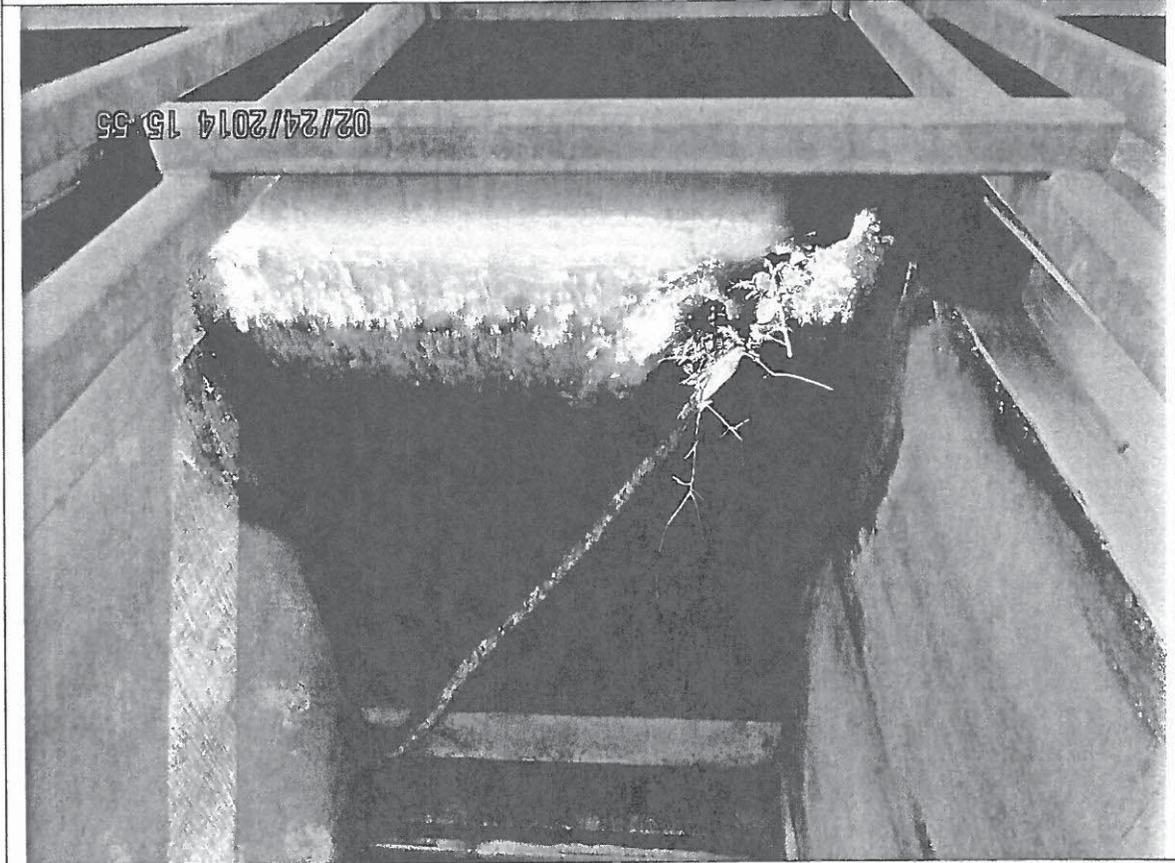
Photo 23- Debris shown within riser/spillway structure of primary ash basin.

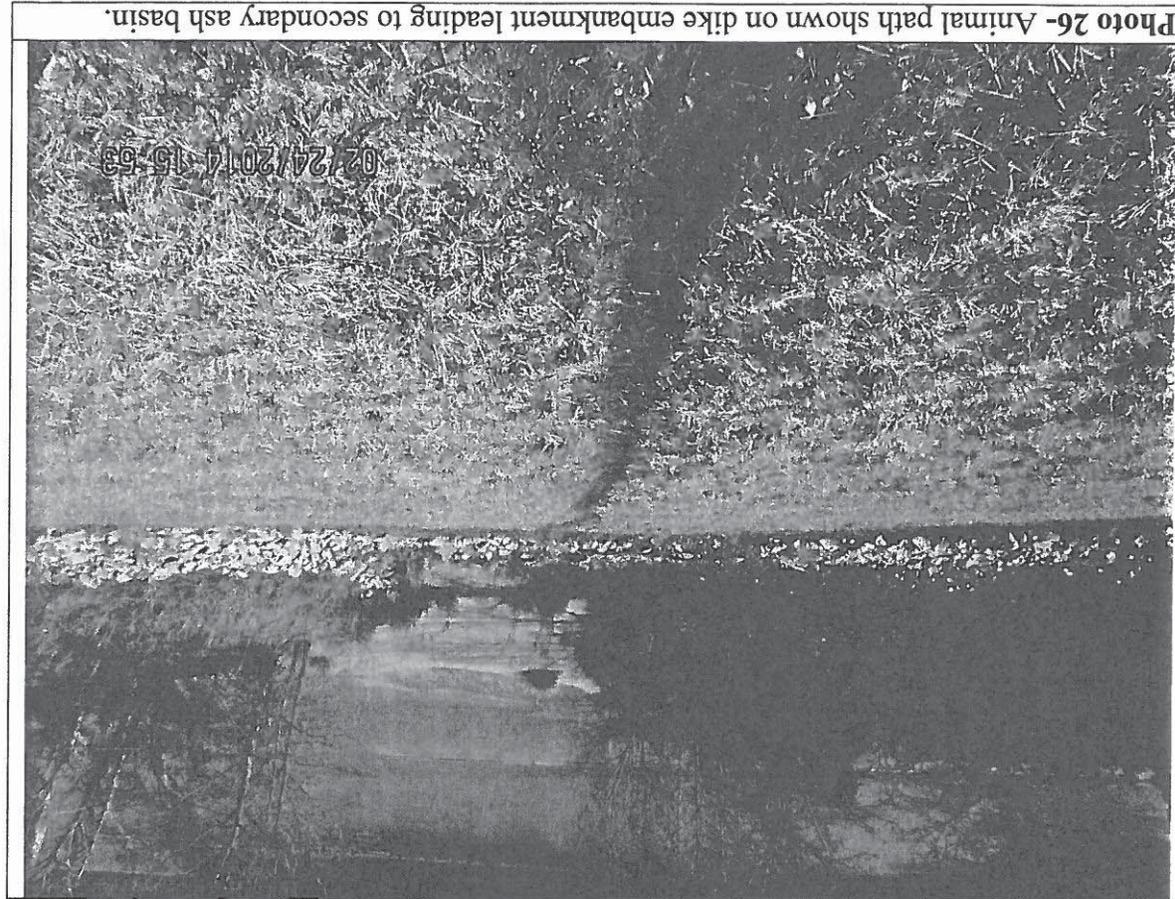
Photo 26 - Animal path shown on dike embankment leading to secondary ash basin.

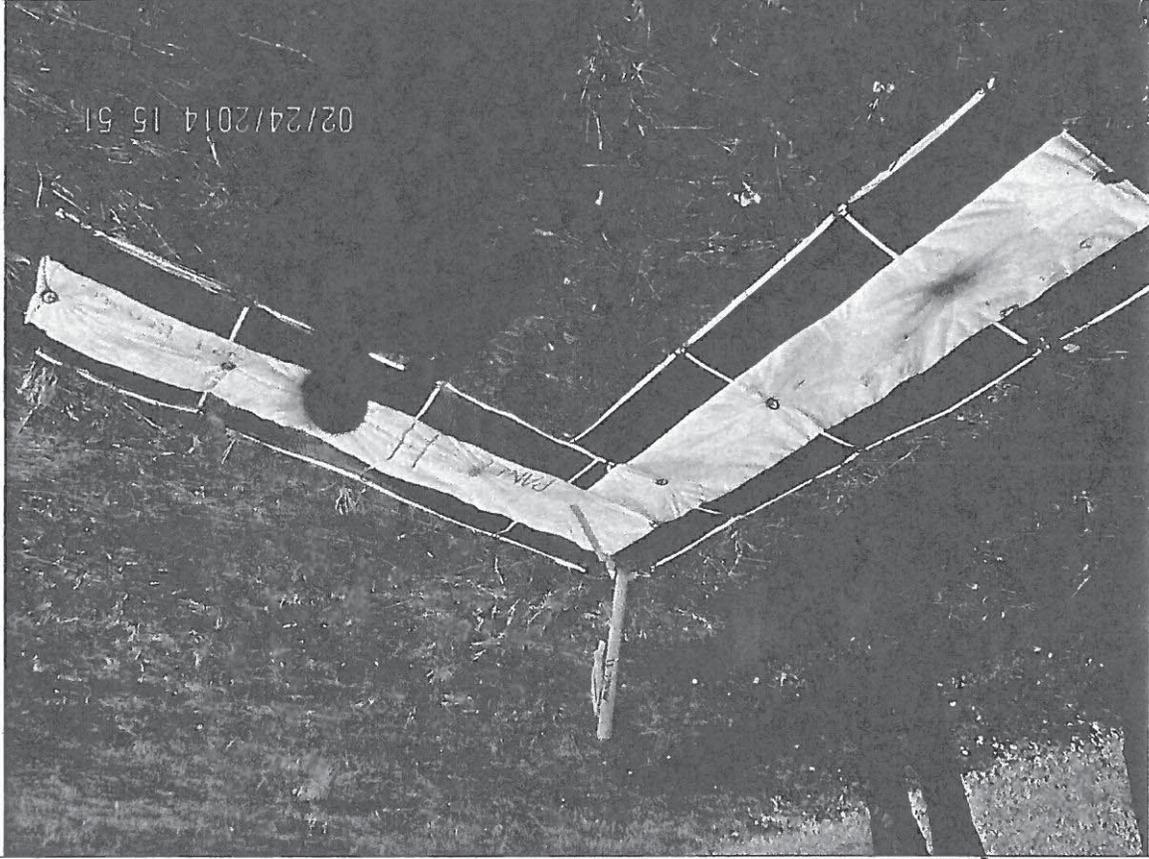
Photo 28- Unusual survey markings on dike embankment.

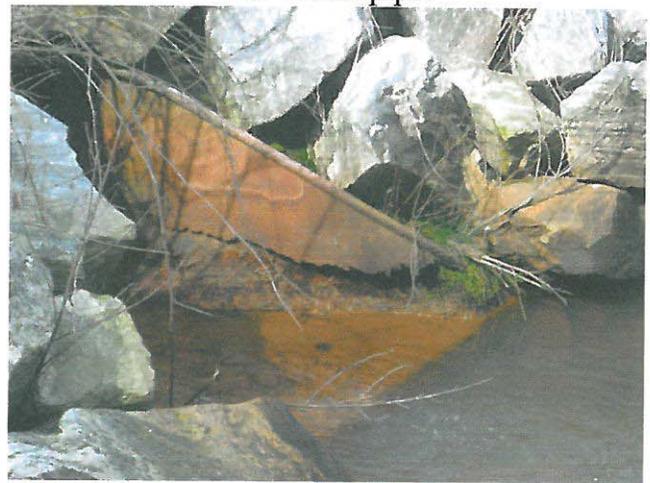
16. Rust on outlet pipe.

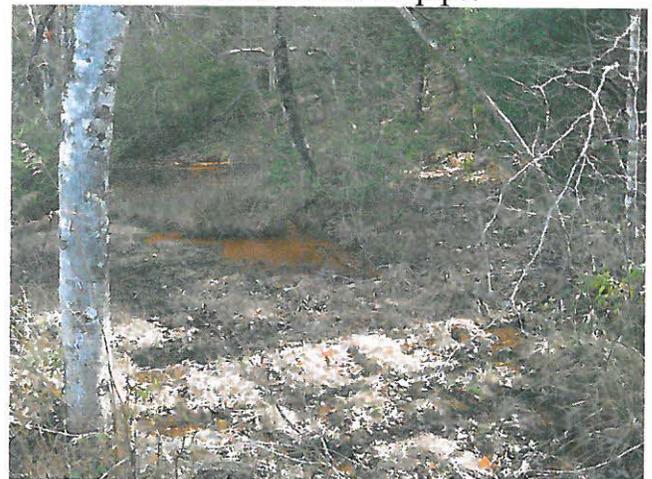
18. Wet area in right groin.

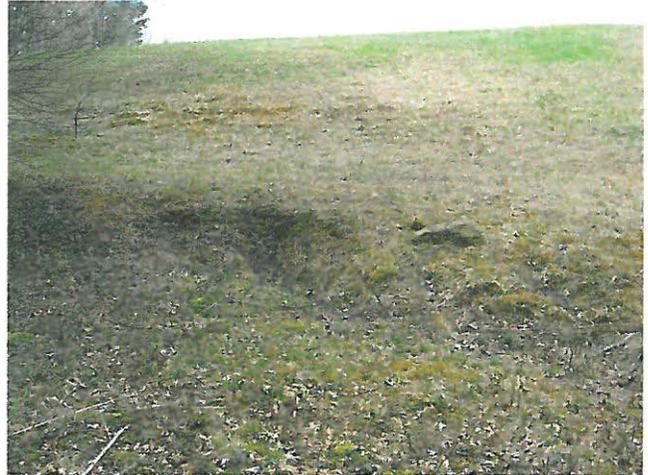
13. Possible spring on back side of dam.

14. Possible spring on back side of dam.

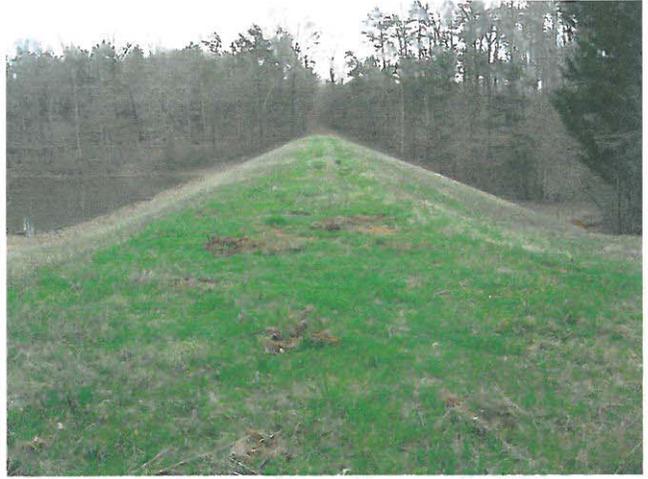
2. Crest of dam with evidence of wild hogs.

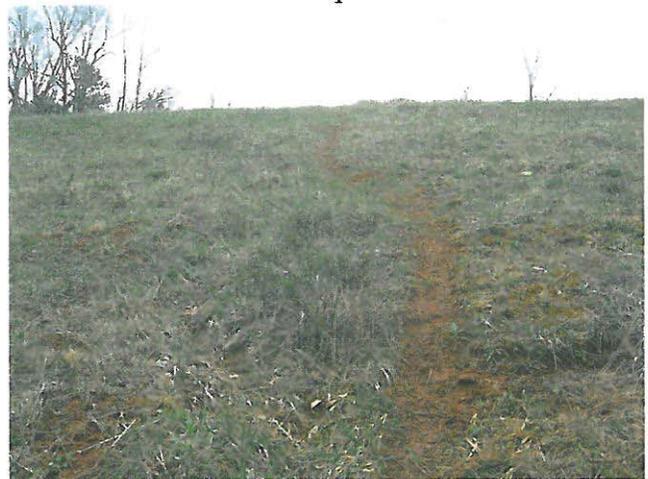
5. Trail on front slope of dam.

6. Another view of trail on front slope of dam.

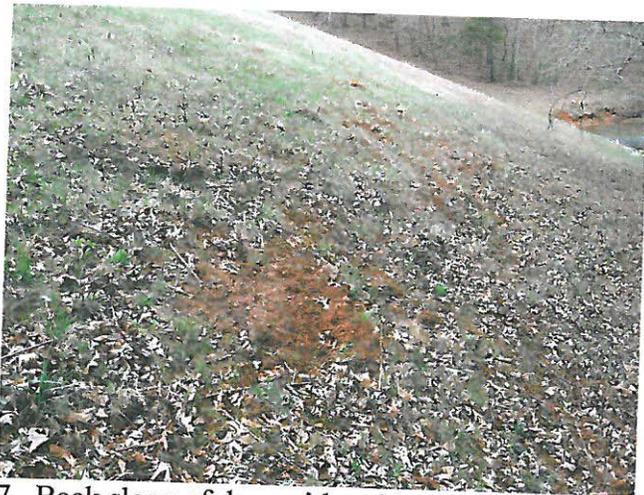
7. Back slope of dam with evidence of wild hogs.

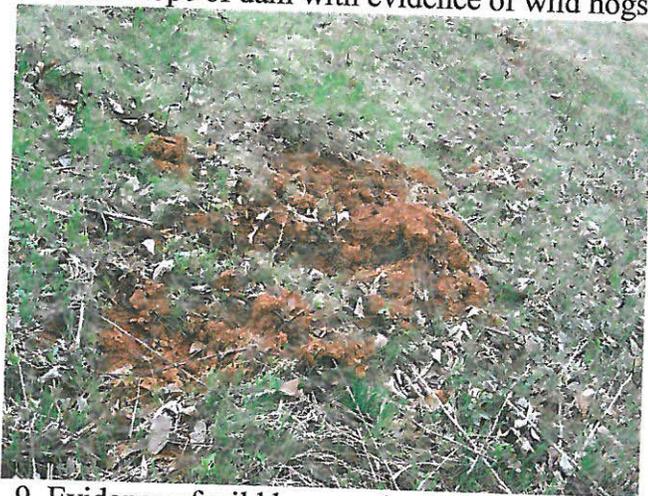
9. Evidence of wild hogs on back slope of dam.

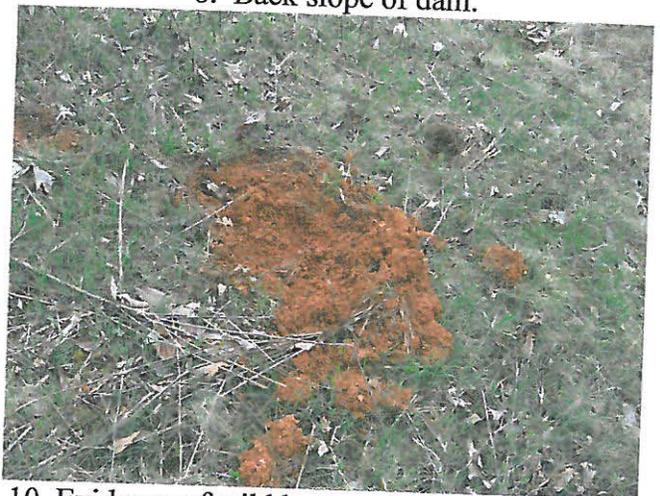
10. Evidence of wild hogs on back slope of dam.

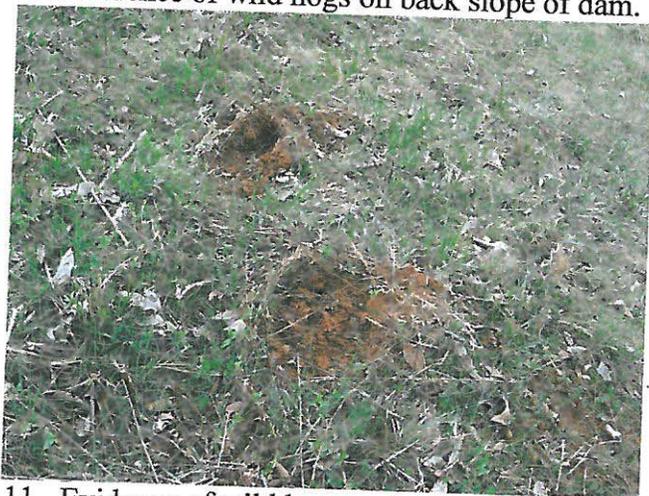
11. Evidence of wild hogs on back slope of dam.

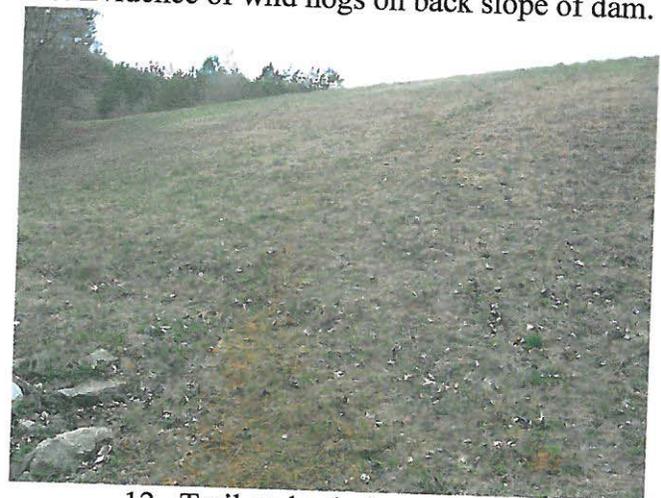
12. Trail on back slope of dam.
