South Carolina Department of Health and Environmental Control

CSXT Bramlett Road MGP Site Community Meeting

March 3, 2022

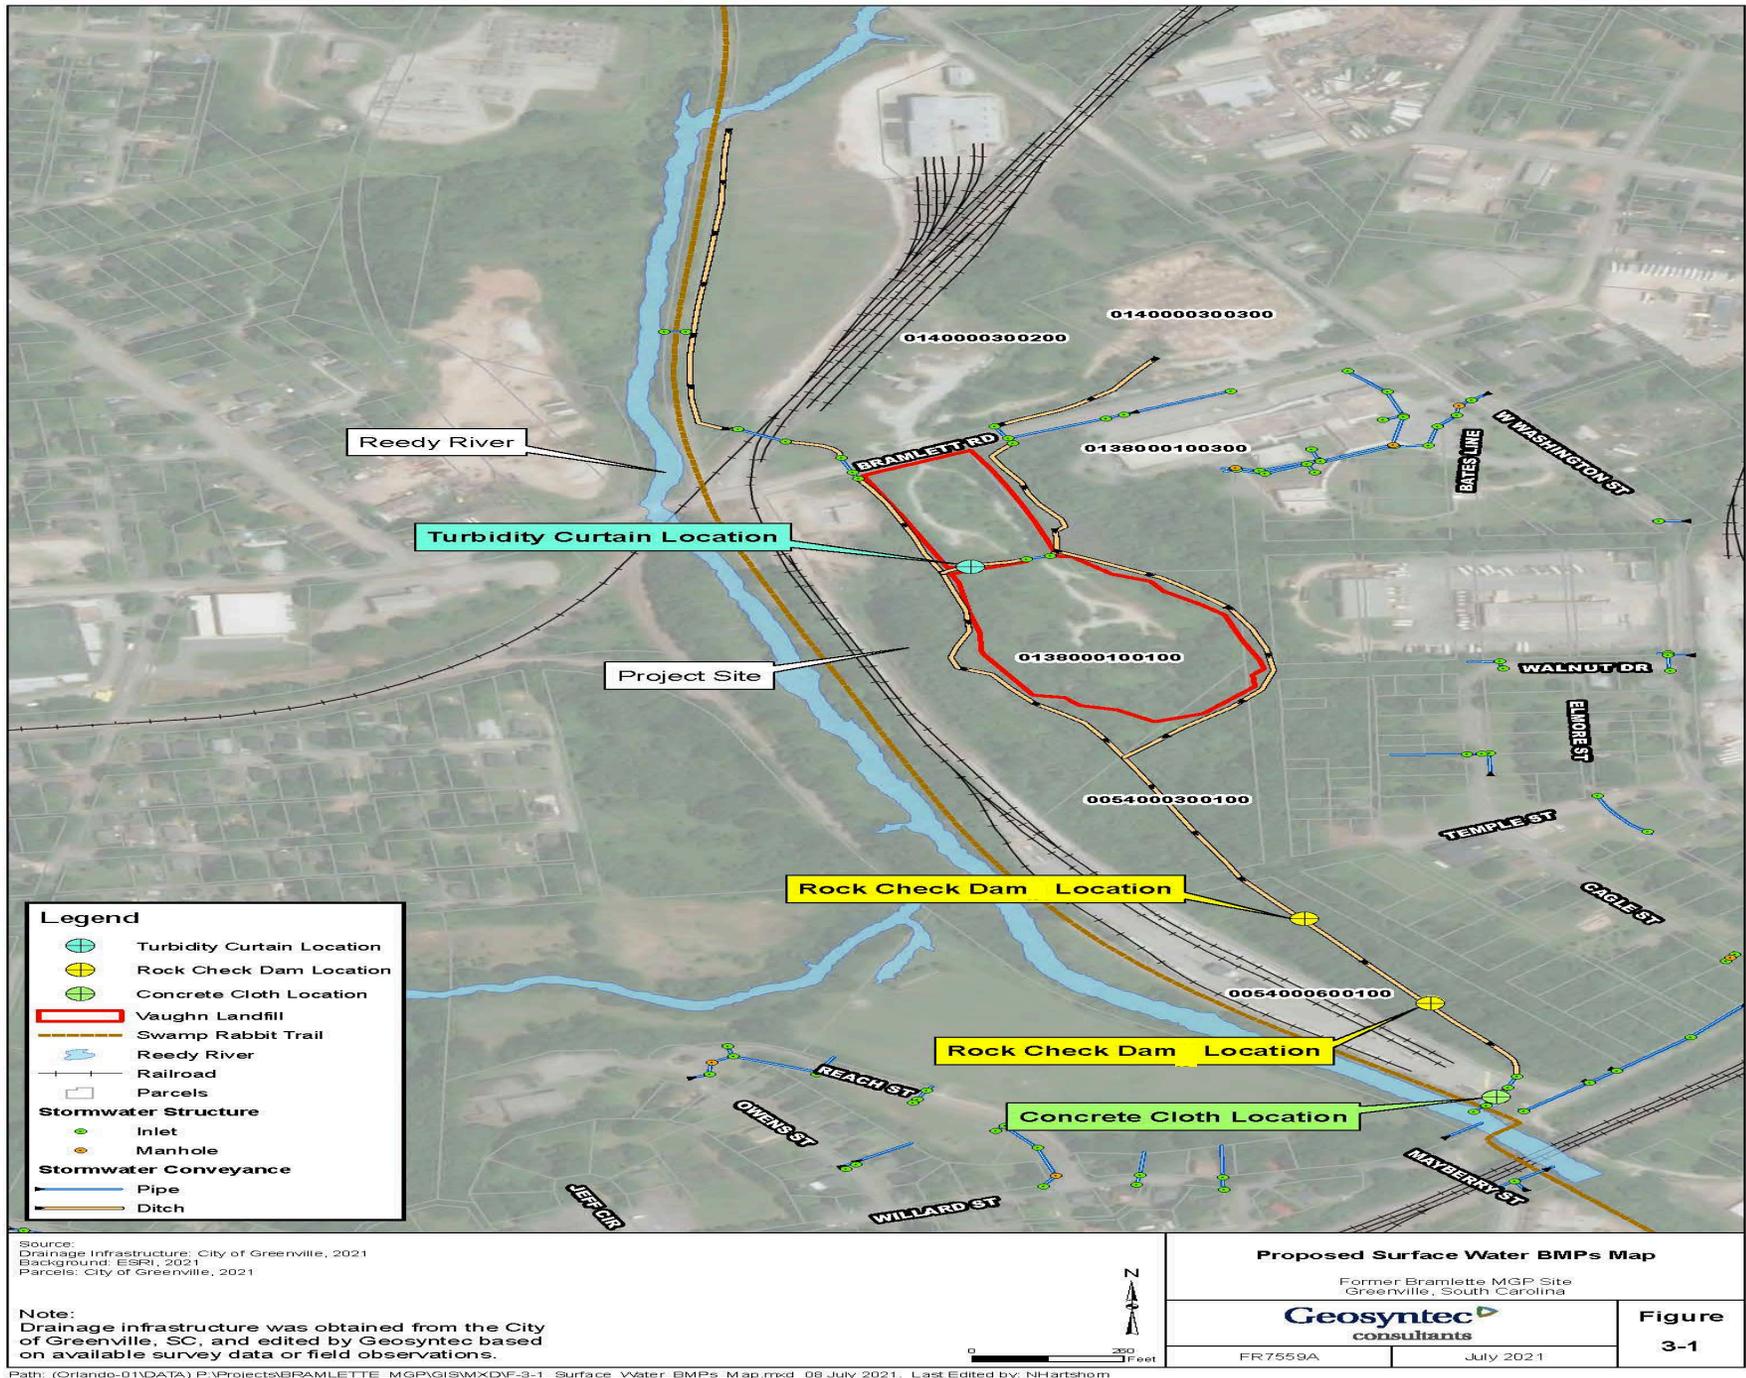
Turbidity Curtain on Parcel 3 (Vaughn Landfill)

- Turbidity Curtain rises and falls with
the water level within the ditch

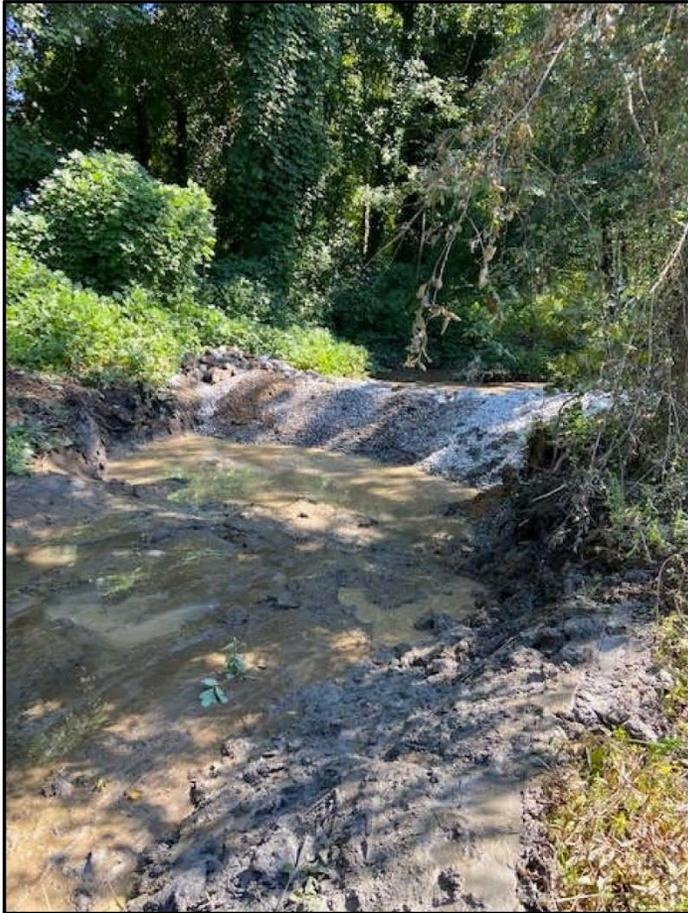
Upstream rock check dam installation
During installation

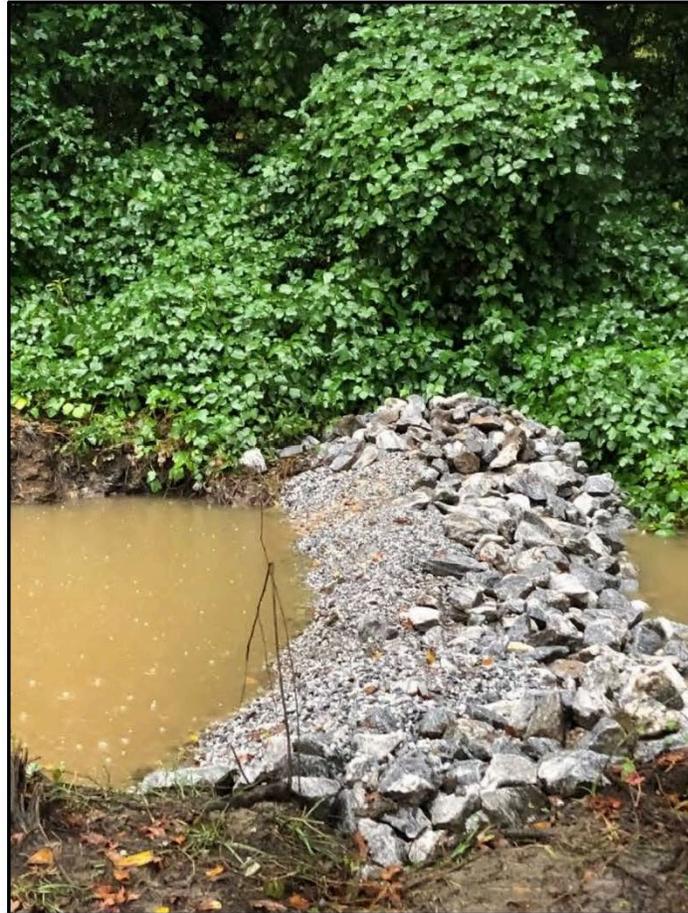
Upstream rock check dam installation
Following heavy rain event

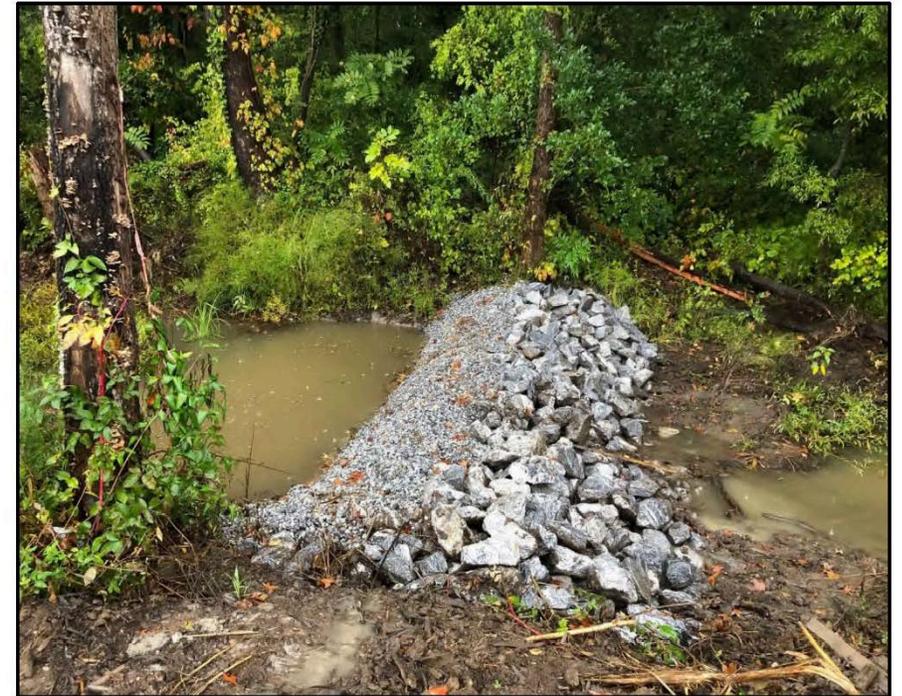
Downstream rock check dam installation
Following heavy rain event

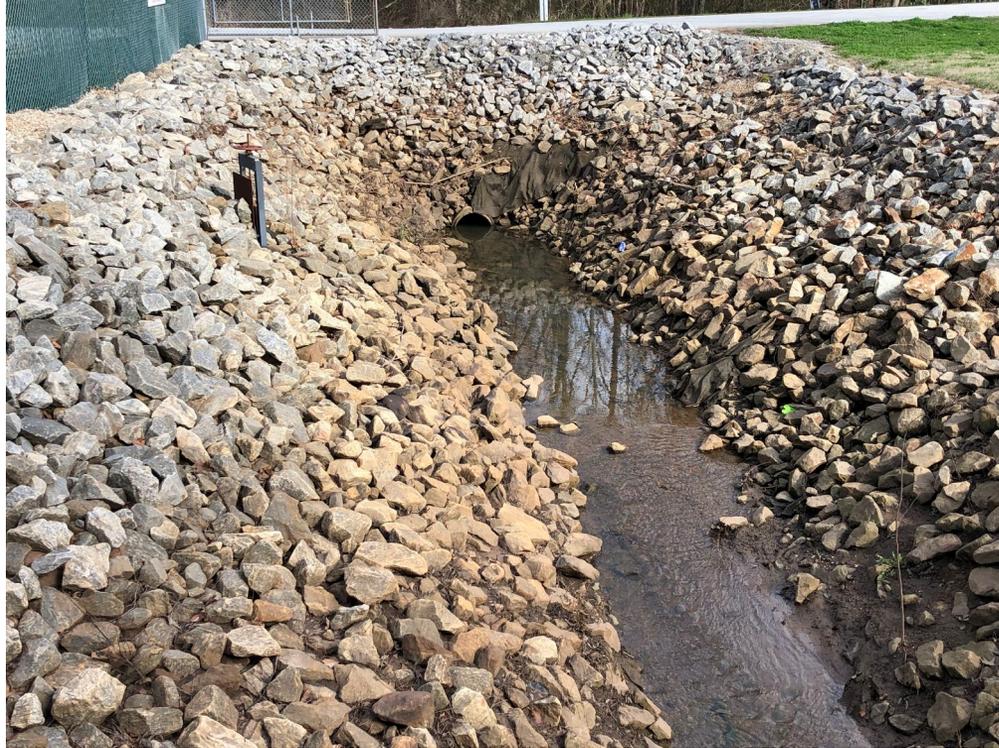
Culvert Ditch Before Work

Concrete Cloth used to replace rip rap in the ditch south of the Transflo Property

- Removed 257 tons of existing rip rap within the ditch
- Removed 1-foot of sediment from the ditch base

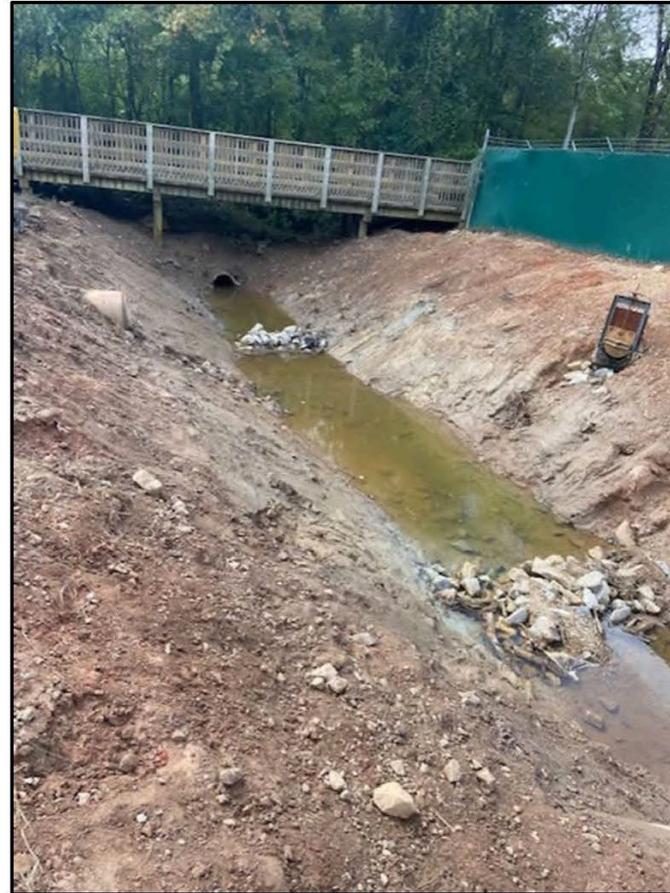
Concrete cloth installation
Following excavation of rip rap

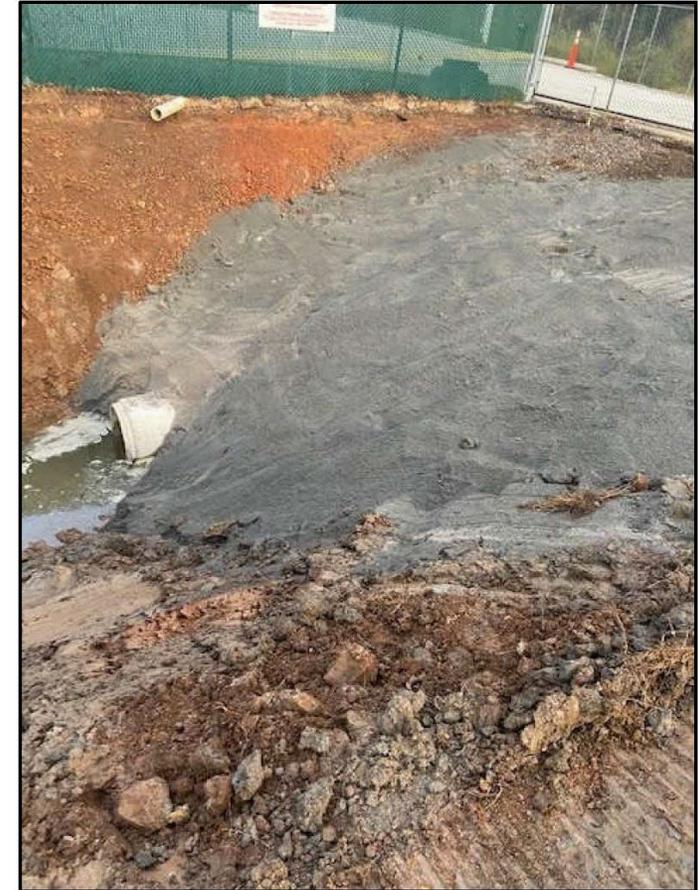
Concrete cloth installation
Installation of culvert extension

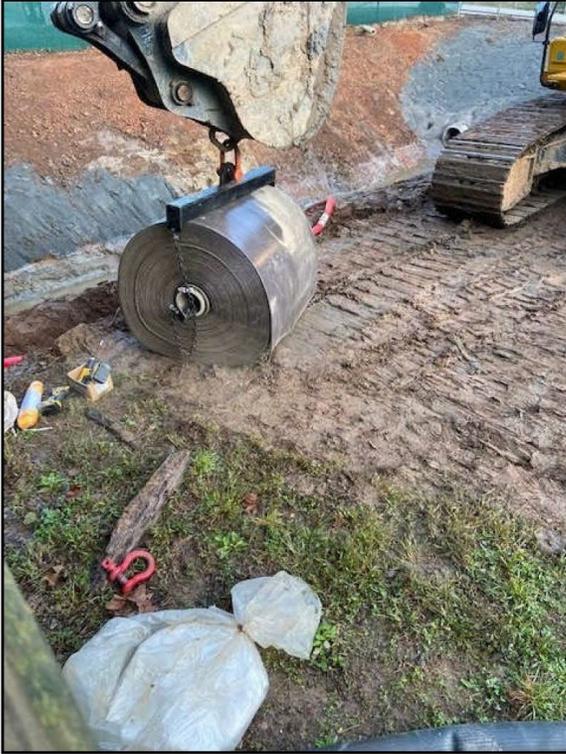
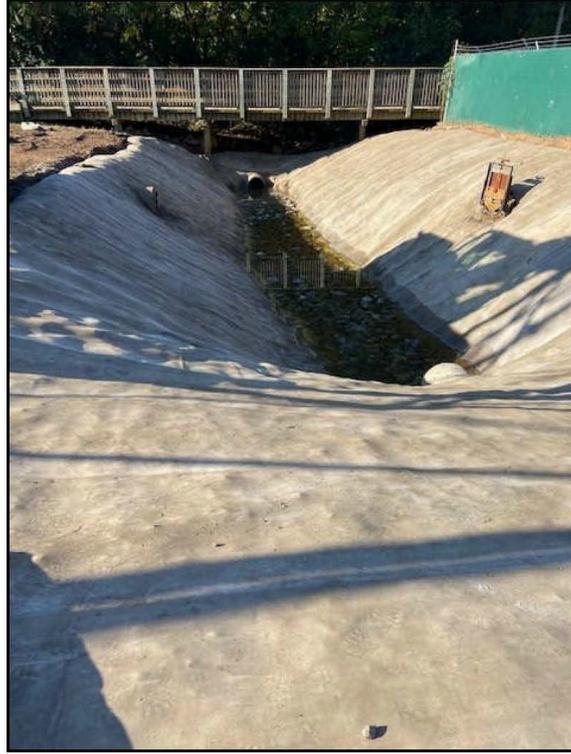
Concrete cloth installation
Cloth installed

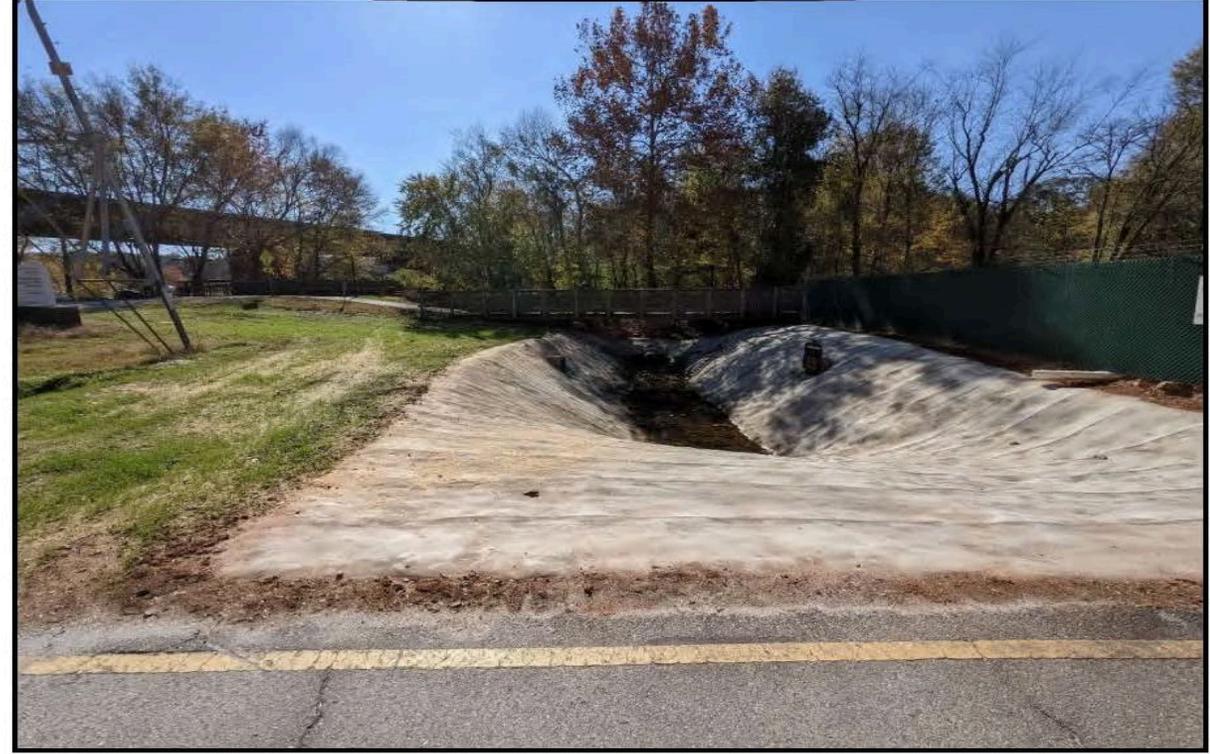
Landscaping - Graded and hydroseeded working area near concrete cloth installation
