Subject: Remedial Investigation Report
Former Bramlette Manufactured Gas Plant
400 East Bramlette Road, Greenville SC
VCC 16-5857-RP

REMEDIAL INVESTIGATION REPORT

FORMER BRAMLETTE MGP SITE

DUKE ENERGY CAROLINAS, LLC

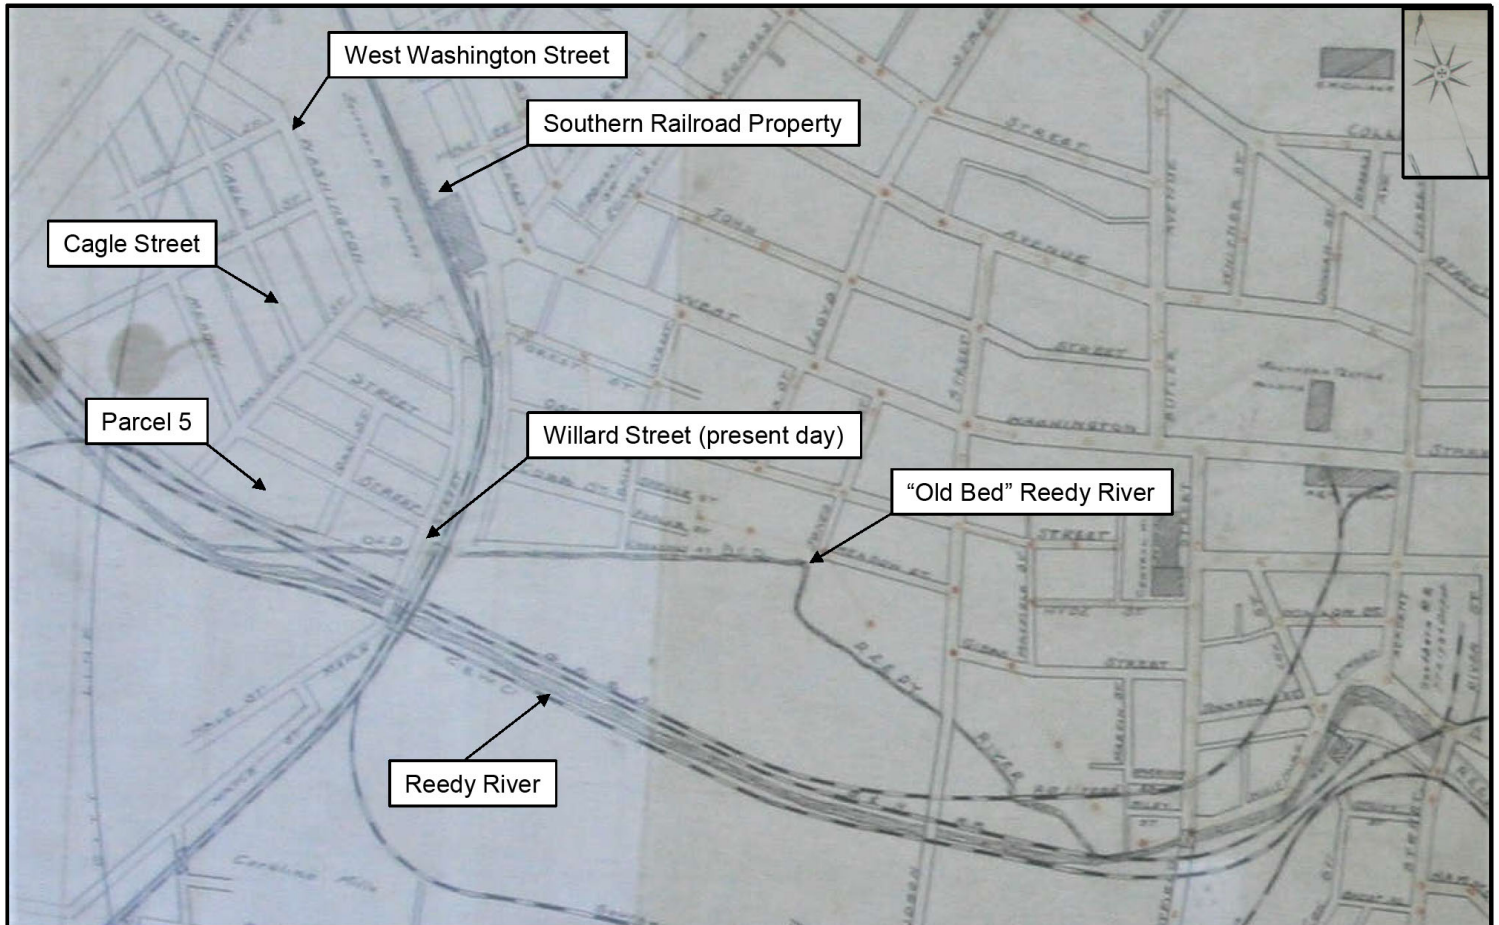
<p>MAP OF GREENVILLE, S.C. REVISED 1921 BY W.D. NEVES City Engineer</p>		<p>DRAWN BY: T. PLATING REVISED BY: CHECKED BY: M. MASTBAUM APPROVED BY: T. PLATING PROJECT MANAGER: T. PLATING</p>	<p>FIGURE 2-2 MAP OF GREENVILLE REVISED 1921 (EXCERPT) REMEDIAL INVESTIGATION REPORT EAST BRAMLETTE ROAD GREENVILLE, SOUTH CAROLINA</p>
<p>Revised Sewer and Street Map 1921, Office of City Engineer (Greenville, SC)</p>		<p>www.synterracorp.com</p>

The Reedy River channel south of the Site was relocated in the late 1800s to early 1900s. The current configuration of the Reedy River is documented in a 1921 revised map of Greenville by W.D. Neeves, the city engineer (**Figure 2-2**). The “old bed” diverted from the current channel approximately 800 feet west of Willard St. Because the majority of MGP production took place after 1927, the “old bed” channel of the Reedy River is not considered relevant to investigations related to MGP operations.
