Regarding: Remedial Investigation Report and Baseline Risk Assessment
Shakespeare Composite Structures Site
Newberry, South Carolina
SCDHEC VCC Number 14-6271-RP
AECOM Project Number 60534283

Remedial Investigation Report Shakespeare Composite Structures Site

Voluntary Cleanup Contract 14-6271-RP

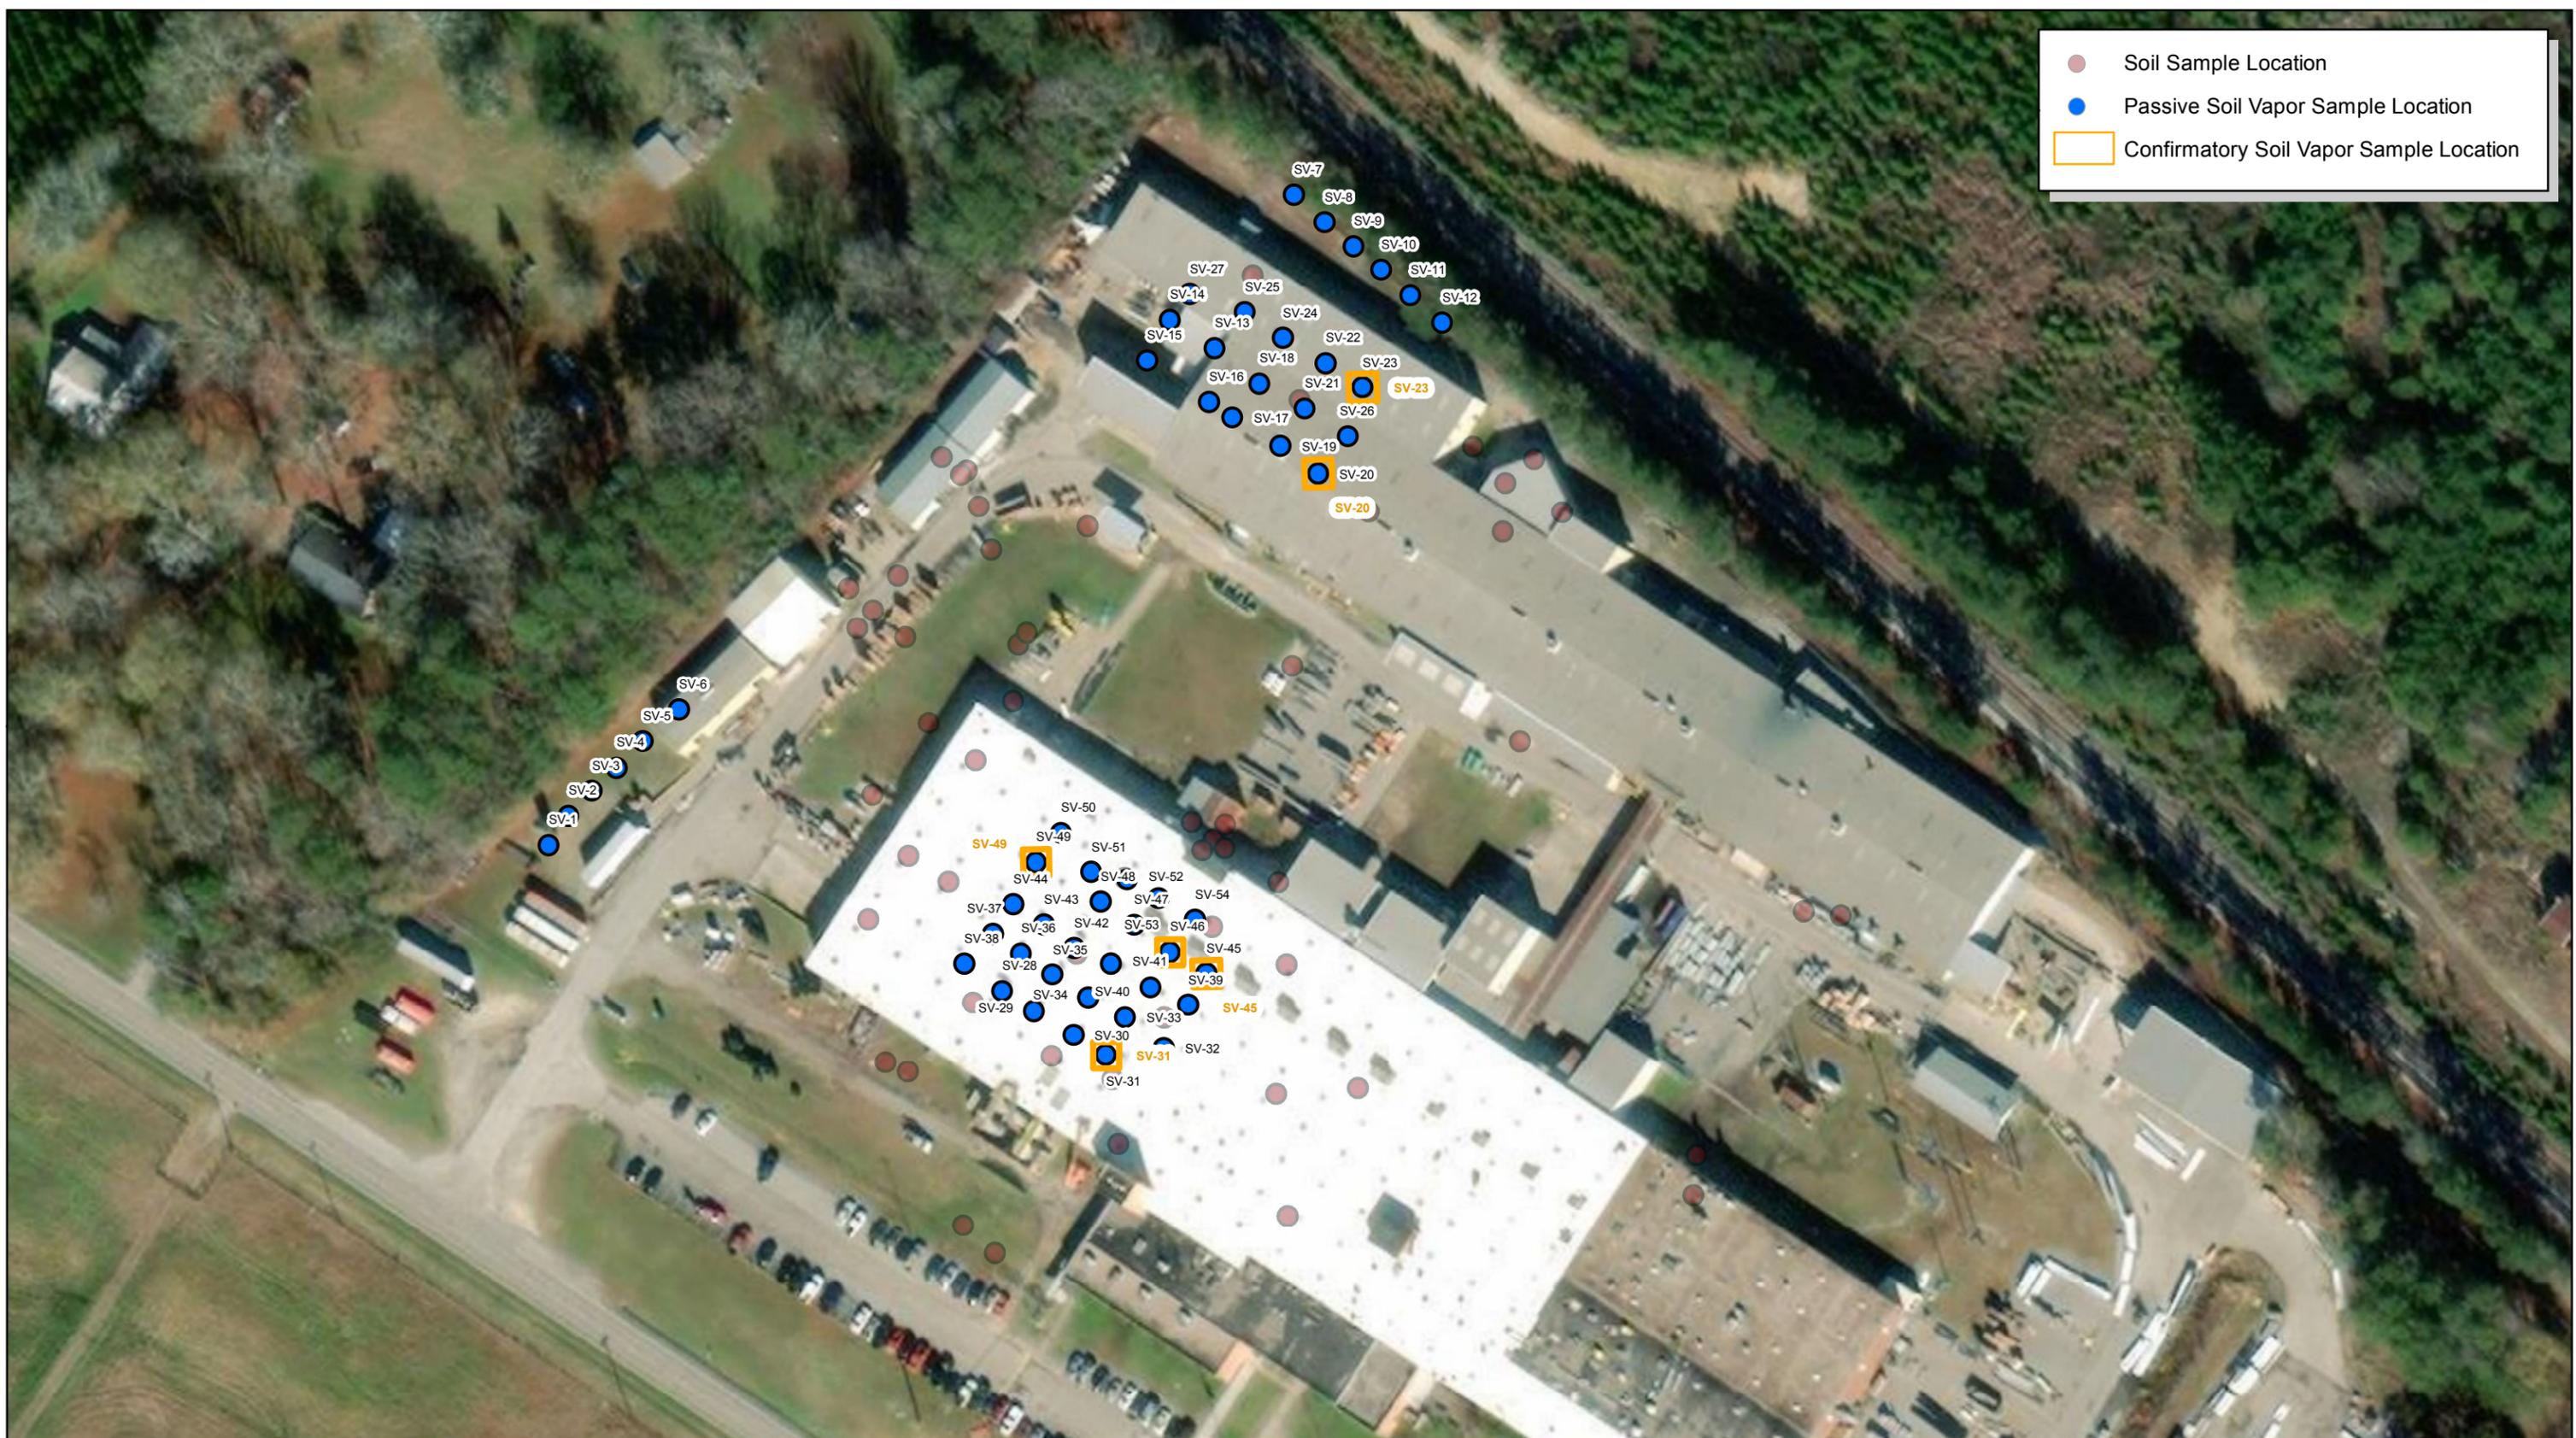
Figure 3-1: Soil Sample Locations
 Shakespeare Composition Structures
 Newberry, South Carolina
 Project No.: 60534283; Prepared by: JG; Date: 5/10/2018.

- Soil Sample Location
- Passive Soil Vapor Sample Location
- Confirmatory Soil Vapor Sample Location

sampling efforts are discussed in Section 3.2.4, below. The intent of this Phase II RI soil sampling was to confirm the presence of elevated organics, as reported in the passive soil vapor samples, which may identify possible release/source areas. This sampling included collection of samples from borings advanced at three SV locations at the Pole Winder building [SV-14 (B-46), SV-20 (B-45PW), SV-23 (B-50)] and three locations at the Main building [SV-31 (B-47), SV-41 (B-48), SV-45(B-49)] (**Figure 3-1**).

Twenty-two borings were advanced within and adjacent to the Main building (**Figure 3-1**). Seventy seven soil samples (including seven surface and 70 subsurface) were collected from the Main building for chemical analysis during this sampling effort. Sample depths varied based on the results of field screening. A description of the soil sample results in this section are based on the areas in and around the Main building from which the samples were collected, not in the numerical order in which the borings were advanced.

Seven soil borings were advanced in and adjacent to the Pole Winder building (**Figure 3-1**). Nineteen soil samples (including two surface and 17 subsurface) were collected from the Pole Winder building for chemical analysis. Borings B-34 (TMW-25) through B-37 were advanced in the vicinity of an underground wastewater vault system on the north side of the Pole Winder building (REC 5a B-9). As many as four VOCs were detected in at least one soil sample collected from these borings. The organic solvent compounds acetone and 2-butanone along with the CVOCs chloroform, PCE, and TCE were detected in at least one sample collected from these four borings (**Table 5-5**). Chloroform was detected above its RBSL of 0.063 ug/kg in B-34-10 at 1.4 ug/kg. TCE was detected above its MCL SSL of 1.8 ug/kg in B-34-10 (2.6 ug/kg) and B-34-13 (4.3 ug/kg).

vapor sample locations SVS-31, SVS-45, and SVS-41 respectively. Borings 45PW and 46 were advanced in the Pole Winder building near locations SVS-20 and SVS-23. Boring 50 was advanced at SVS-14, which is located outside the south western corner of the Pole Winder building (**Figure 3-1**). Each soil sample was analyzed for TCL VOCs. **Table 5-6** summarizes the analytical results for the Phase II RI soil samples.
