# PRO DISPOSAL USA (BARNWELL RESOURCES) CLASS 2 LANDFILL : P1TJ-QJAP-426

Solid Waste - Class 2 Landfill

Start Date: 08/25/2026

| <b>Permit #</b> | 072410-1201 |

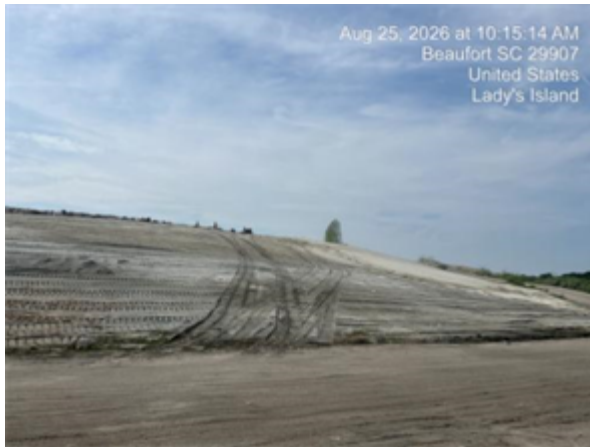
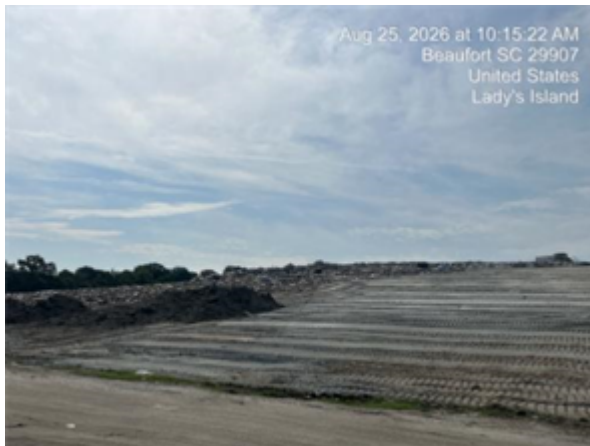
**10. > Six inches of soil (short-term cover) meets regulatory/permit requirements**

Facility reported last cover as 8/12/2026.

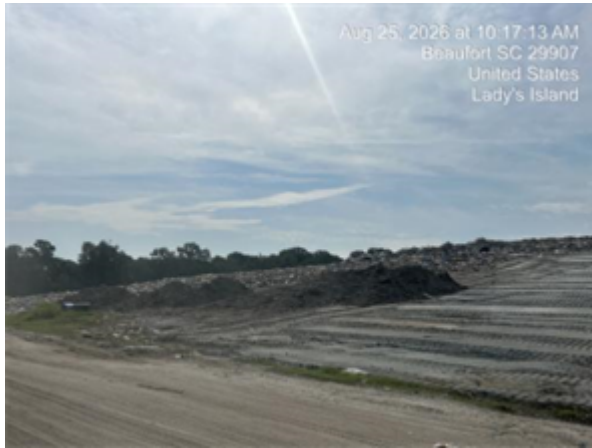
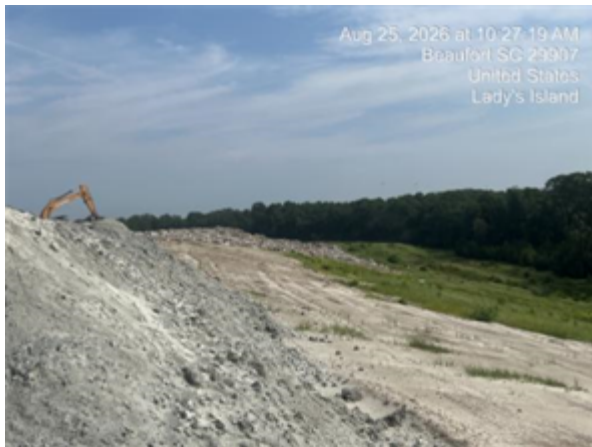
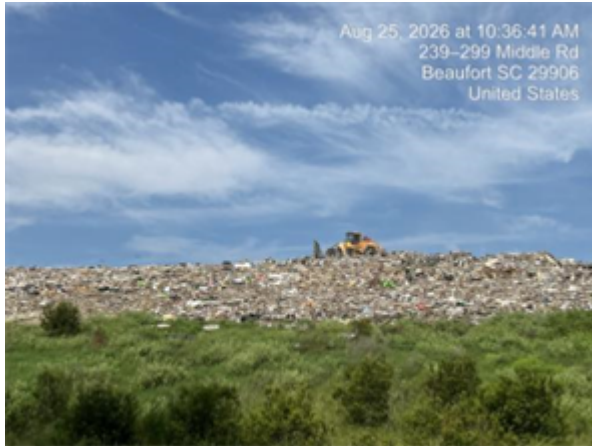
**16. Working face as small as can efficiently and safely be managed**

Working face looks better than last inspection. Continue working on shrinking working face to the smallest manageable size.

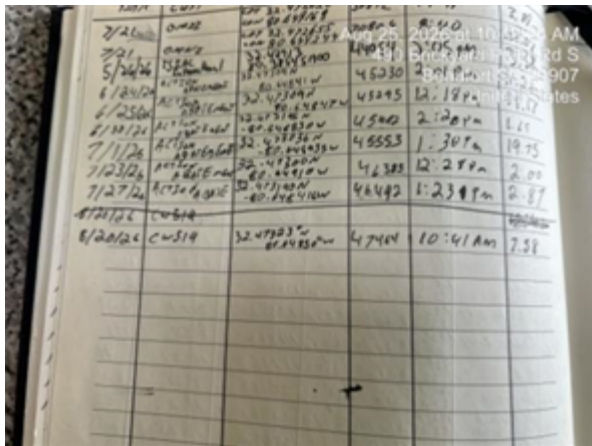
### 17. Asbestos containing material adequately handled

3 loads since last inspection: 7/23, 7/27, and 8/20

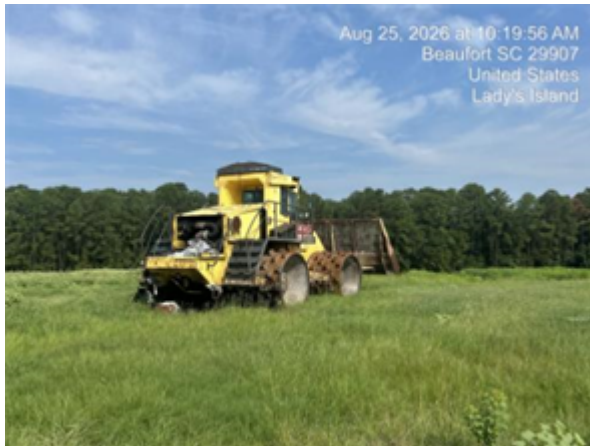
### 19. All required equipment operational

Backup compactor down but primary compactor and all other equipment operational.

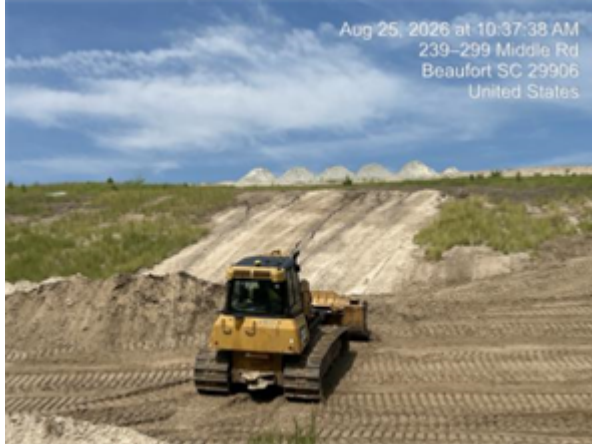
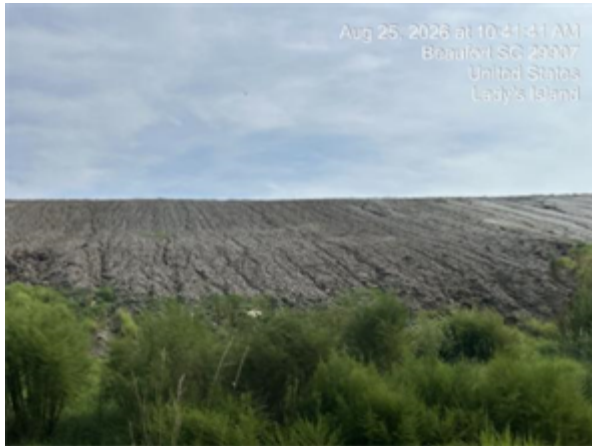
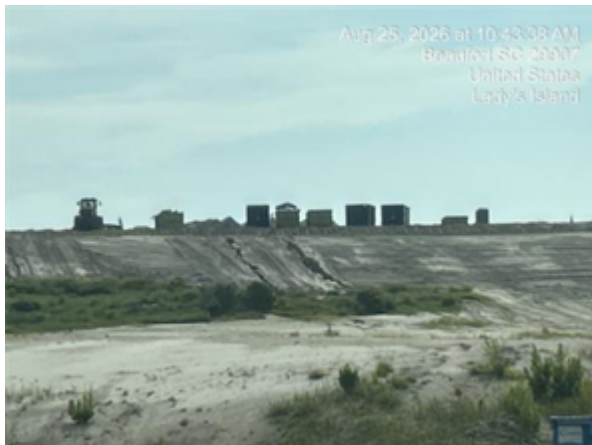
### 23. Adequate condition of berms/terraces/downchutes

Some erosion rills from recent rain, get these repaired. Facility was working on repairing some on the east slope at the time of the inspection.

Repair washouts in slopes.

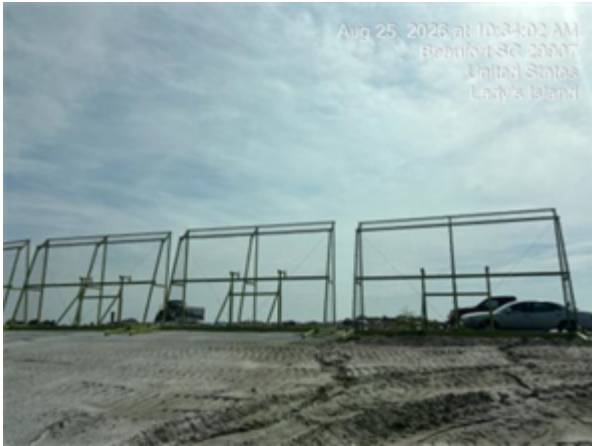
| Inspection Detail | |
|---|---|
| 26. Control of Litter | Yes |
| <b>Comments:</b><br>Litter fencing present. | |

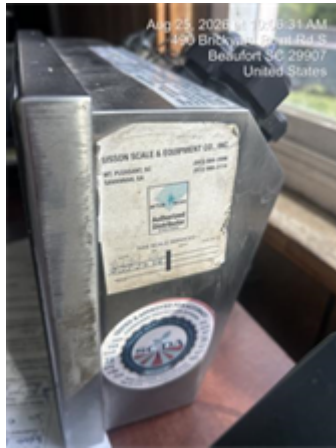
**31a. Last date of calibration**

3/23/2026
