# PRO DISPOSAL USA (BARNWELL RESOURCES) CLASS 2 LANDFILL : P1TJ-QJAP-426

Solid Waste - Class 2 Landfill : SW\_CLS2\_LF

| <b>Date of Inspection</b> | 7/22/2026 |
| <b>Reason for Inspection</b> | Routine,Follow-up |

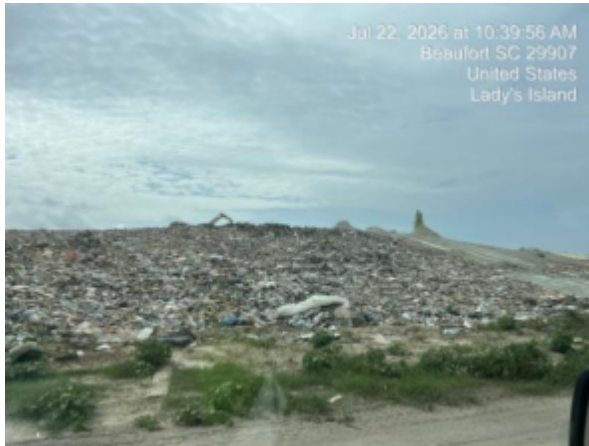
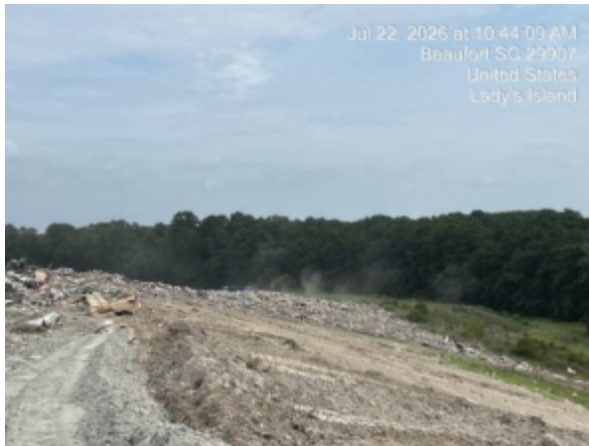
**9. Frequency of cover meets regulatory/ permit requirements** No

A portion of last month's working face adjacent to internal road has been covered, but did not meet the 30 day requirement for all exposed waste.

| Inspection Detail | |
|---|---|
| <i>Comments:</i><br>Cover all exposed waste within 30 days per regulatory requirement and maintain a smaller working face size. | |

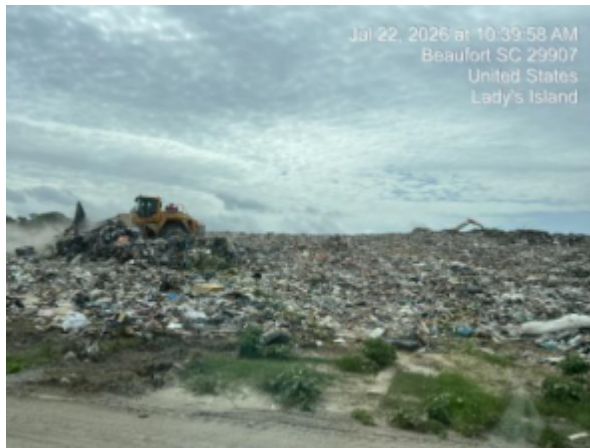
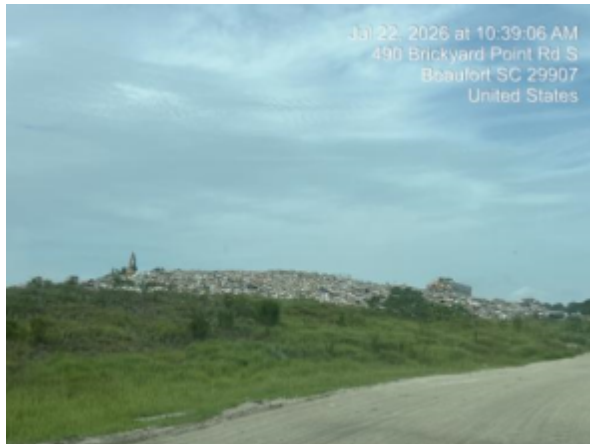
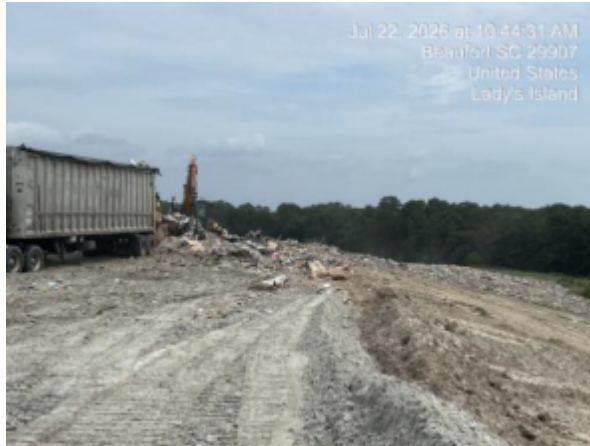
**16. Working face as small as can efficiently and safely be managed**

Compactor is back online, compaction looks a lot better than last month's.

Working face a little smaller than last month's but still large.

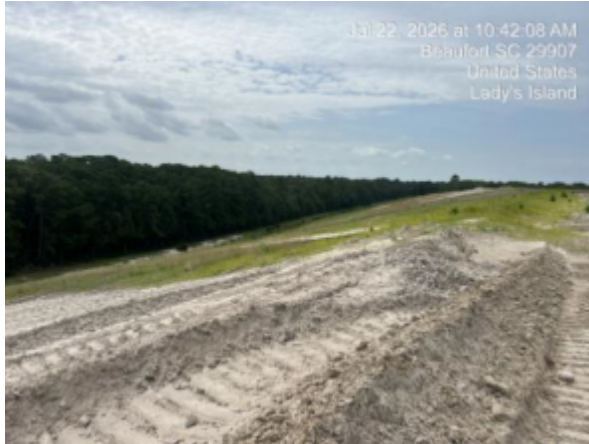
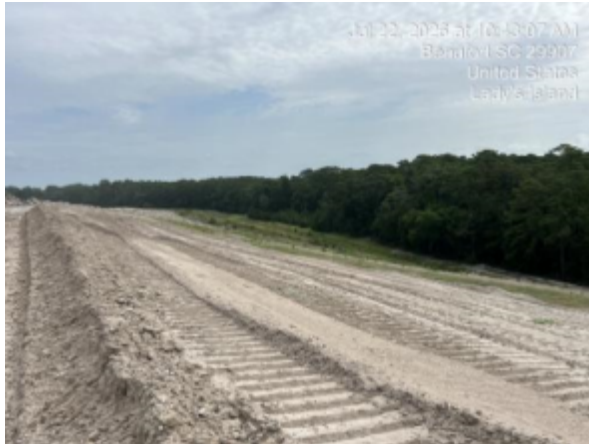
### 23. Adequate condition of berms/terraces/downchutes

Small berm of dirt has been added along eastern edge of top of landfill to control stormwater. No erosion rills noted on the eastern slopes. Grass growth looks better.
