PRO DISPOSAL USA (BARNWELL RESOURCES) CLASS 2 LANDFILL

P1TJ-QJAP-426

Solid Waste - Class 2 Landfill Facility	
Facility Name	PRO DISPOSAL USA (BARNWELL RESOURCES) CLASS 2 LANDFILL
Date of Inspection	1/09/2026
Time of Inspection	11:03 AM
County	Beaufort
Permit #	072410-1201
Inspection Processing	
Reason for Inspection	Routine
Weather Conditions	Cloudy
Temperature	60s
Rainfall in past week	0-0.5
Weather Condition Description	Foggy today
Last Inspection	12/17/2025
Inspection Detail	
1. Attendant Present	Yes
2. Required signs posted	Yes
3. Inspection of all incoming loads conducted	Yes
4. Unauthorized waste training conducted and documented	Not Applicable
5. No unauthorized waste present	Yes
6. Access controlled	Yes
7. Adequate entrance all-weather roads	Yes
8. Adequate internal all-weather haul roads	Yes
9. Frequency of cover meets regulatory/ permit requirements	Yes
10. > Six inches of soil (short-term cover) meets regulatory/permit requirements	Yes

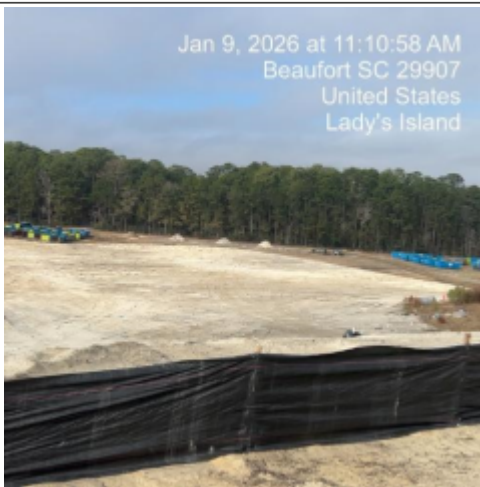
Photo Taken: 1/9/2026 4:10:00 PM
GPS Latitude: 32.47131666666667
GPS Longitude: -80.64943611111111
GPS Altitude: 21.19 meters
GPS Orientation: 1 degrees

Lower deck is fully covered, previous upper deck working face is also covered as of yesterday. Eastern slope grass has been slow to grow, facility plans to re-seed some areas. Odor was not detectable on Middle rd driving in to inspection, and was not as strong on site as last inspection. Facility also plans on acquiring tarp to cover turn-around areas of working face to limit odor.
