**CSX/VAUGHN LANDFILL AND
BRADLETTE ROAD LOCATIONS**

**PHASE III INVESTIGATION AND
SITE ASSESSMENT REPORT**

**SITE REMEDIATION SERVICES GROUP
DUKE ENGINEERING & SERVICES, INC.
400 SOUTH TRYON STREET
P.O. BOX 1004
CHARLOTTE, NORTH CAROLINA
28201-1004**

JUNE 2000

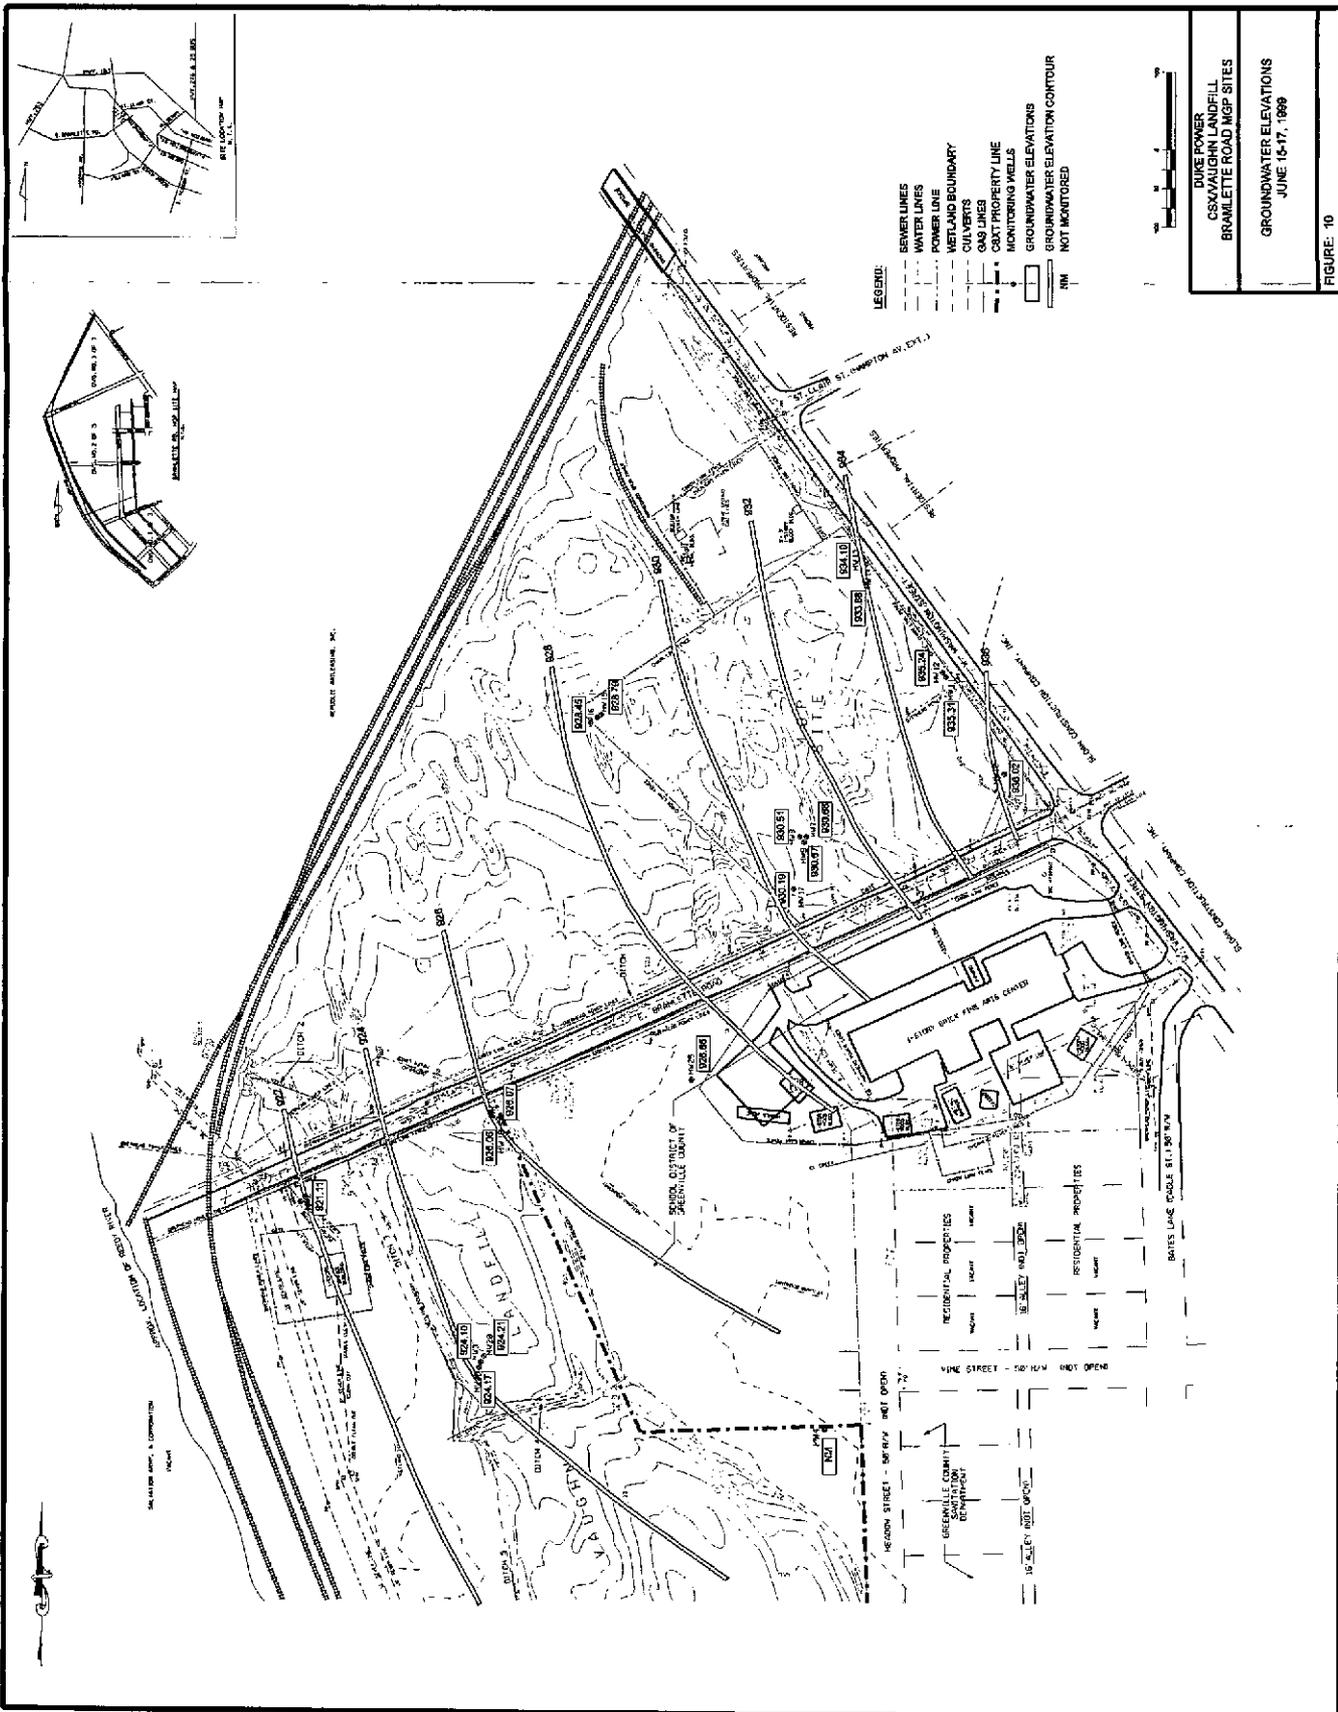
FIGURE 10

DUKE POWER
 CSX/AULGHIN LANDFILL
 BRANLETTE ROAD HGF SITES
 GROUNDWATER ELEVATIONS
 JUNE 15-17, 1999

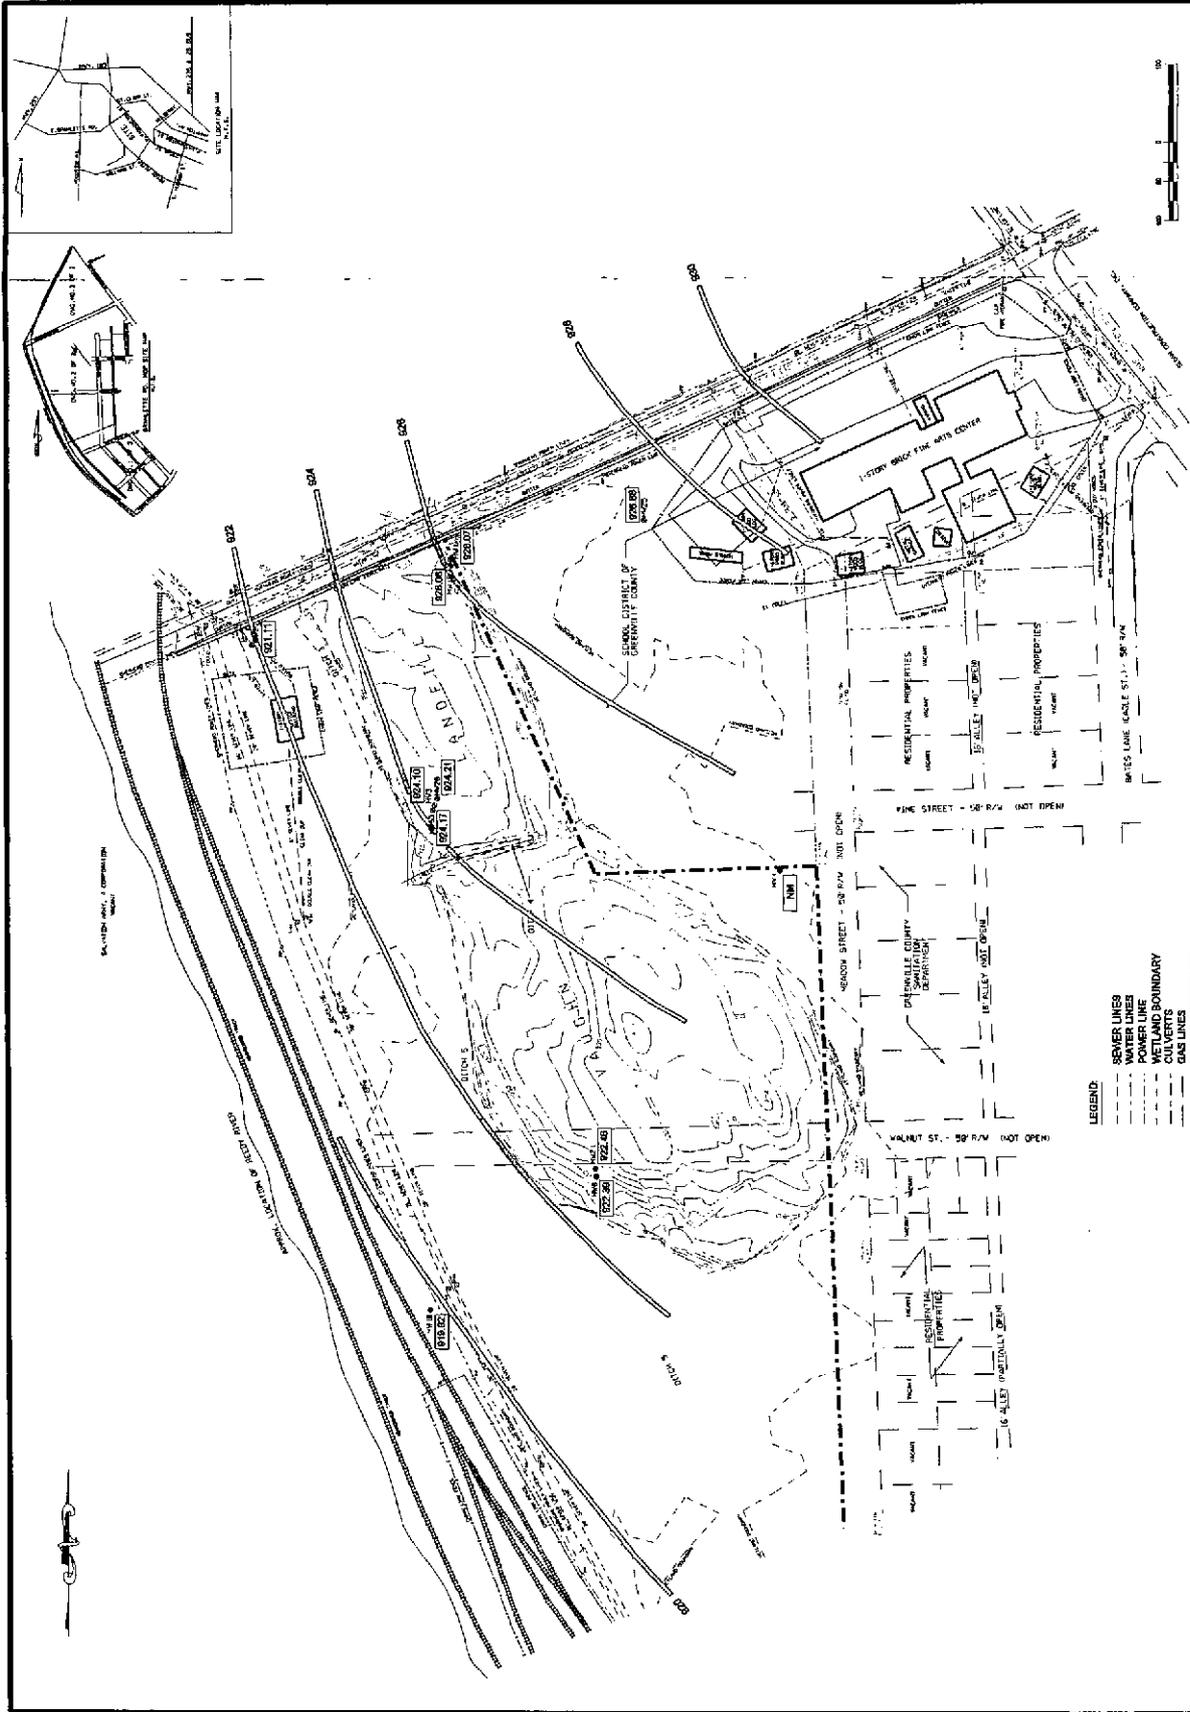
FIGURE 11

DUNE POWER
 MONITORING WELLS
 BRAMLETTE ROAD MGR SITES
 GROUNDWATER ELEVATIONS
 JUNE 15-17, 1999

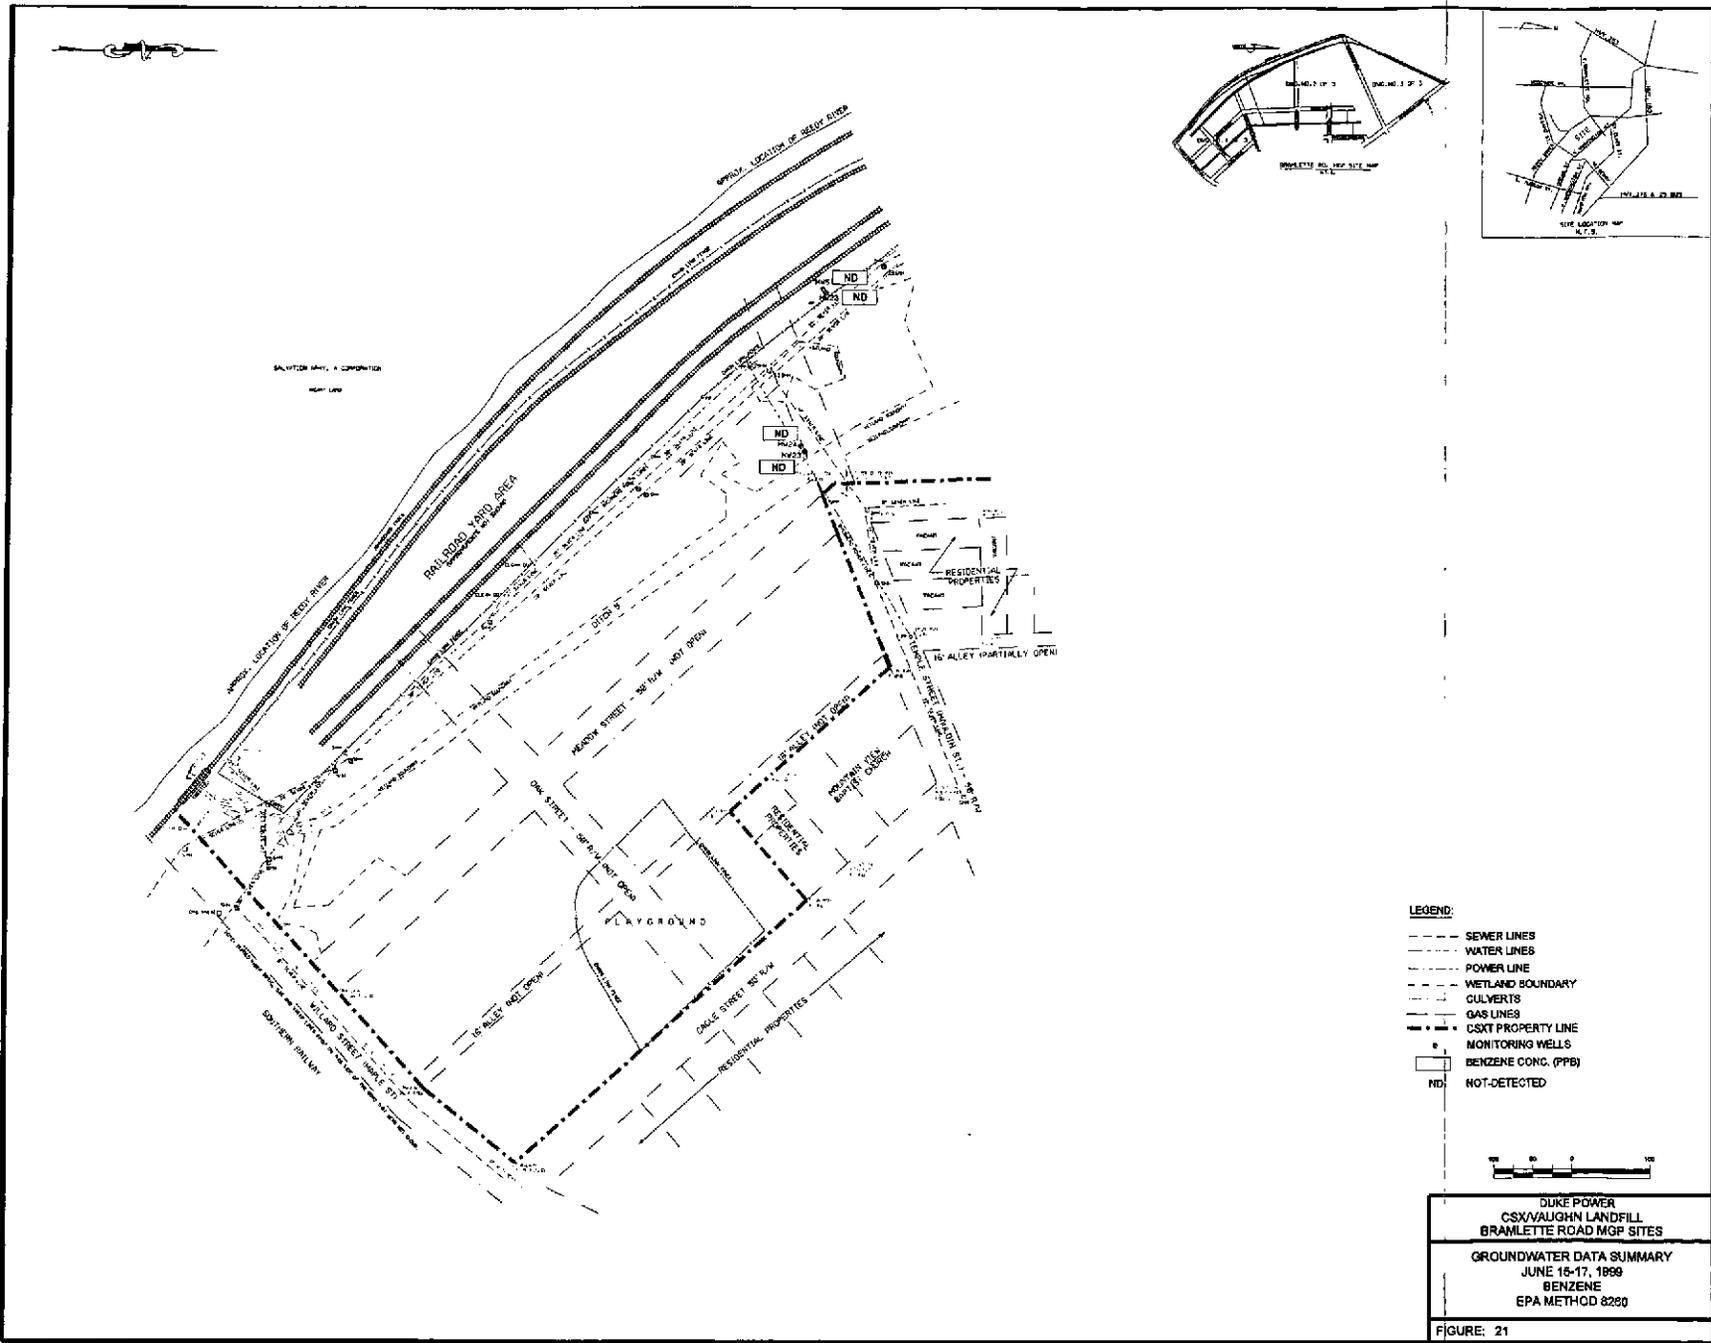
DUKE POWER
 CSX/VAUGHN LANDFILL
 BRAMLETTE ROAD MGP SITES
 GROUNDWATER DATA SUMMARY
 JUNE 15-17, 1999
 BENZENE
 EPA METHOD 8280
 FIGURE: 21

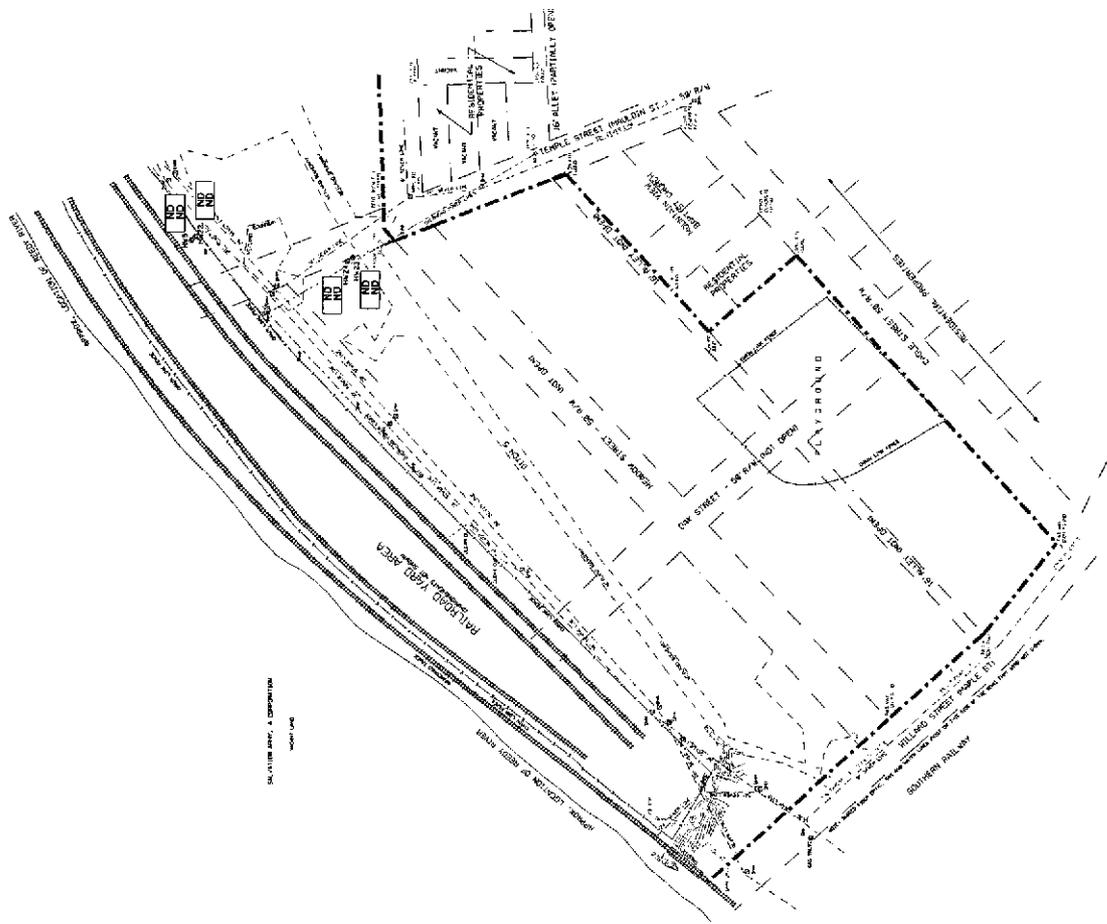
FIGURE: 27

DUKE POWER
 CSX/AUGHRN LANDFILL
 BRAMLETTE ROAD MSP SITES
 GROUNDWATER DATA SUMMARY
 JUNE 16-17, 1999
 NAPHTHALENE
 EPA METHODS 8260 AND 8270

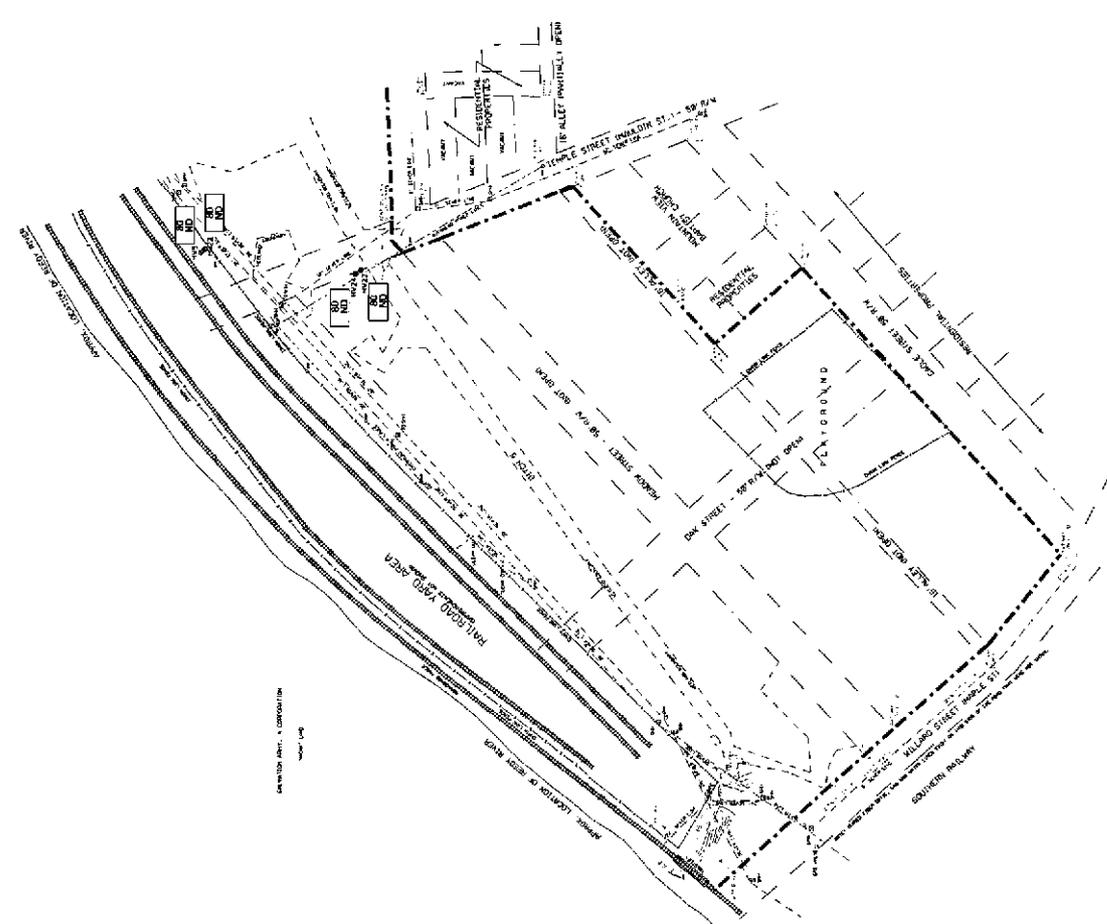
FIGURE 30

DUKE POWER
 CSX/VAUGHN LANDFILL
 BRAMLETTE ROAD MGP SITES
 GROUNDWATER DATA SUMMARY
 JUNE 16-17, 1998
 TOTAL PAHs
 EPA METHOD 8270

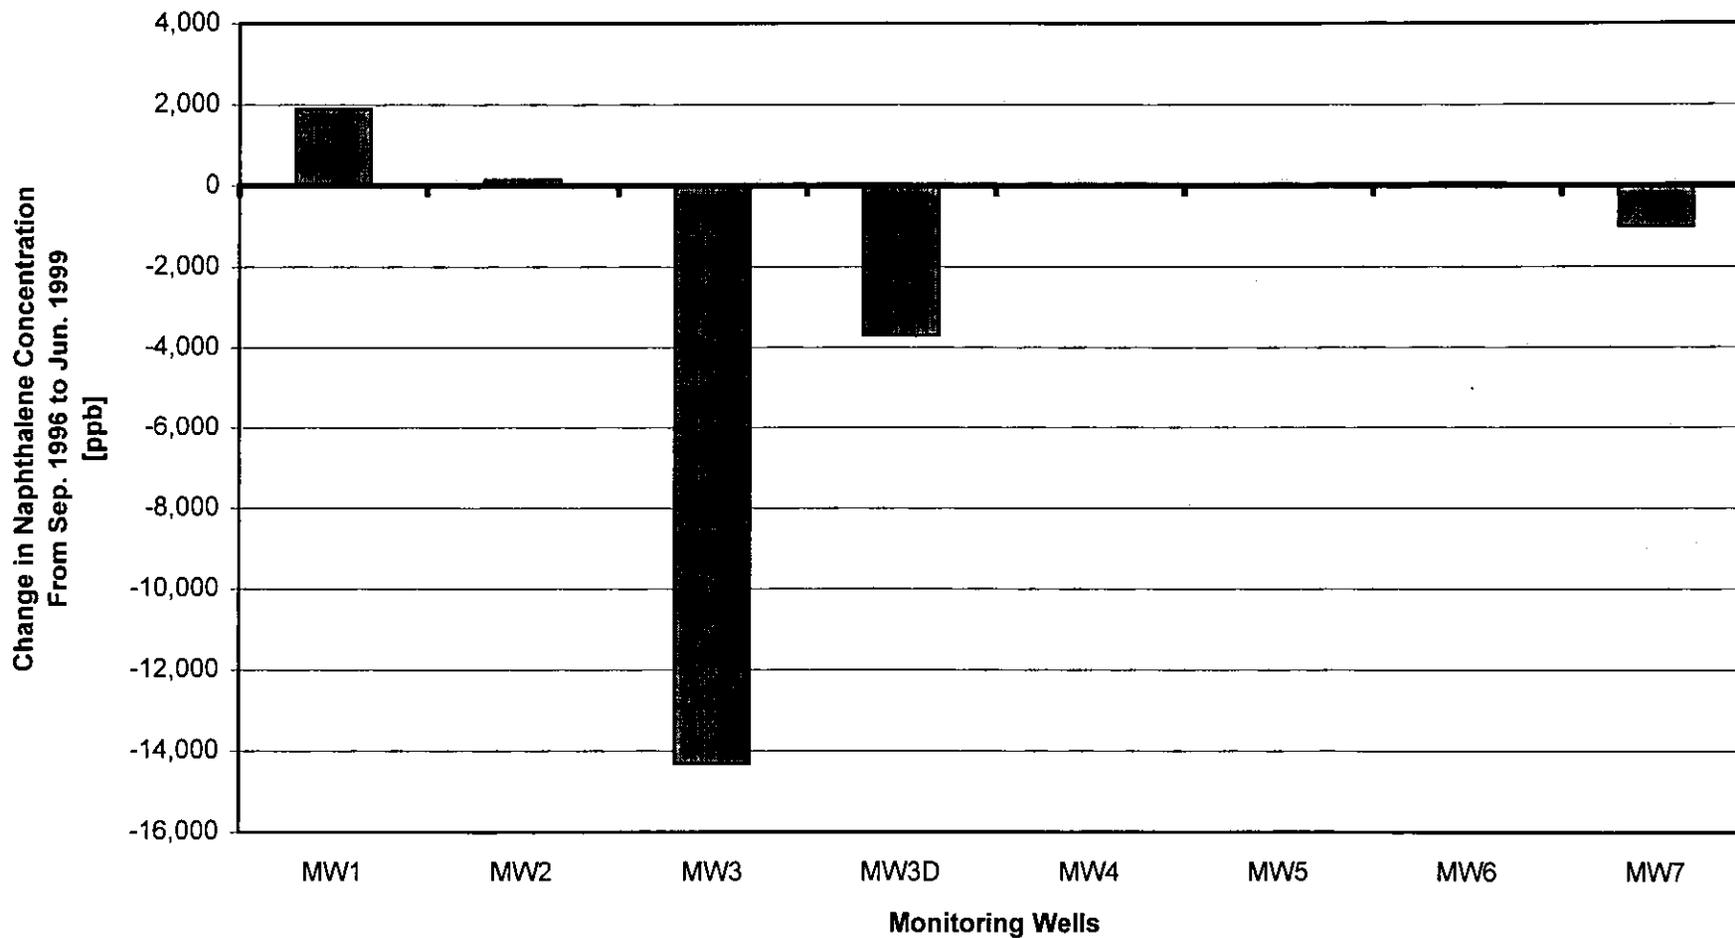
Figure 39

CSX/Vaughn Landfill and Bramlette Road MGP Sites
Change in Groundwater Naphthalene Concentration: Sep. 1996 to Jun. 1999
Method 8260 Analytical Results

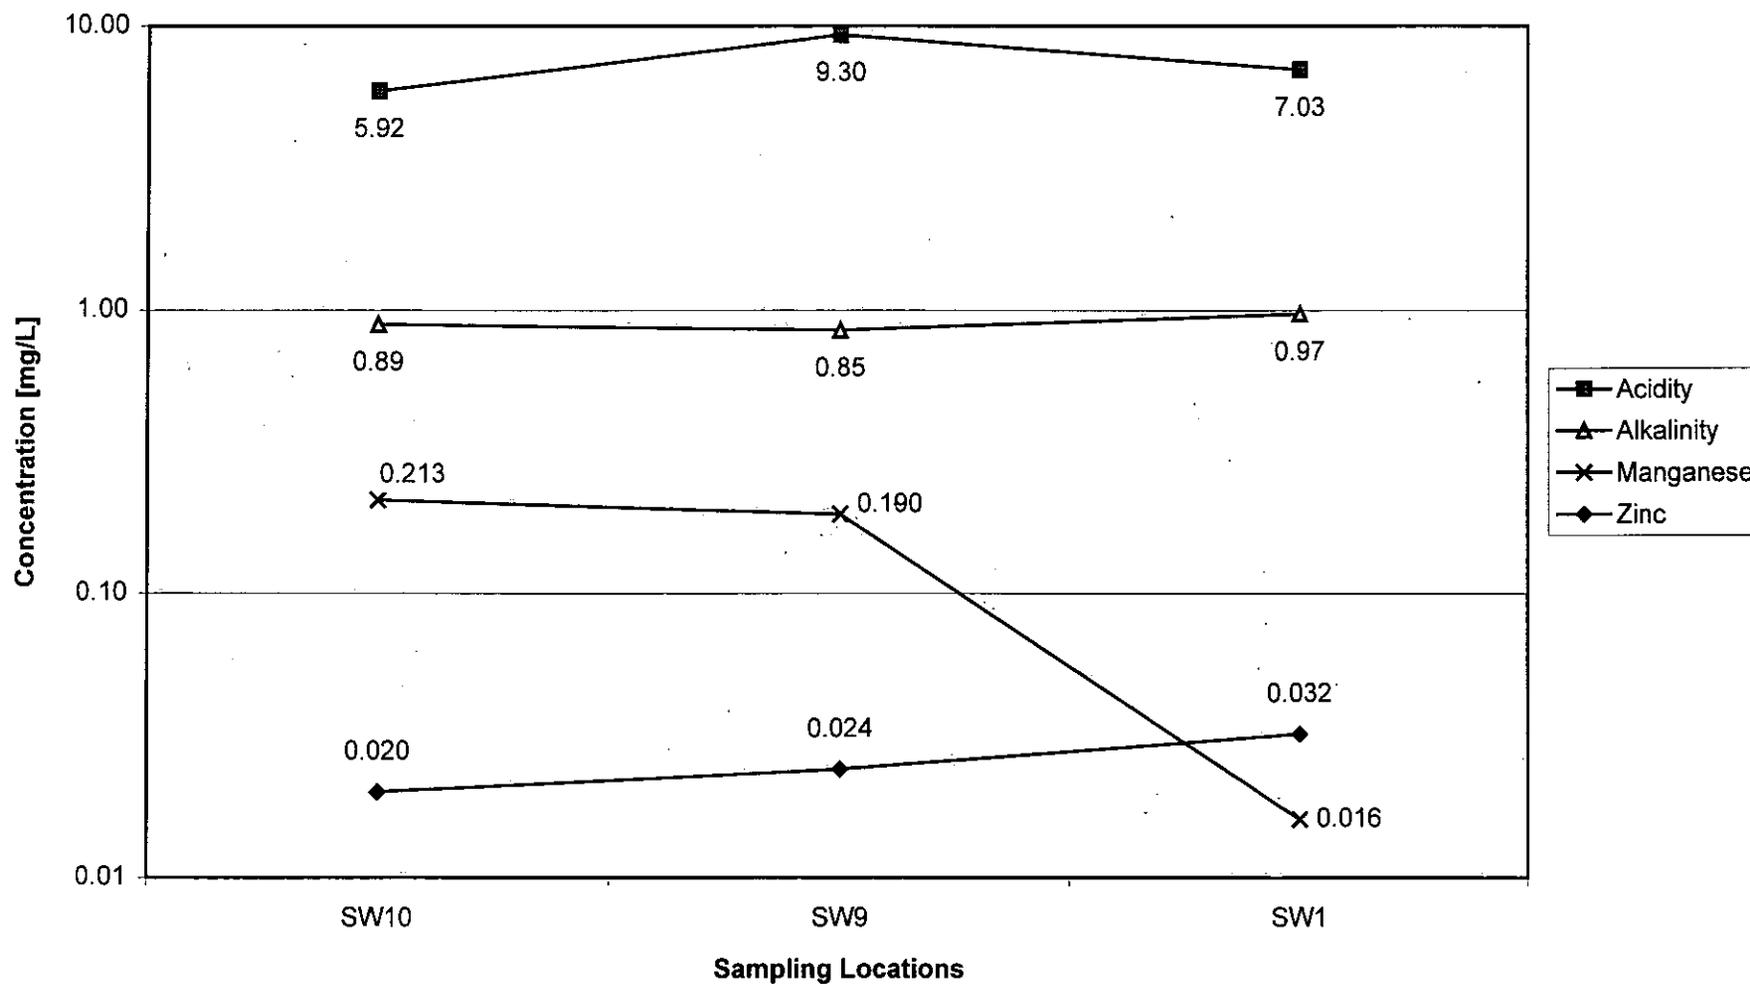
Figure 46

CSX/Vaughn and Bramlette Road MGP Sites
Ditch 5 Surface Water Samples
Miscellaneous Parameters

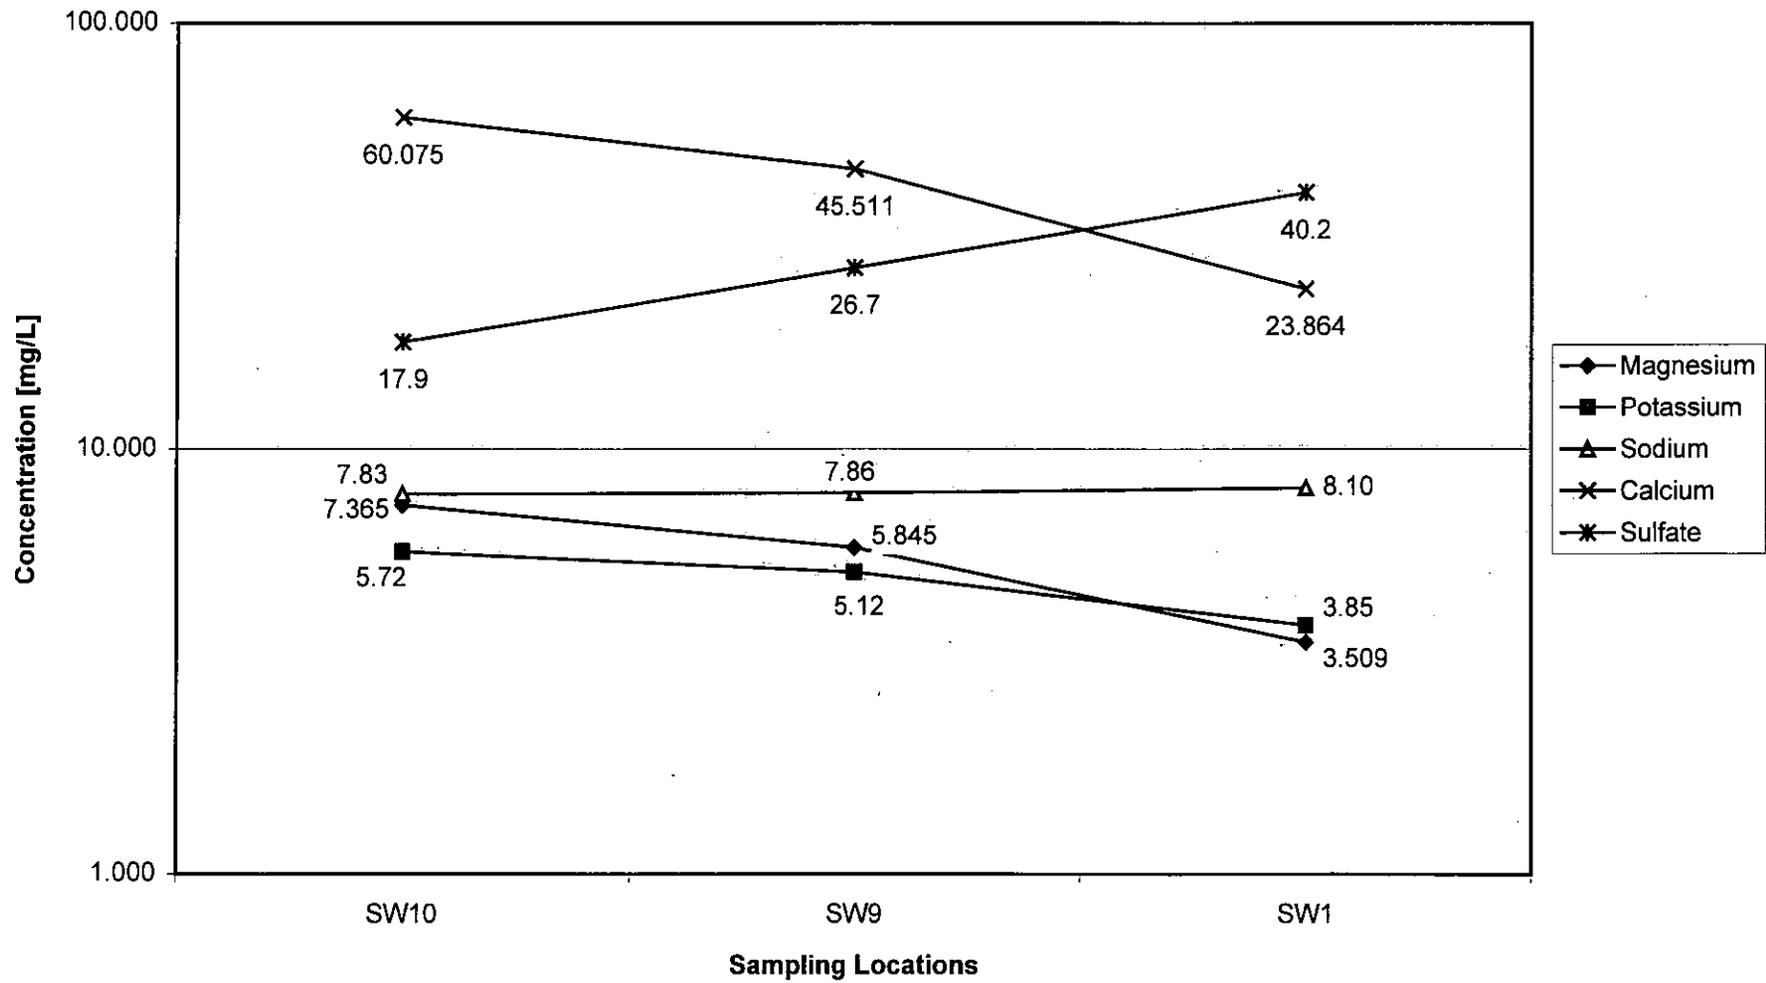
Figure 47

CSX/Vaughn and Bramlette Road MGP Sites
Ditch 5 Surface Water Samples
Miscellaneous Parameters

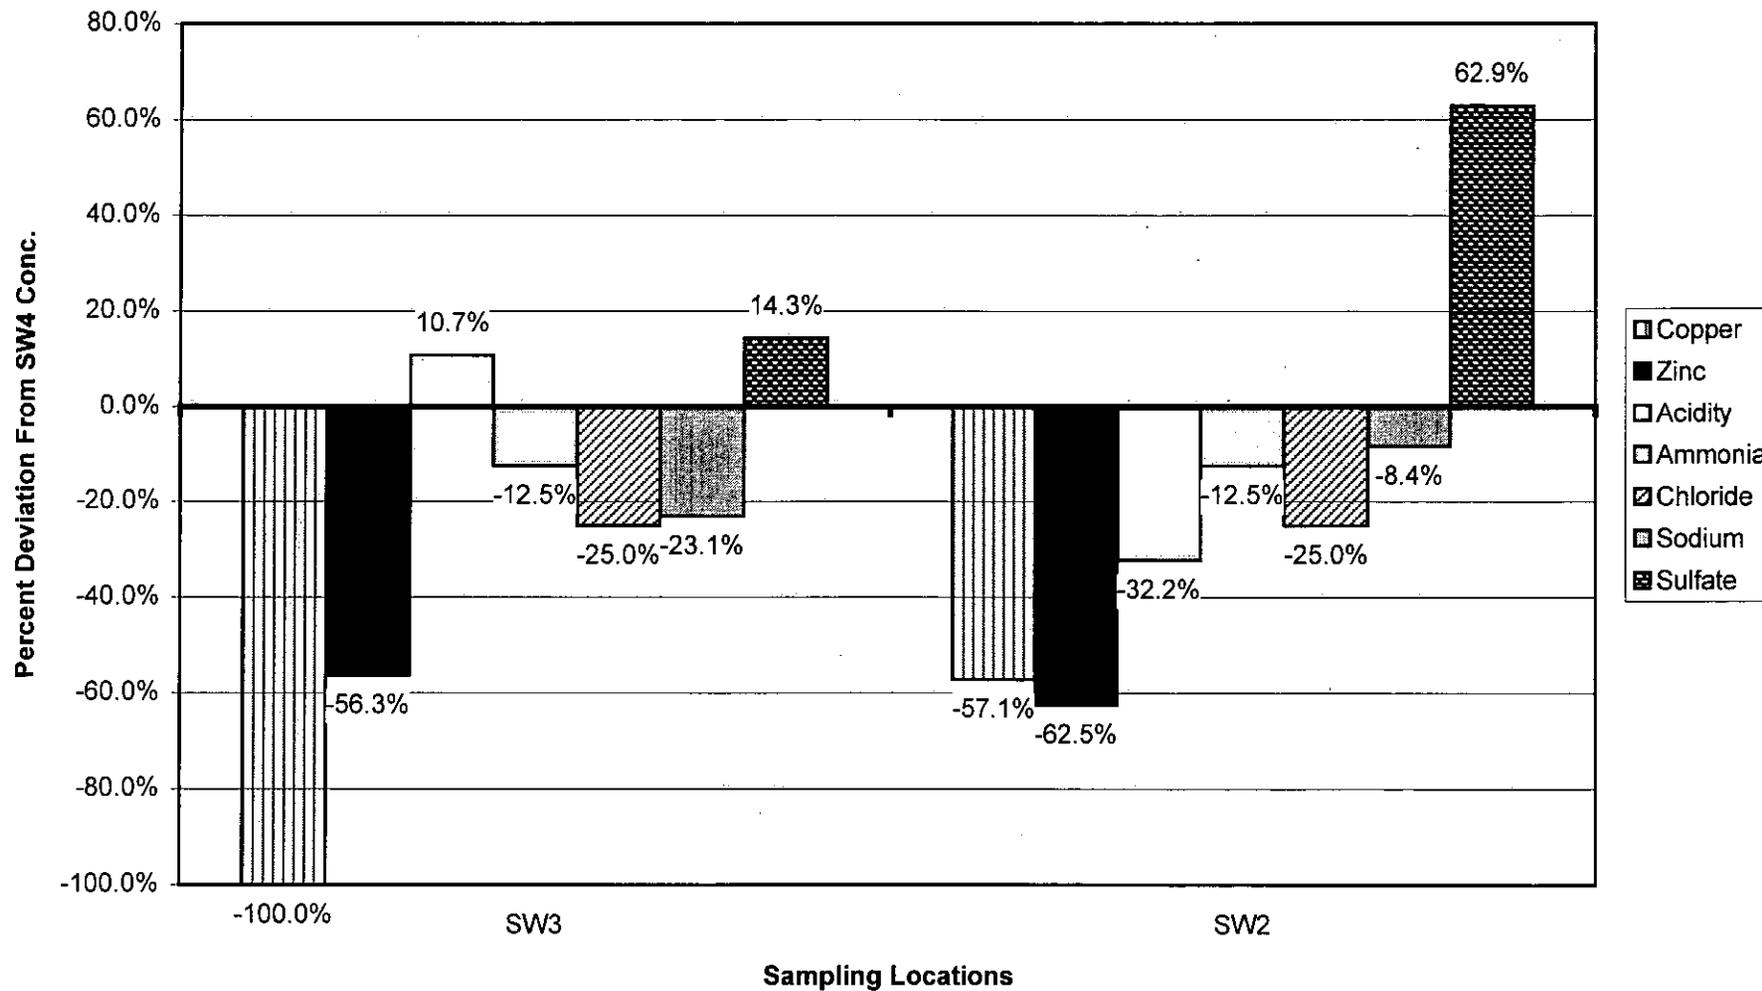
Figure 48

**CSX/Vaughn and Bramlette Road MGP Sites
Reedy River Surface Water Samples
Miscellaneous Parameters**

Sulfate increased 14.3 % at SW3 and 62.9% at SW2 relative to the SW4 baseline concentration. Iron levels increased with distance downstream (Table 40), from 2,838 ppb at SW4, to 2,730 ppb at SW3, and finally to 2,691 ppb at SW2. Low sulfate levels, in conjunction with higher relative iron levels, in groundwater are likely indications of biological degradation as has been previously discussed. The increasing sulfate levels along with the decreasing iron levels indicated in the stretch of the Reedy River from SW4 to SW2 could be an indication of contaminated groundwater discharge into the river from the Landfill site.

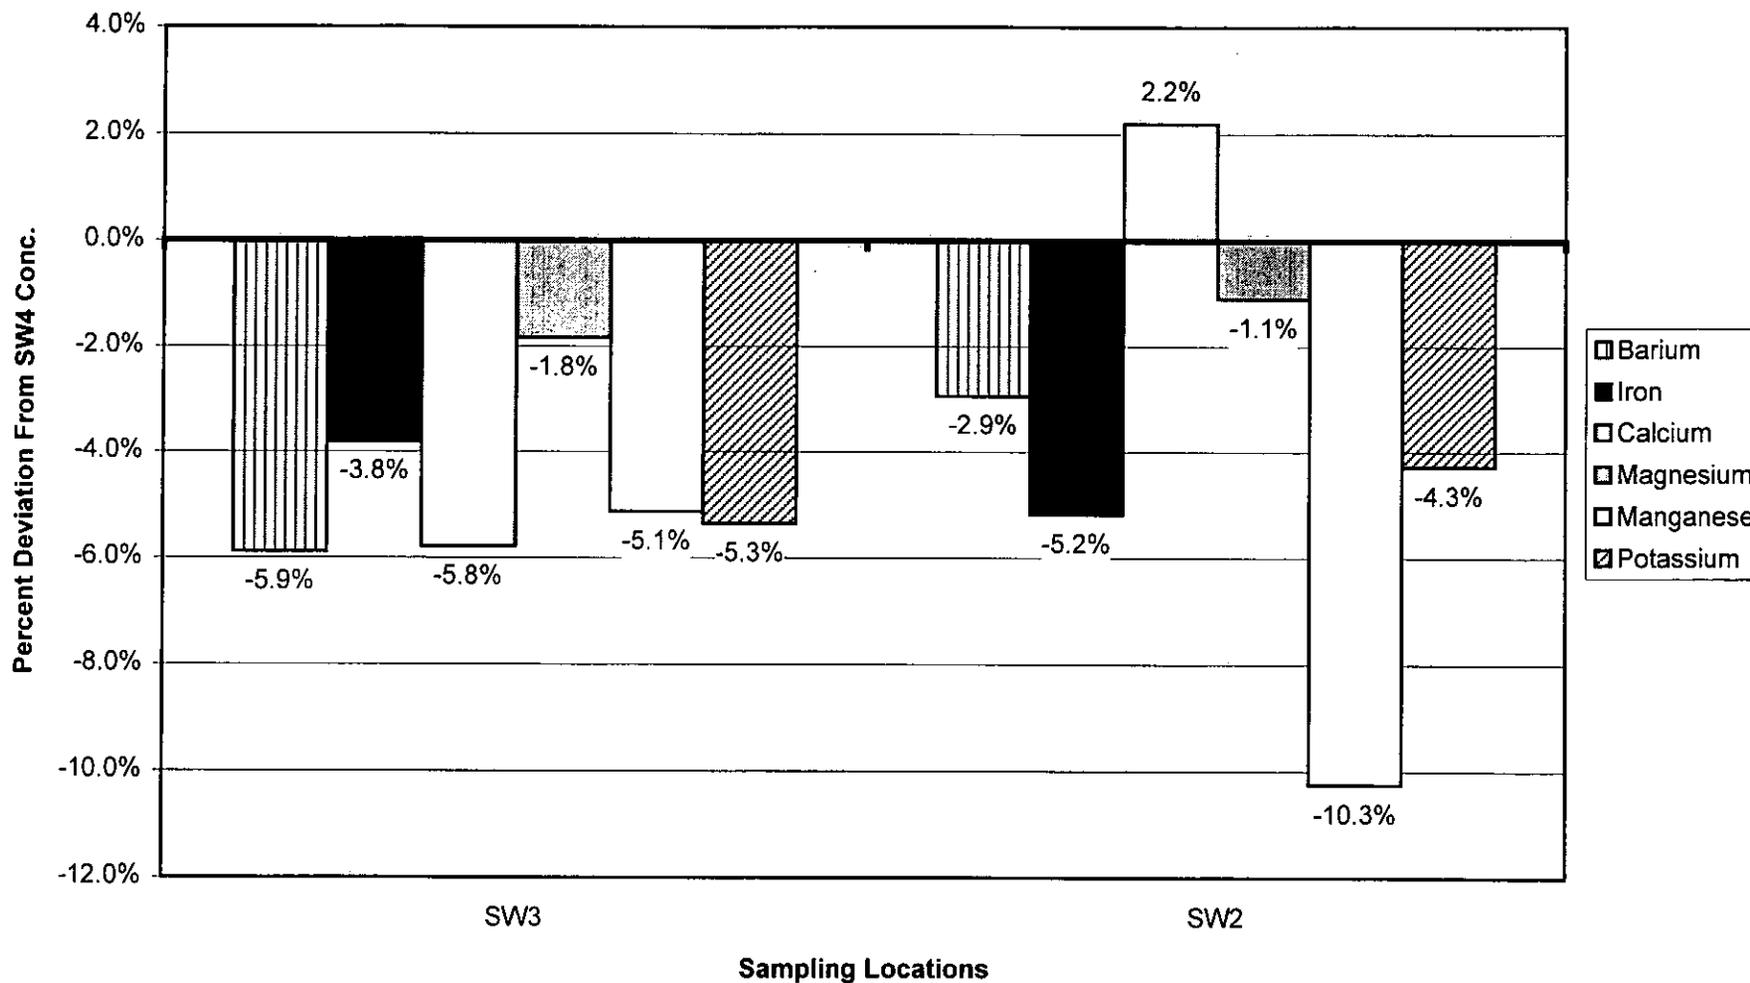
Figure 49

**CSX/Vaughn and Bramlette Road MGP Sites
Reedy River Surface Water Samples
Miscellaneous Parameters**

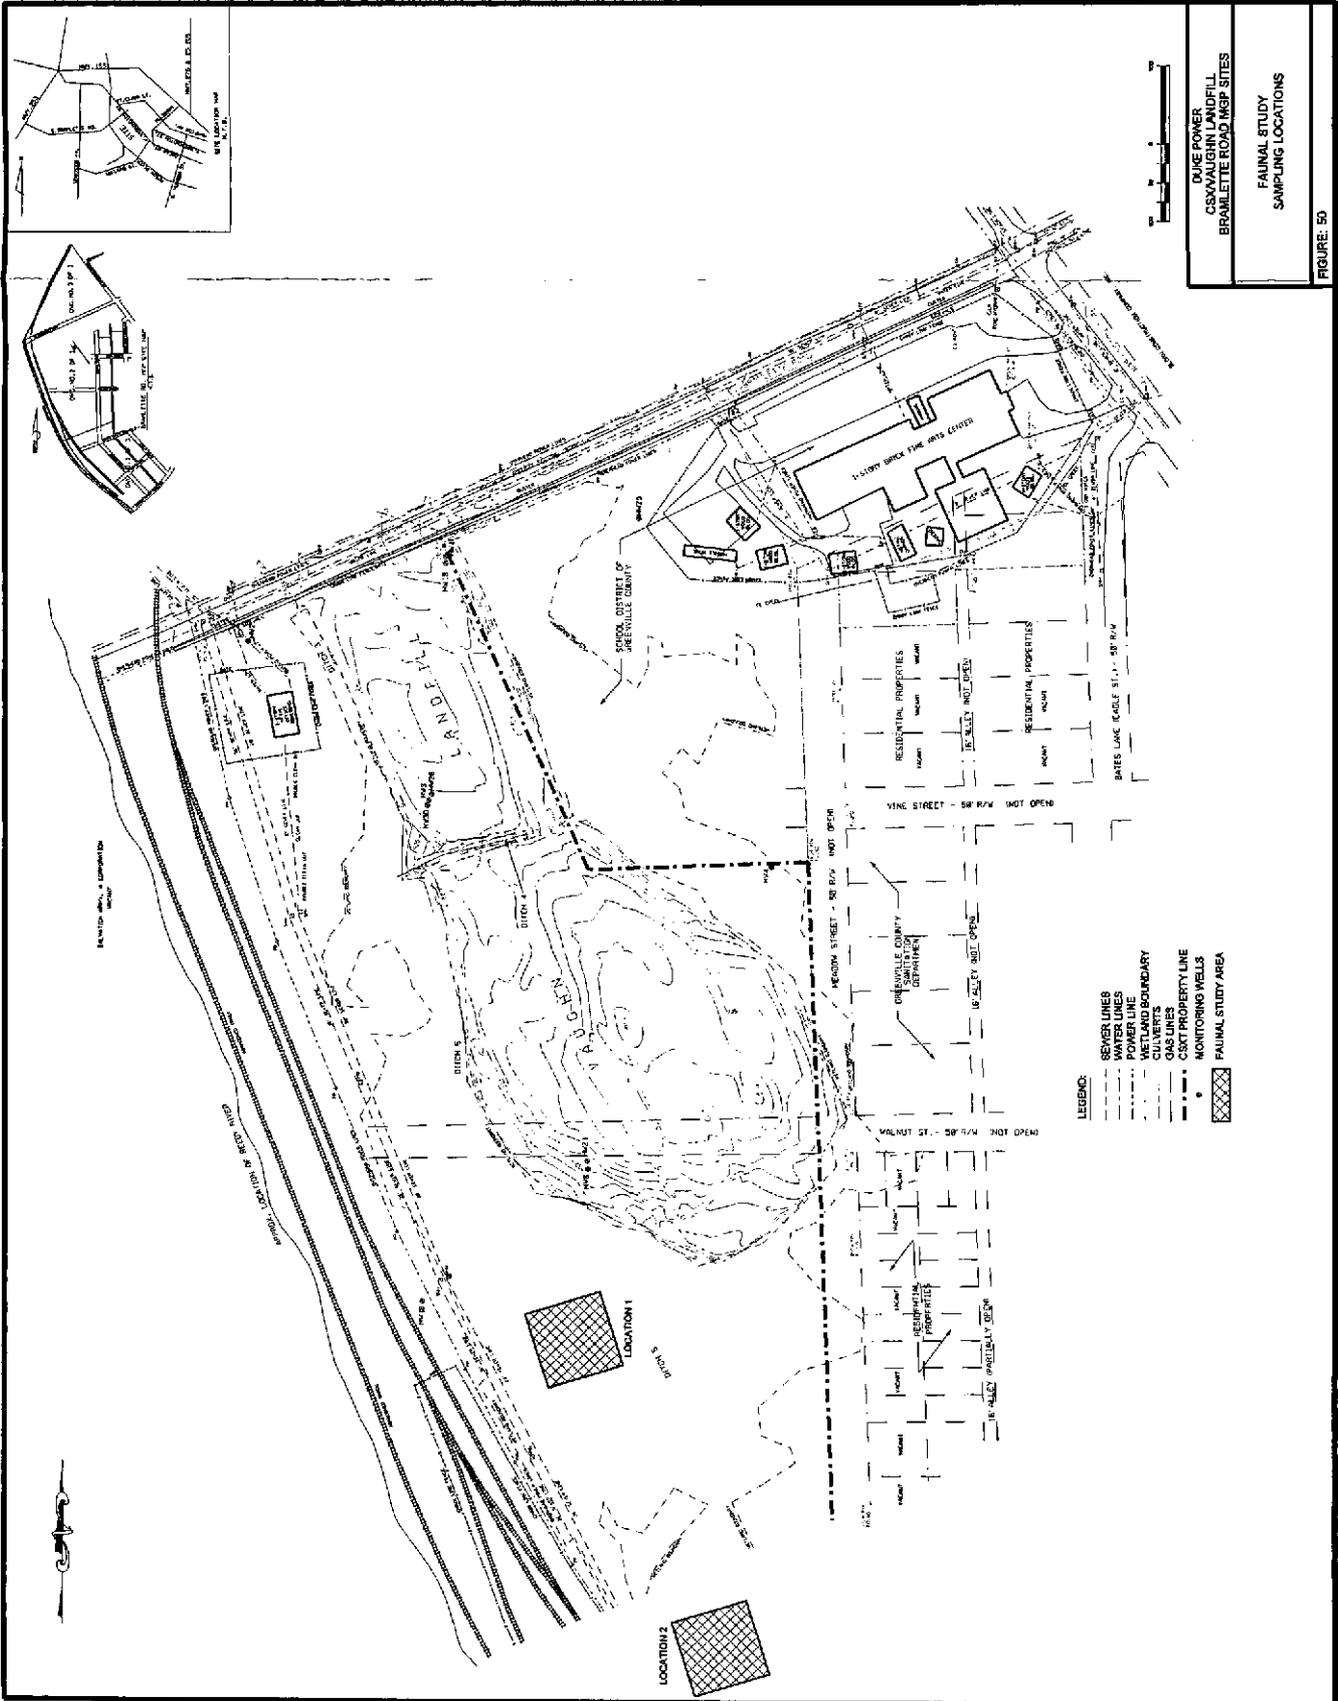
FAUNAL STUDY
SAMPLING LOCATIONS

The assessment included the evaluation of 5 sample plots equal in size to 450 square feet. Sample plots were selected to maintain similar environmental characteristics (plant community structure, water depth, water temperature and sunlight exposure) at each location. Two basic wetland habitats were observed at the site; floodplain habitat areas, and deeper drainage channel habitats areas. Both areas are primarily inundated year-round.
