**SITE INSPECTION  
BURLINGTON INDUSTRIES CHERAW  
SCS 123 457 698  
CHERAW, SOUTH CAROLINA  
CHESTERFIELD COUNTY**

**U.S. ENVIRONMENTAL PROTECTION AGENCY  
Region 4  
61 Forsyth Street  
Atlanta, Georgia 30303**

**South Carolina Department of Health and Environmental Control  
Division of Site Assessment and Remediation  
Federal & State Site Assessment Section  
2600 Bull Street  
Columbia, South Carolina 29201**

September 27, 2016

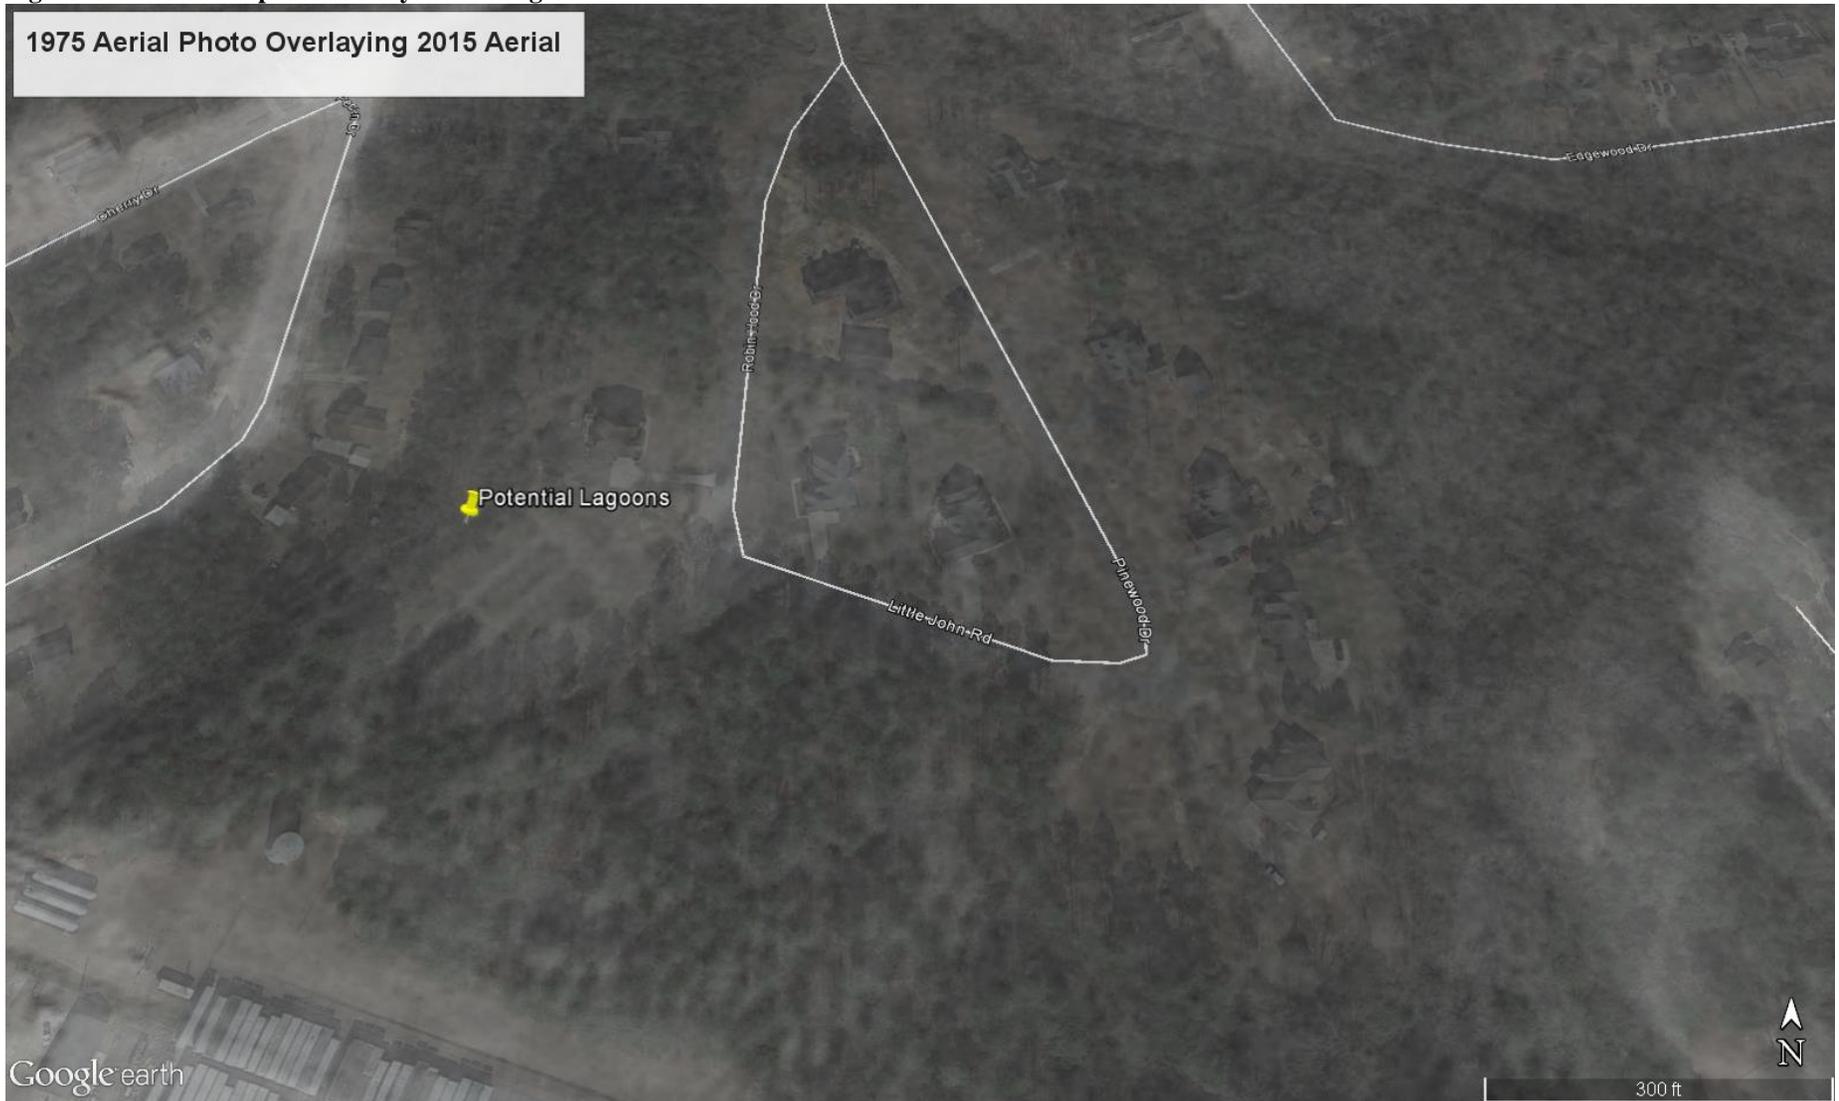
Figure 4 – 1975 aerial photo overlay from Google Earth

A large land tract owned by Burlington Industries was sold in 1990 to a developer who subdivided it into the current residential neighborhood (Ref. 7). Based on overlays of historical aerial photography, it appears that the sludge drying beds sat predominantly on the vacant lot at the intersection of Little John Road and Robin Hood Drive. Today, this lot is mostly cleared with woods bordering south, east, and west boundaries. Noted during field activities at the site are small pieces of a dark green/dark gray rubbery sludge-like material across the lot and the adjoining lot on Robin Hood Drive. This same material is present in larger “chunks” along the western edge of the vacant lot, appearing as though the material was pushed to that side of the property as the lot was graded (Ref. 6).

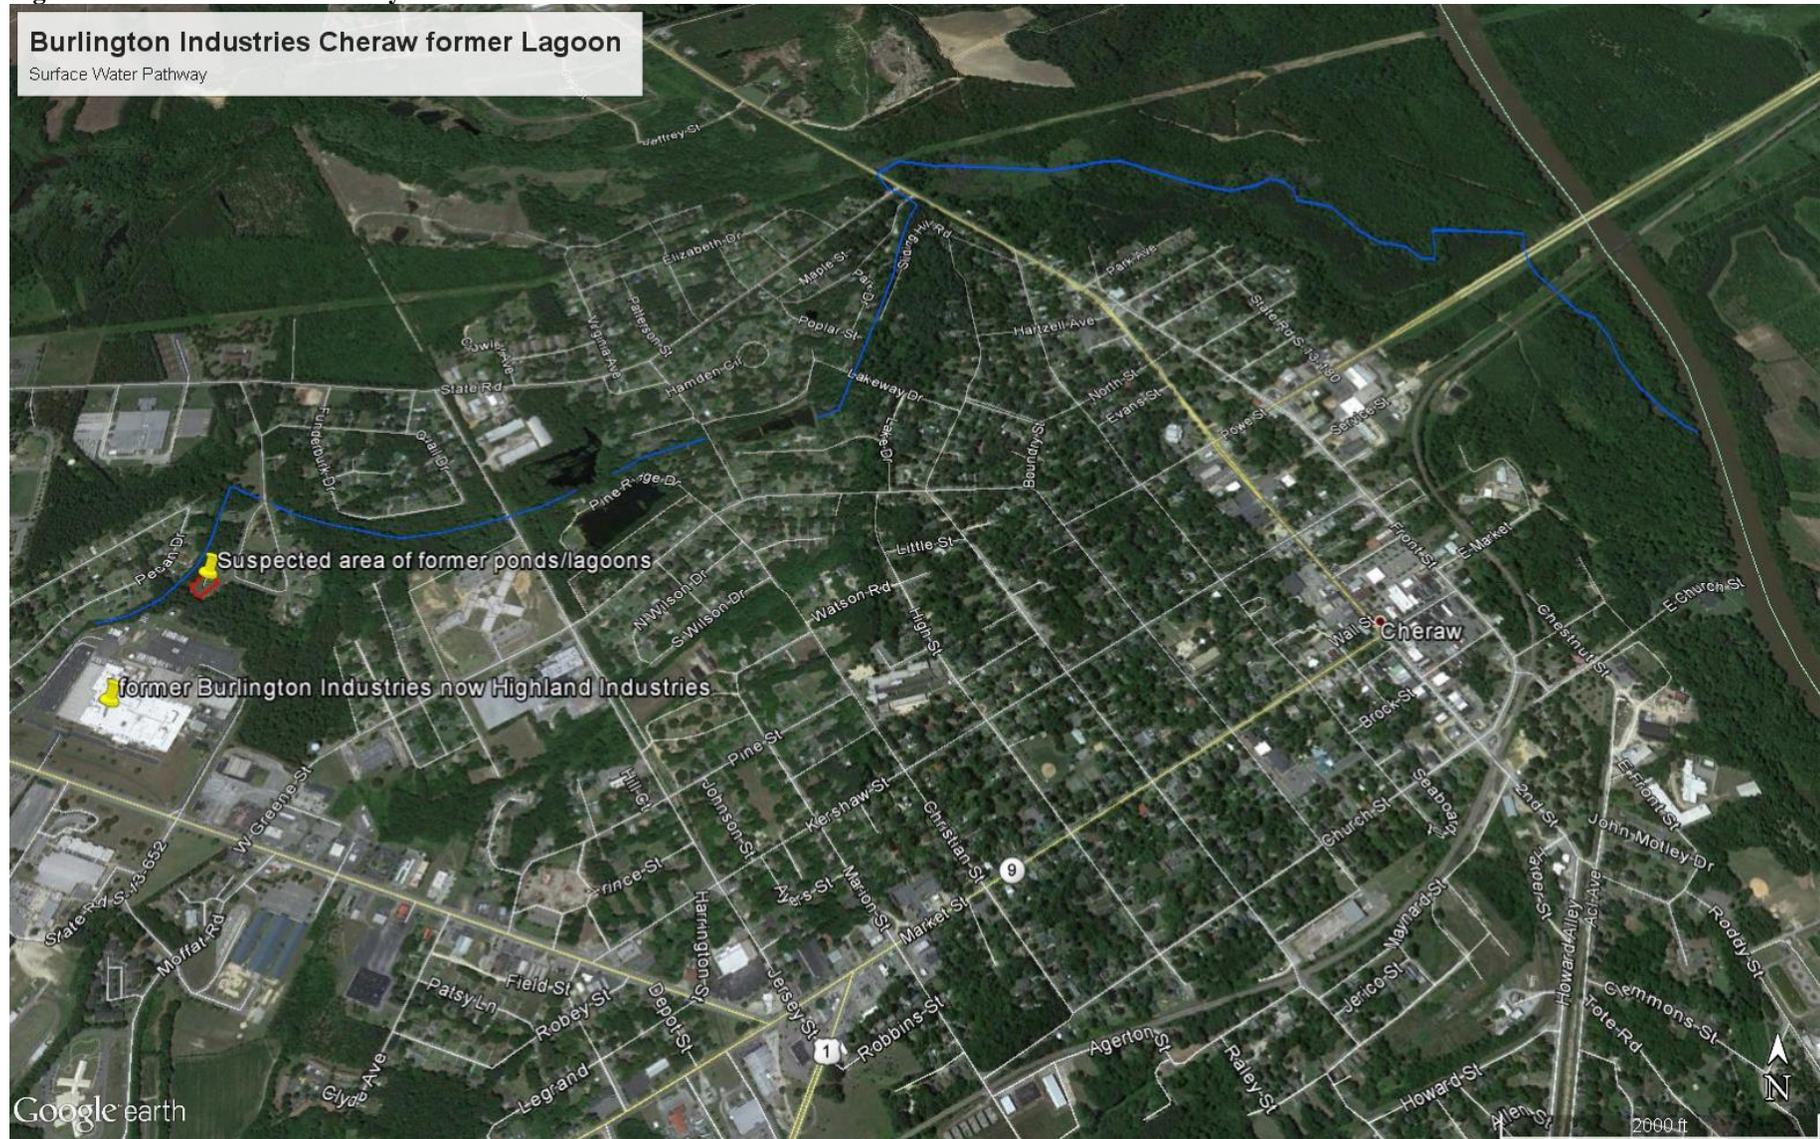
**Figure 6 – Surface Water Pathway to Great Pee Dee River**

The site lies within the Pee Dee River sub-basin (Ref. 8). A small drainage ditch that begins on Highland Industries property flows along the western edge of the vacant lot in a northerly direction approximately 1,000 feet to meet an easterly-flowing creek. This intermittent creek flows approximately one mile to the east meet the perennial Wilson Branch (Ref. 1). Wilson Branch flows in a northeasterly direction for ½-mile to meet Huckleberry Branch. Huckleberry Branch flows 1.5 miles east/southeasterly to reach the Great Pee Dee River. The 15-mile target distance limit for purposes of this report ends 13 miles downstream in the Great Pee Dee River near Bennettsville (Ref. 1). There are several ponds located along the surface water pathway near the intersection of Wilson Branch. The interaction of the creek and these ponds is not fully documented at this time. However, a branch of the creek directly flows through at least one of the three downstream ponds (Ref. 16).

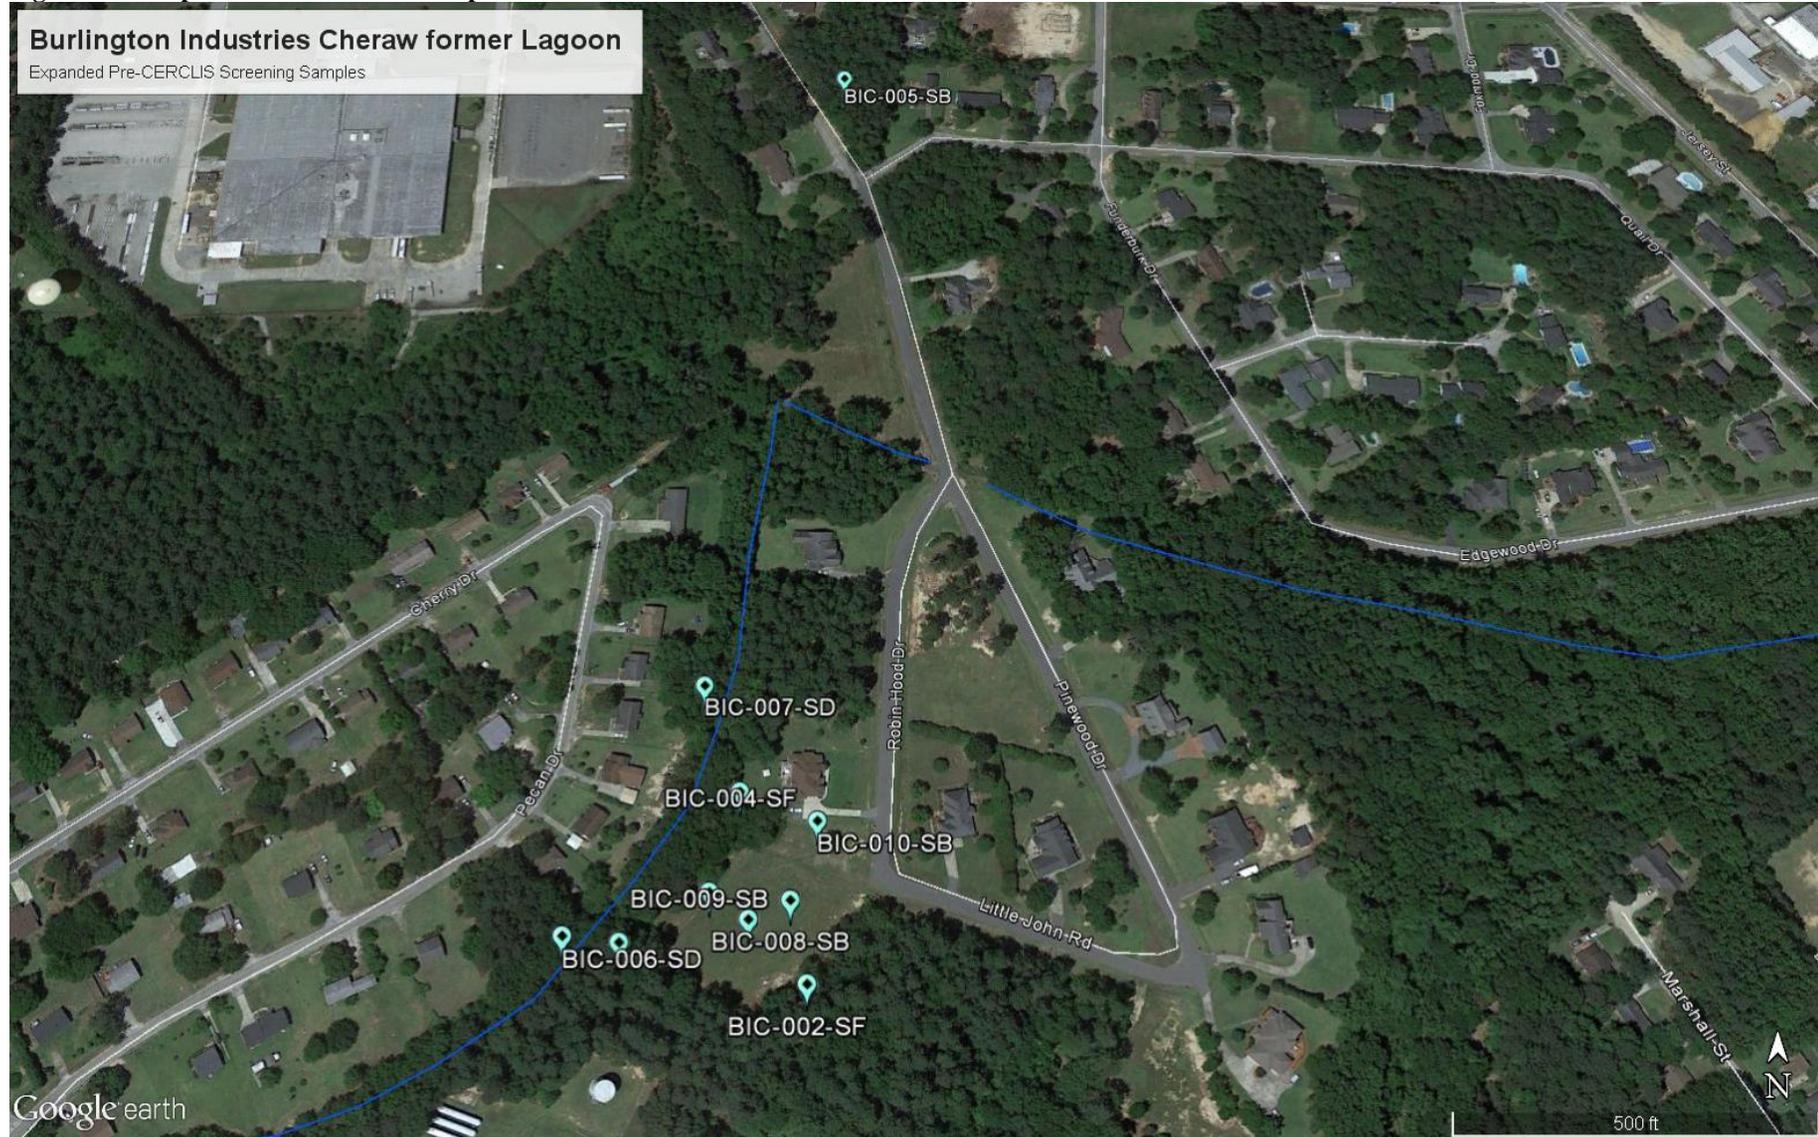
Figure 7 – Samples collected for 2016 Expanded PSA

Sampling for the PSA in February 2016 found levels of PCB 1248 and several polycyclic aromatic hydrocarbons (PAHs) in two sediment samples from the ditch leaving Highland Industries at levels significantly elevated above screening values (Ref. 5). Sampling for this investigation again detected very high levels of PCBs in the ditch, both on and off current Highland Industries property (Ref. 17). Selected PCB laboratory analysis is shown below in Tables 2 and 3:

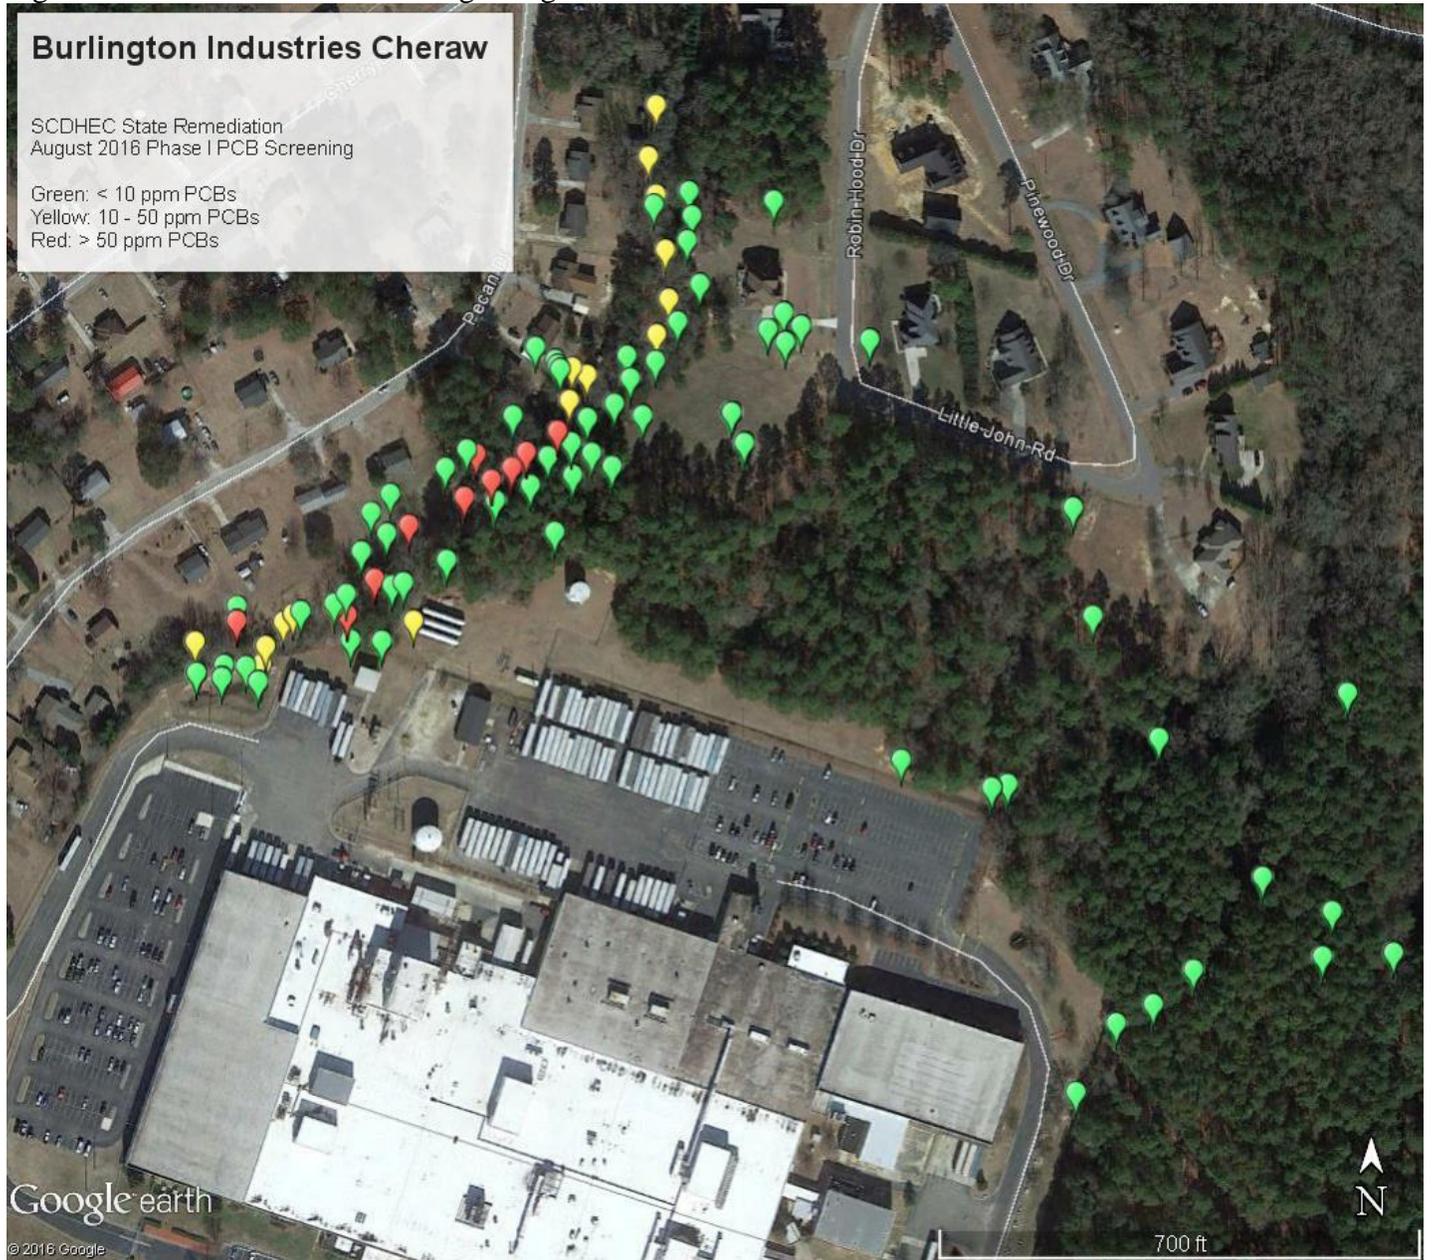
Figure 9 : SCDHEC PCB Screening - August 2016

decide which samples would be sent for laboratory analysis (Ref. 18). Over 100 samples were collected for field screening and 56 were sent for laboratory analysis (all for Aroclors, selected samples for PCB congeners, metals, SVOAs, and VOCs). See Figures 9-11 for sampling locations for this investigation. This Site Inspection will utilize this SCDHEC-gathered analytical data to determine future Federal Superfund actions.
