U.S. Army Corps of Engineers – Charleston District - Regulatory Division
REQUEST FOR CORPS JURISDICTIONAL DETERMINATION (JD) / DELINEATION
 (For Jurisdictional Status and Identifying Wetlands and Other Aquatic Resources)

Site Name: Pacolet Quarry Site Date: March 14, 2023
 City/Township/Parish: Spartanburg County: Spartanburg
 Latitude/Longitude: 34.9370N, -81.7681W Acreage: 782
 Tax Map Sequence (TMS) #(s): Multiple Spartanburg Co. TPNs (Appendix C)
 Property Address(es): Southwest and northeast of Hammett Grove Road

On December 6, 13, and 20, 2022, January 5 and 18, 2023, and March 9, 2023, S&ME Biologists Chris Daves, P.W.S., Chris Handley, and Will Trotter conducted the Wetland Delineation. The following features were observed (see **Appendix A** for mapping and representative site photographs and **Appendix B** for Summary Tables):

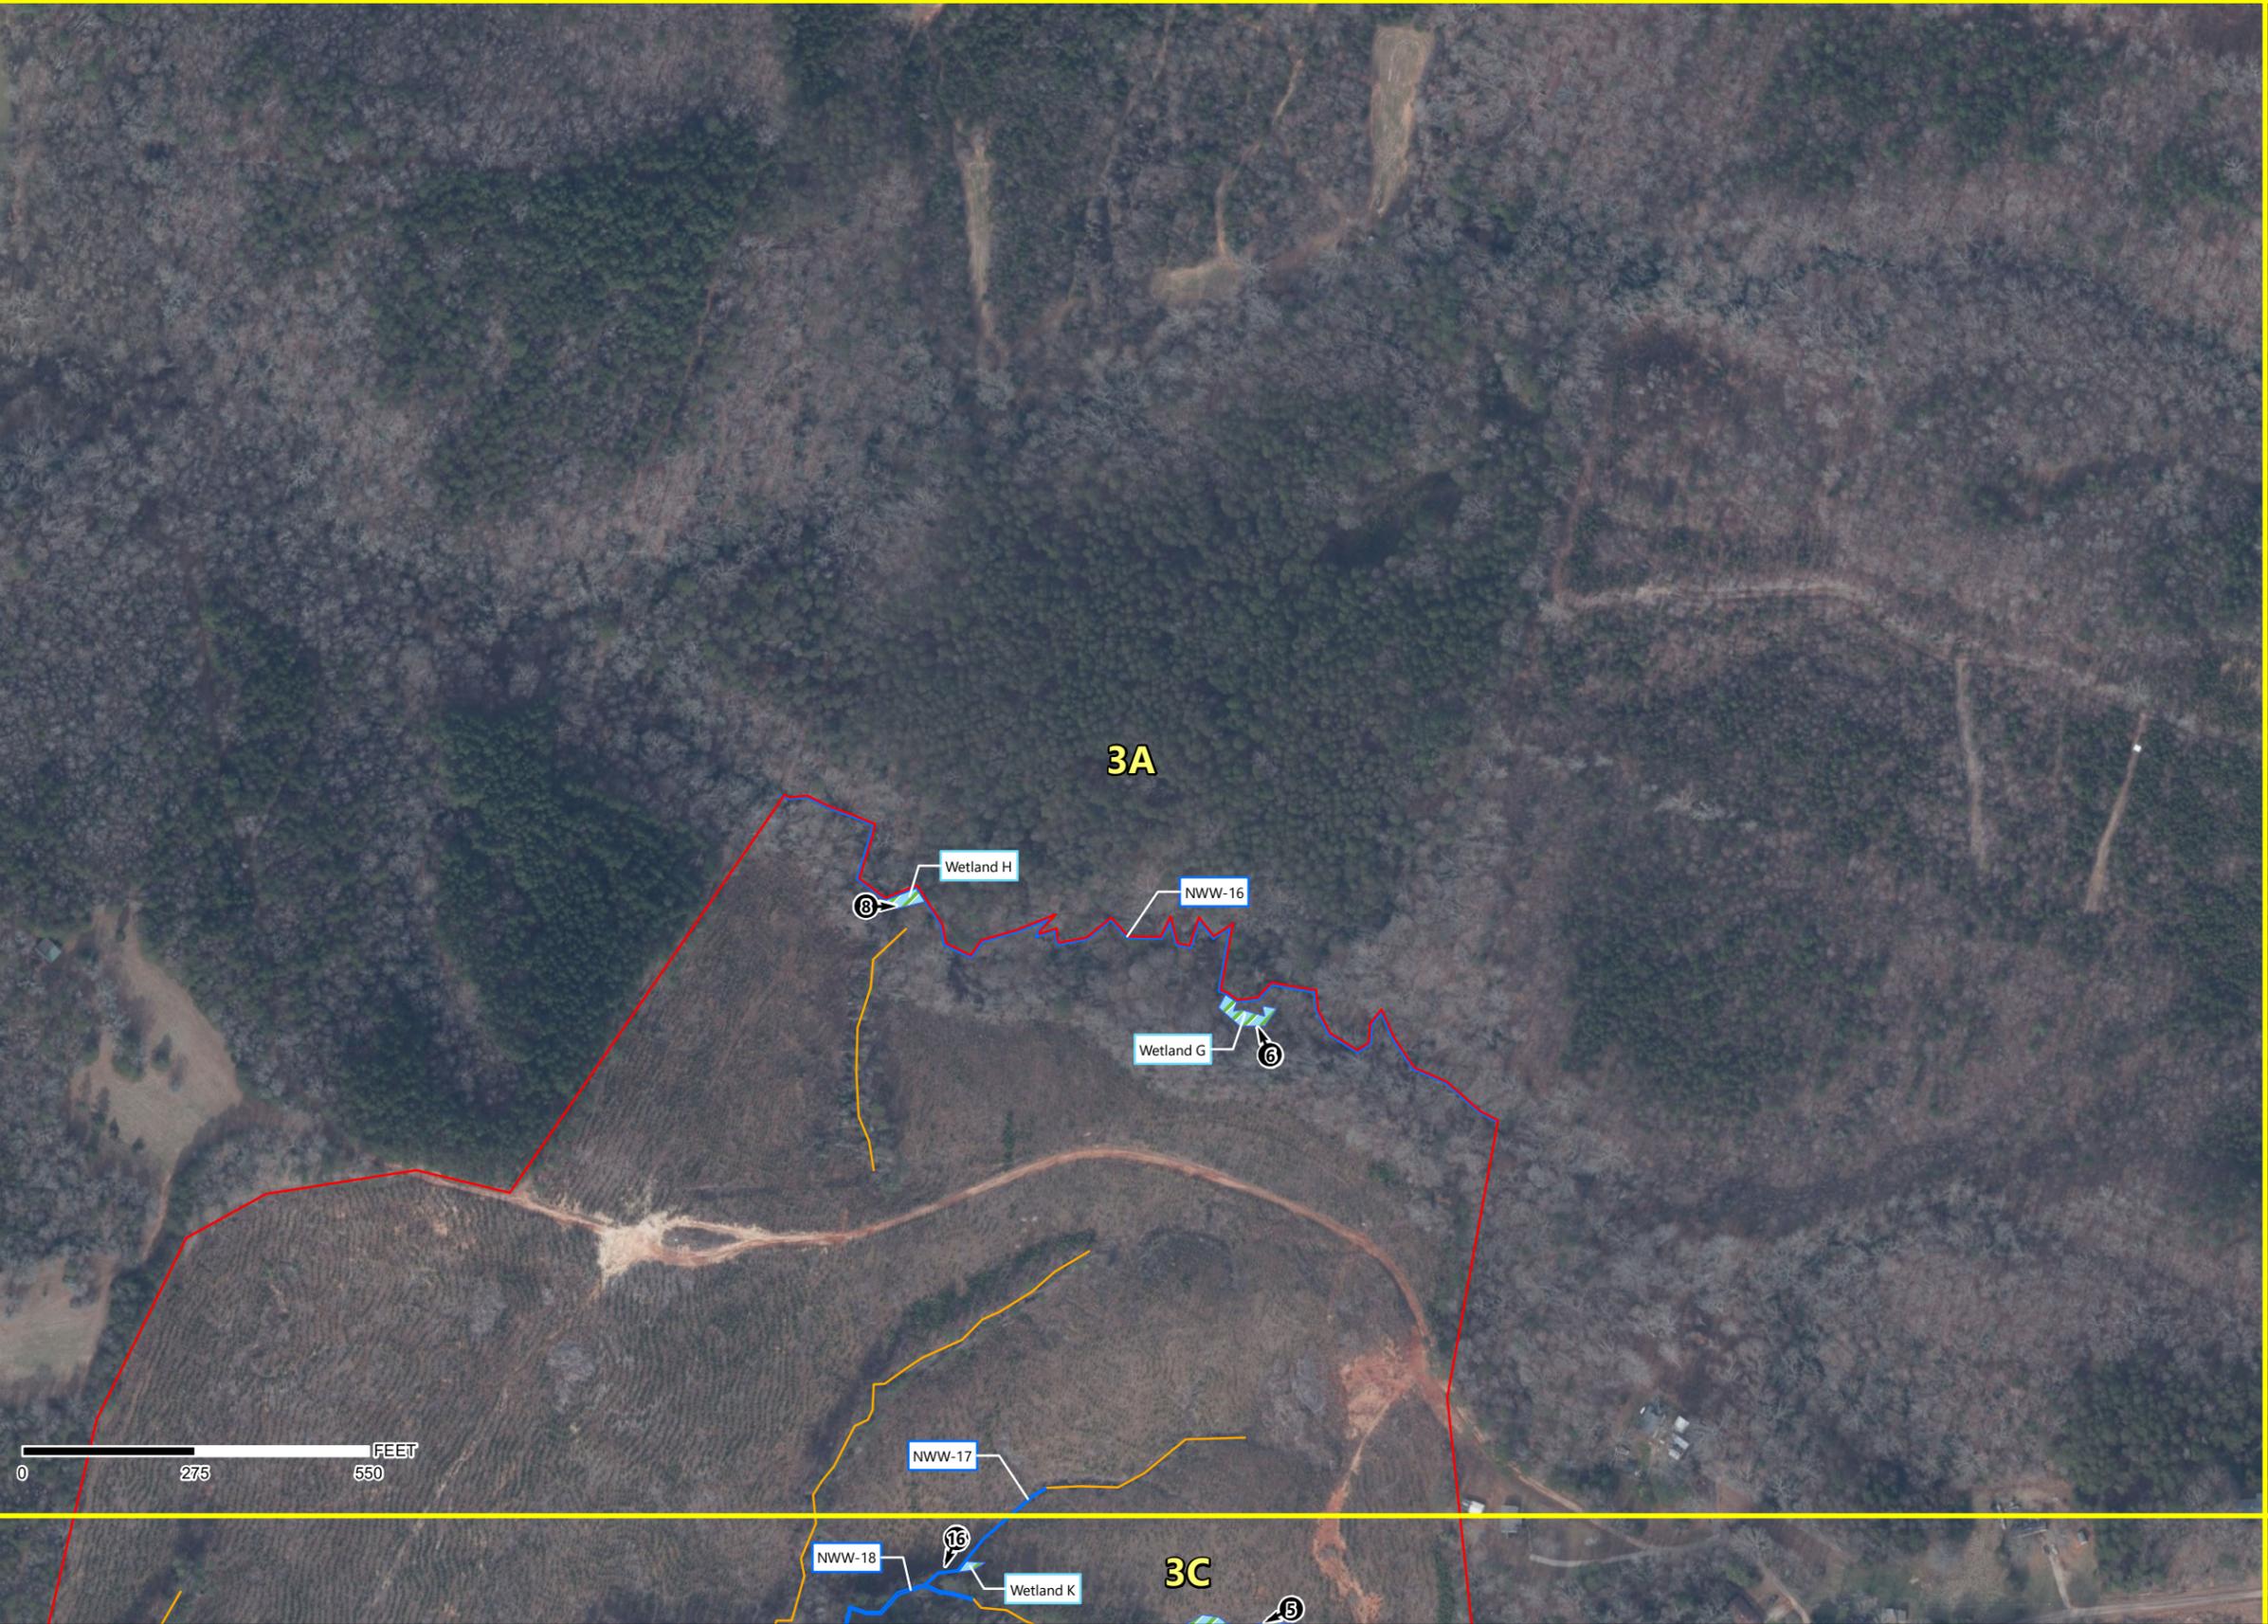
Aerial Index Exhibit

- Photograph Location & Direction
- Grid Index
- Site Boundary
- Non-Wetland Waters (Tributaries)
- Non-Aquatic Resources (Ephemeral Drainages)
- Wetlands

Pacolet Quarry Site +/- 782 Acres
Pacolet, Spartanburg County, South Carolina
Source: SC Imagery 2020

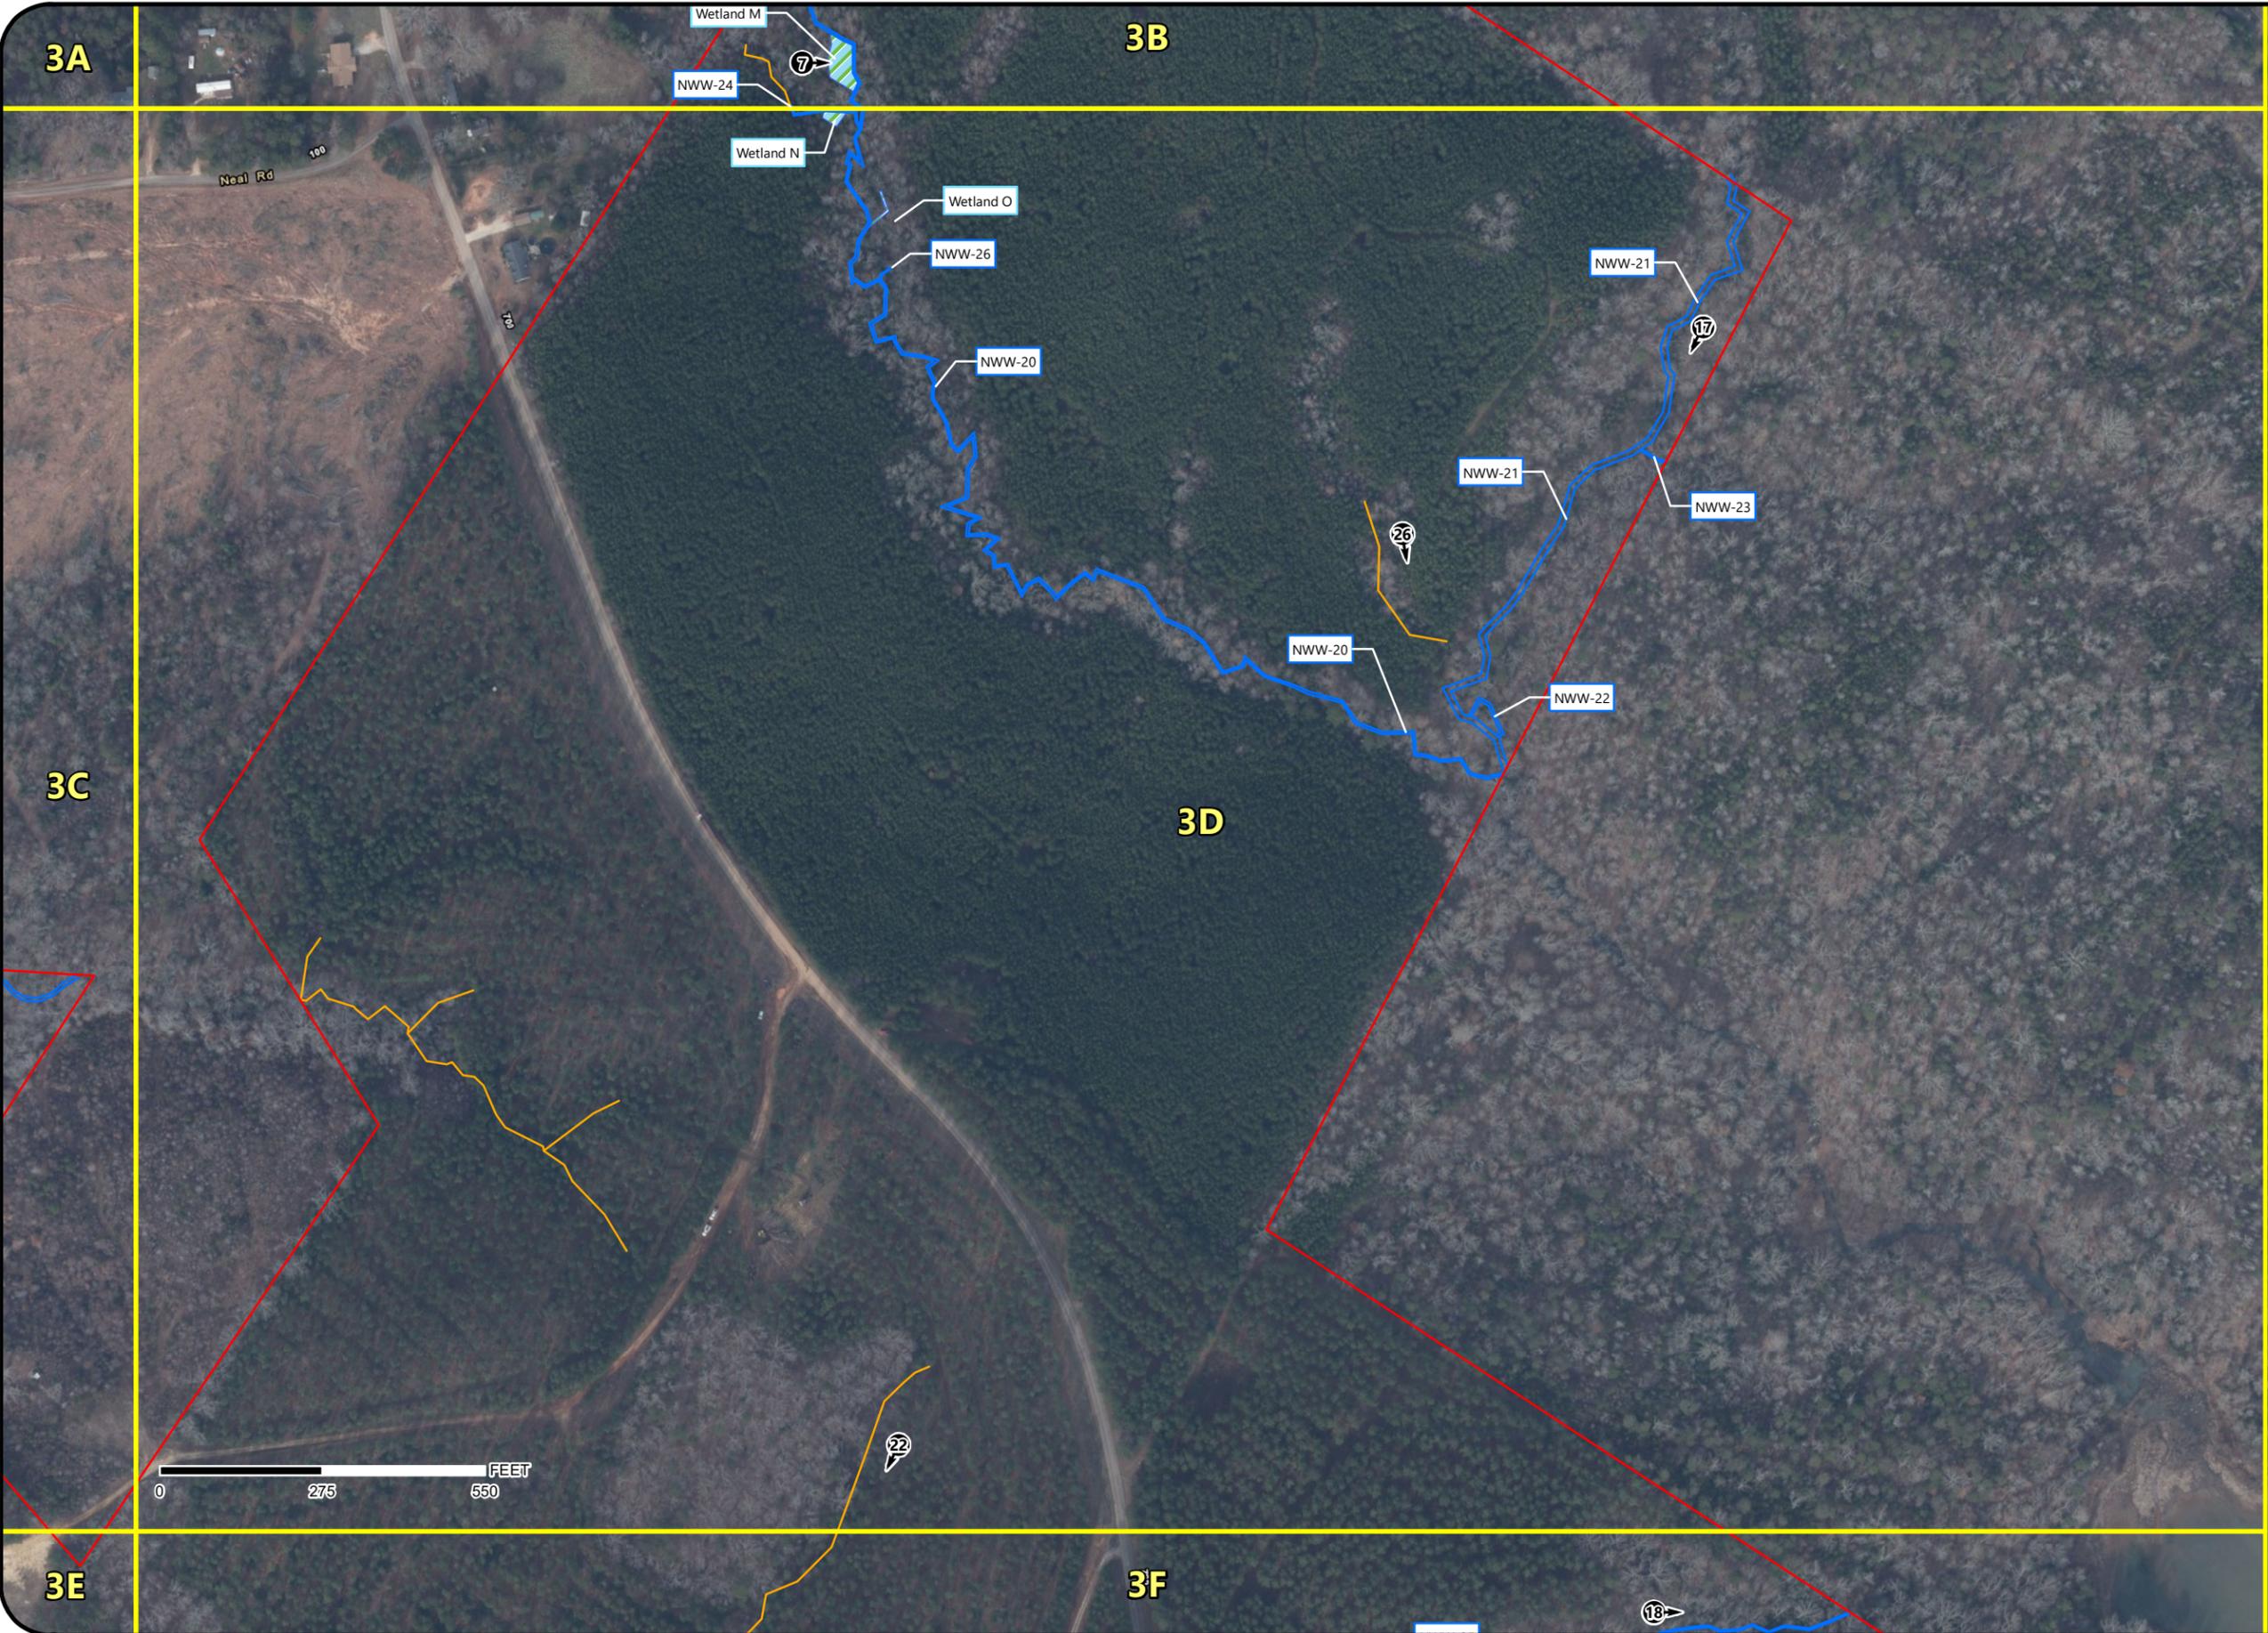
Aerial Index Exhibit

Pacolet Quarry Site +/- 782 Acres
Pacolet, Spartanburg County, South Carolina
Source: SC Imagery 2020

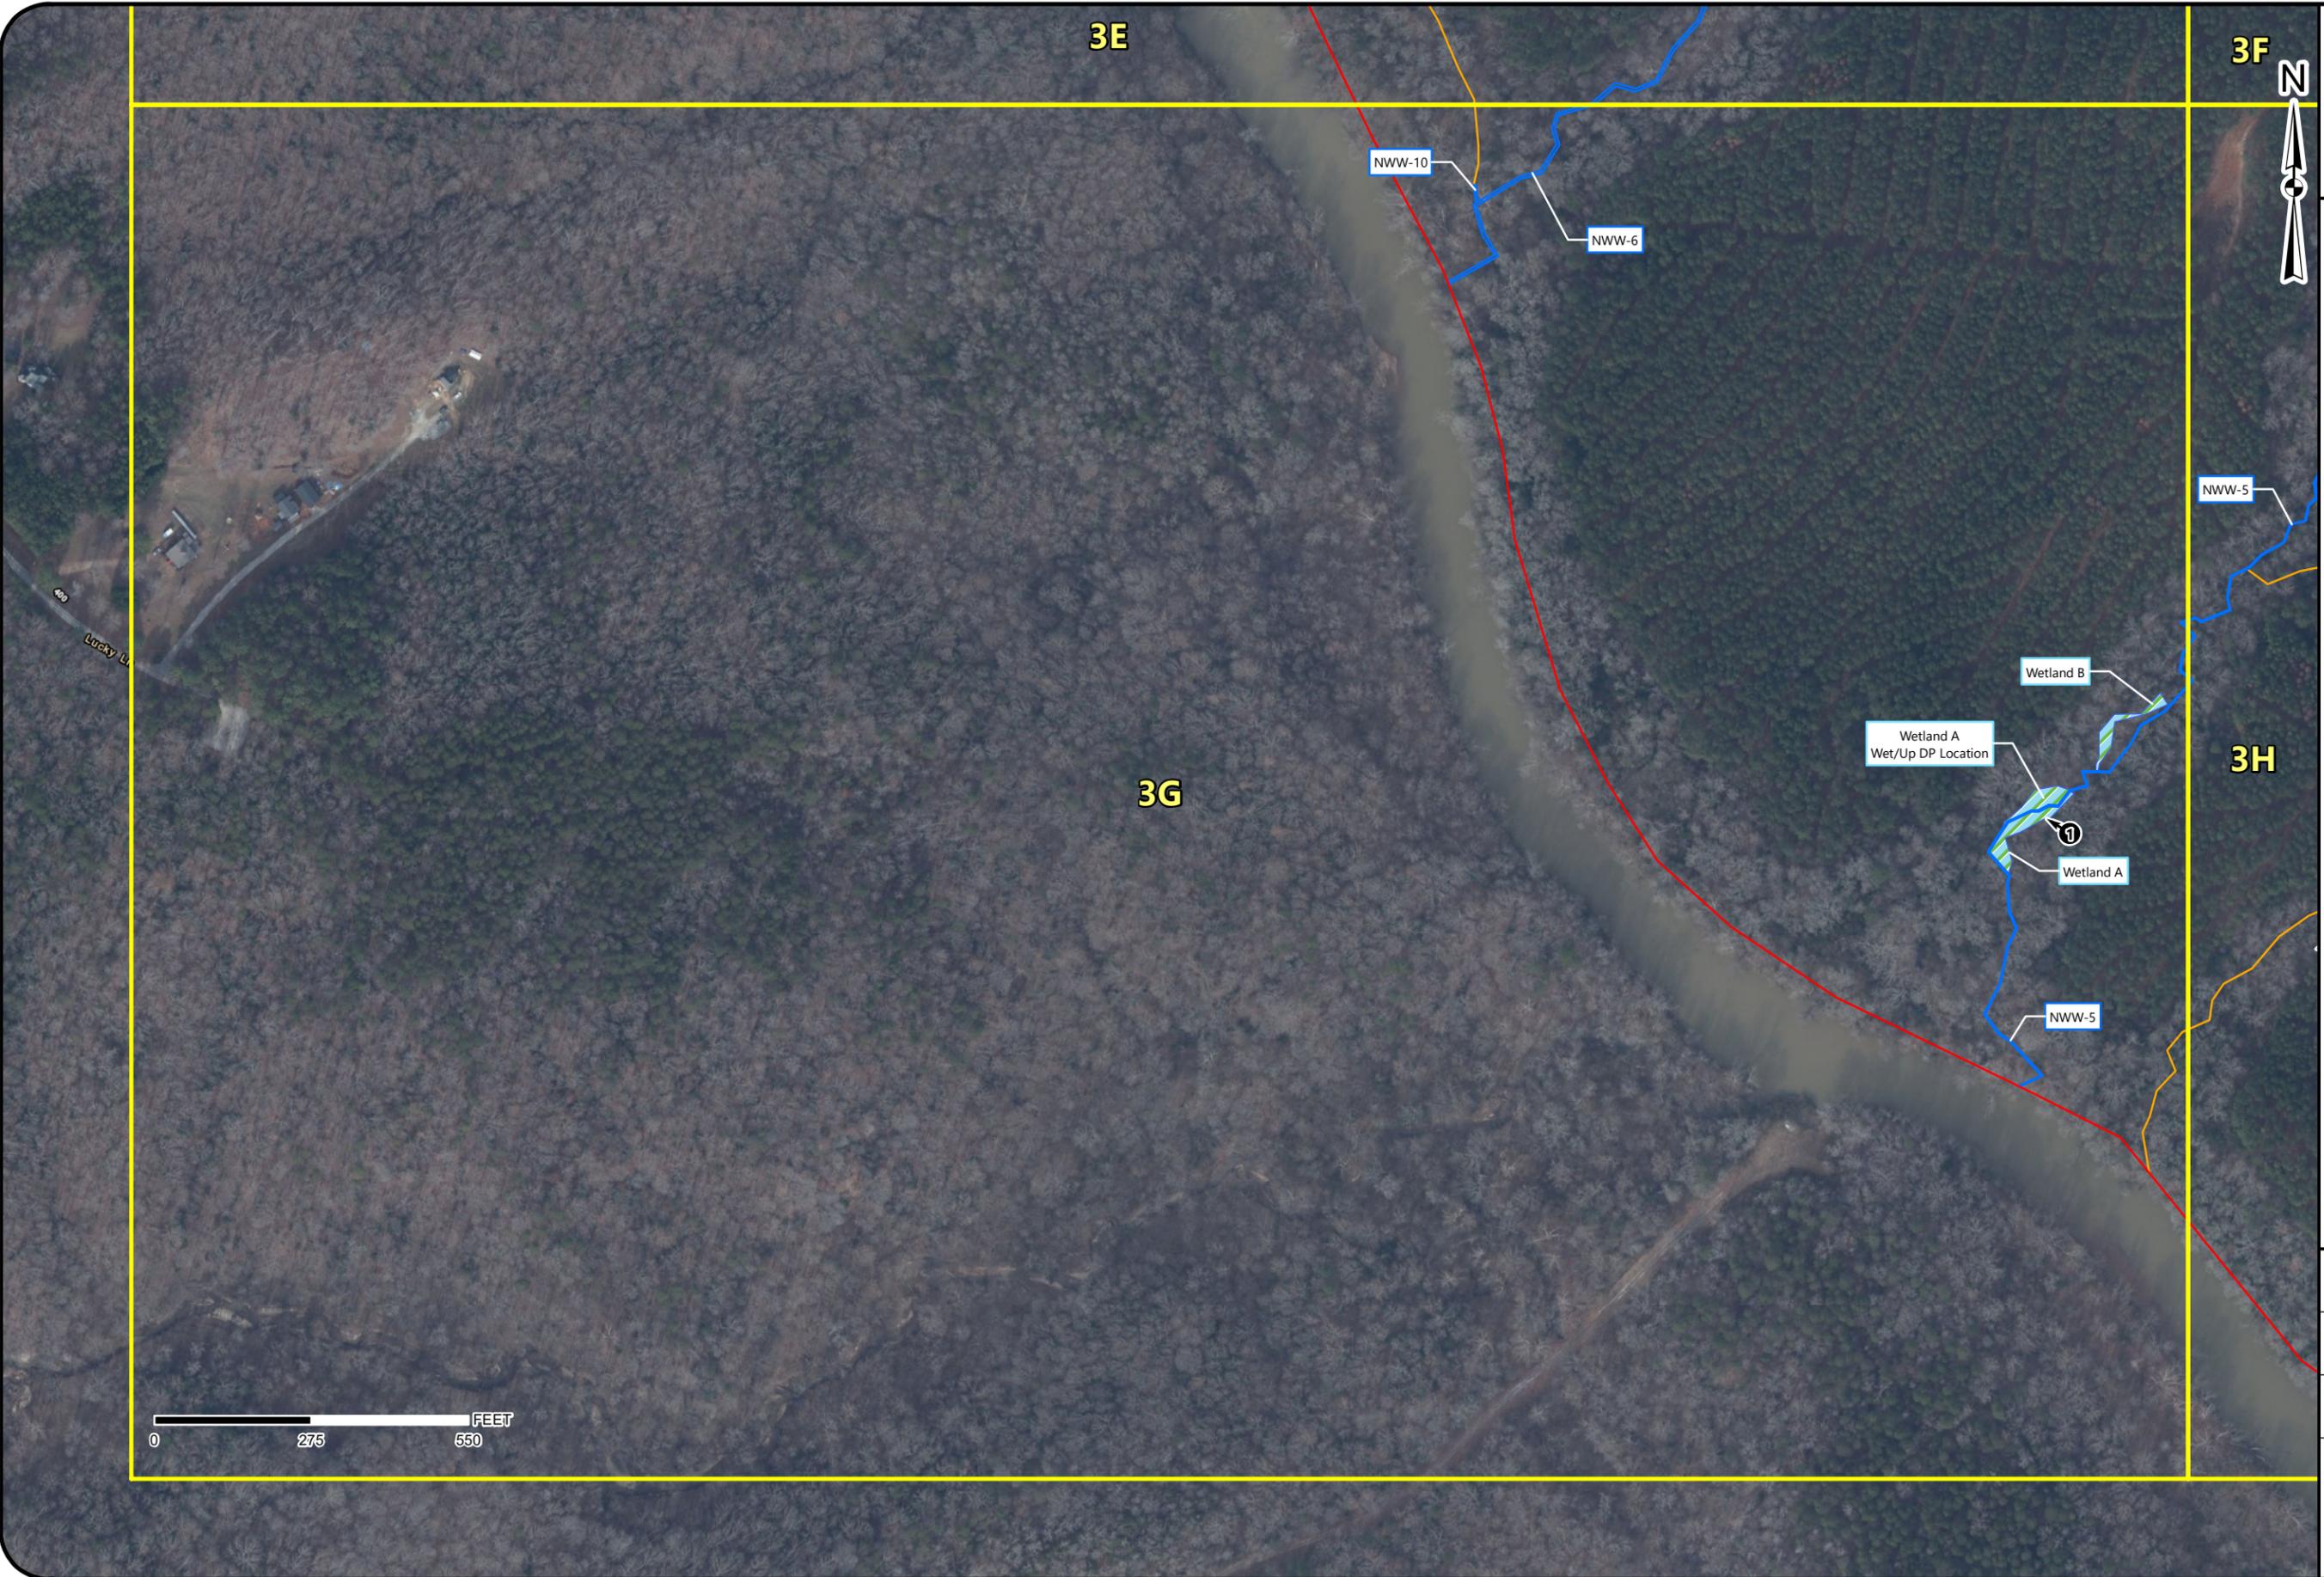
Aerial Index Exhibit

Pacolet Quarry Site +/- 782 Acres
Pacolet, Spartanburg County, South Carolina
Source: SC Imagery 2020

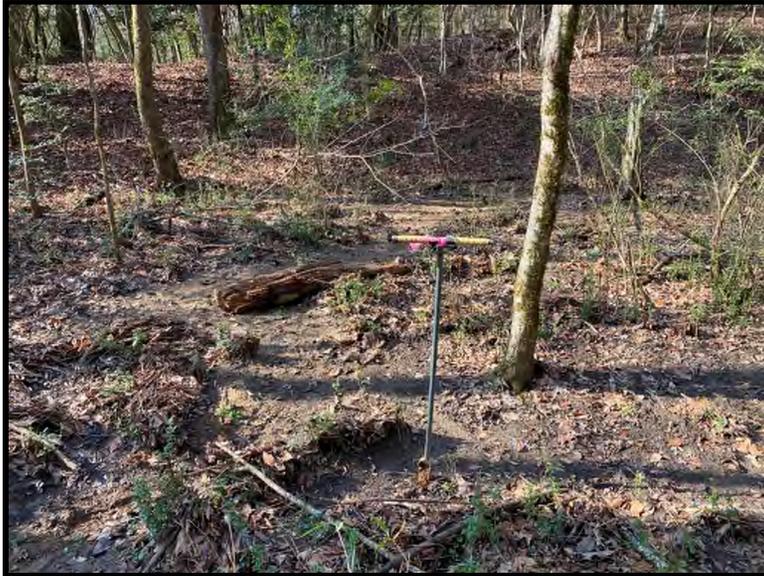
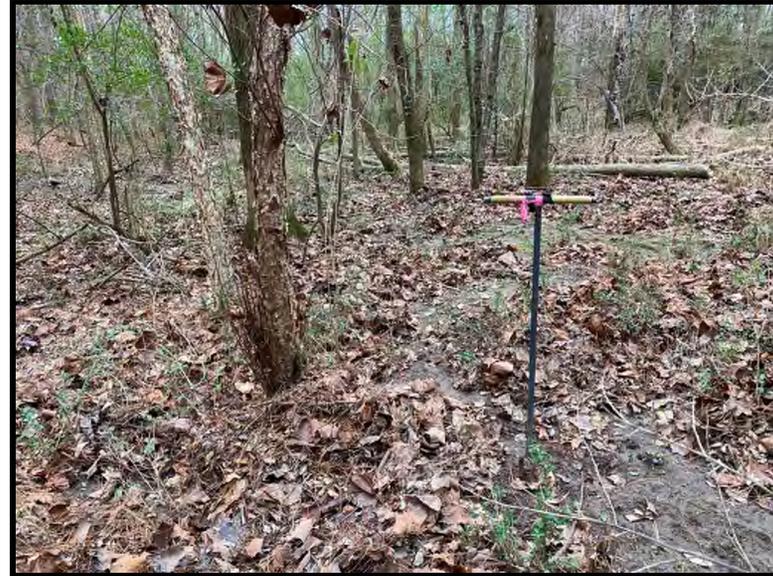
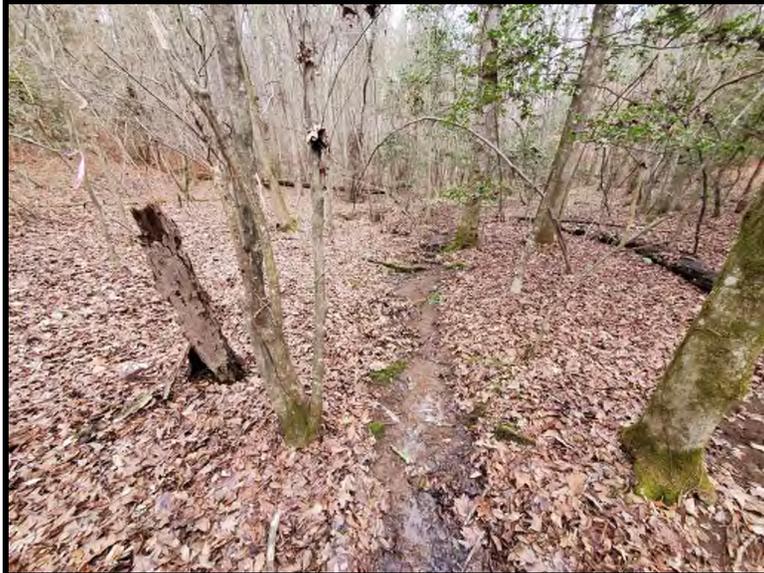
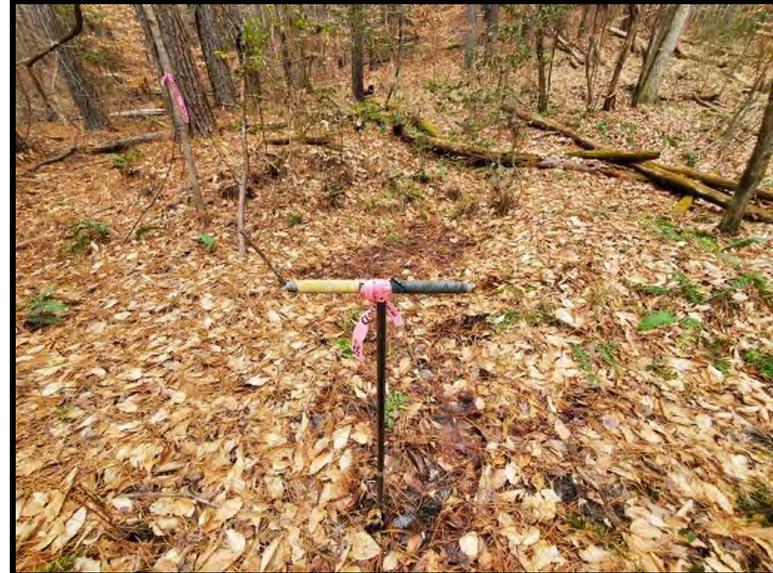
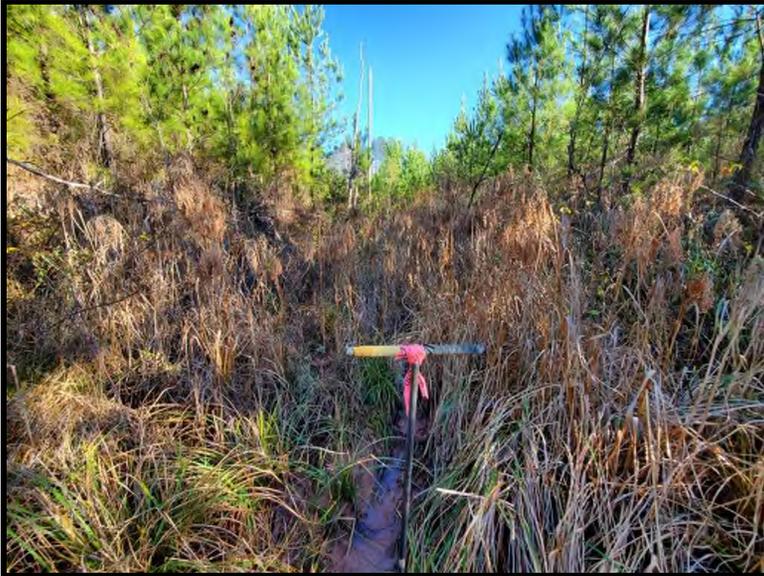
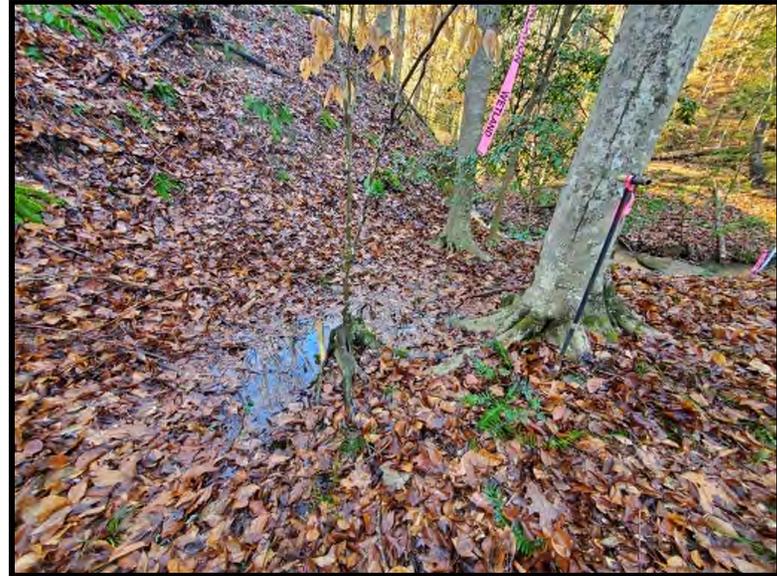
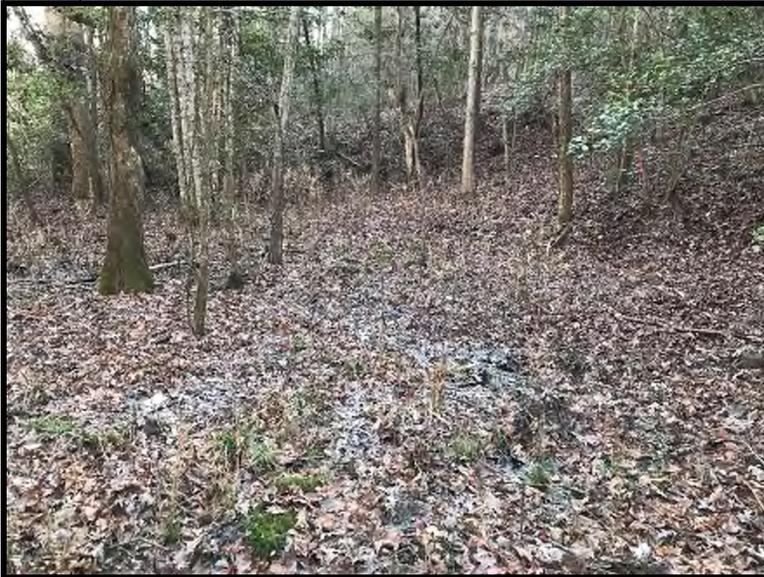
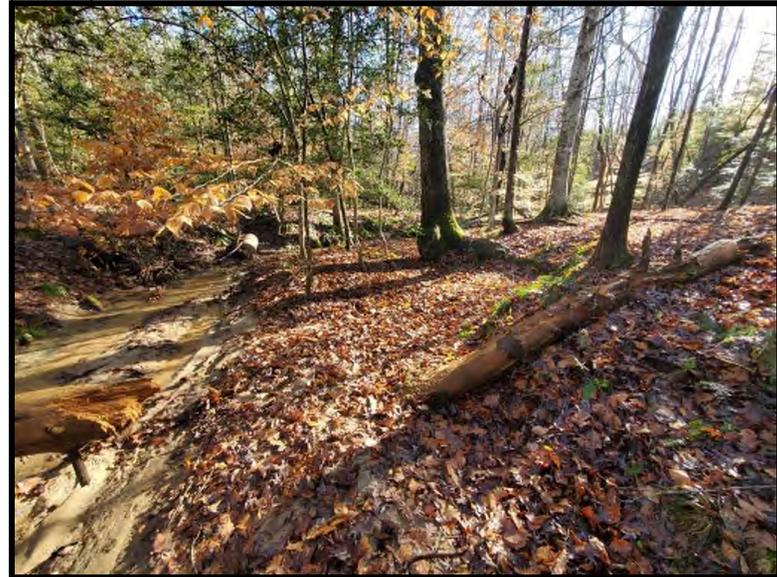
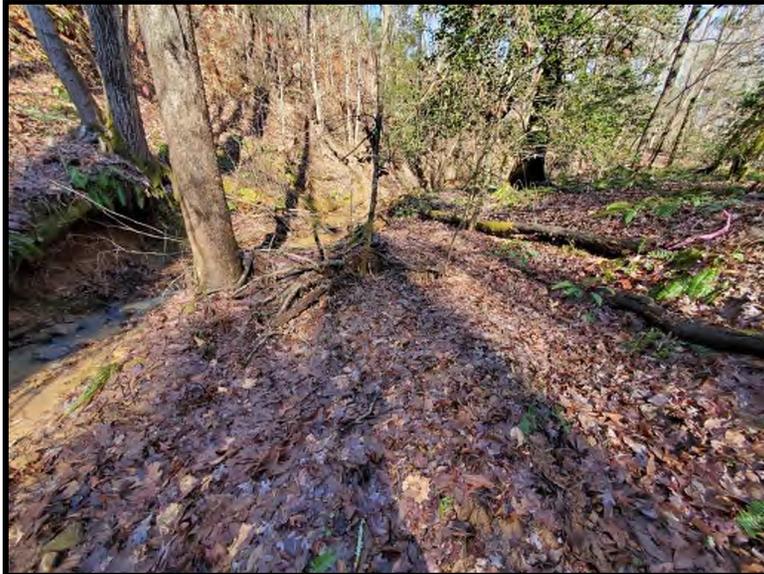
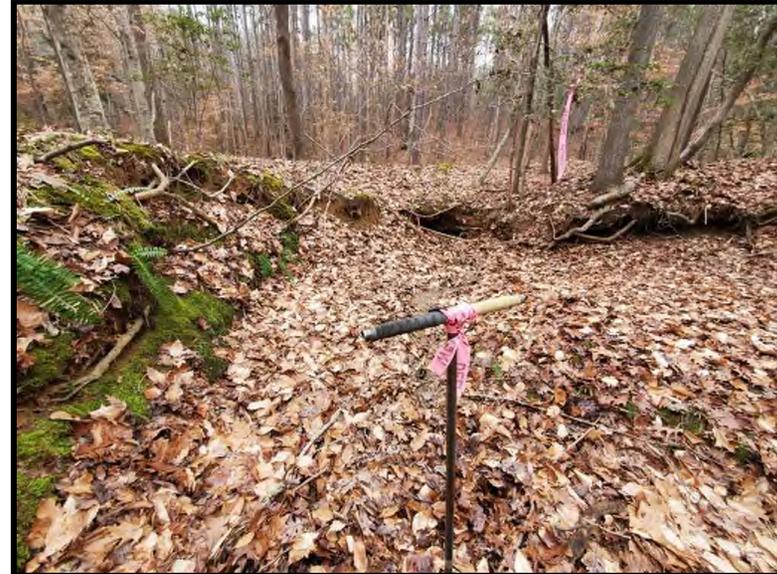
Fifteen (15) wetlands (1.104 acres) were observed on the site (Photographs 1-10). The wetlands are classified as palustrine forested (PFO), Palustrine Scrub-Shrub (PSS), and Palustrine Emergent (PEM), riparian and headwater wetlands.

1 Wetland A.

2 Wetland D.

3 Wetland C.

4 Wetland E.

5 Wetland L.

6 Wetland G.

7 Wetland M.

8 Wetland H.

9 Wetland I.

10 Wetland F.

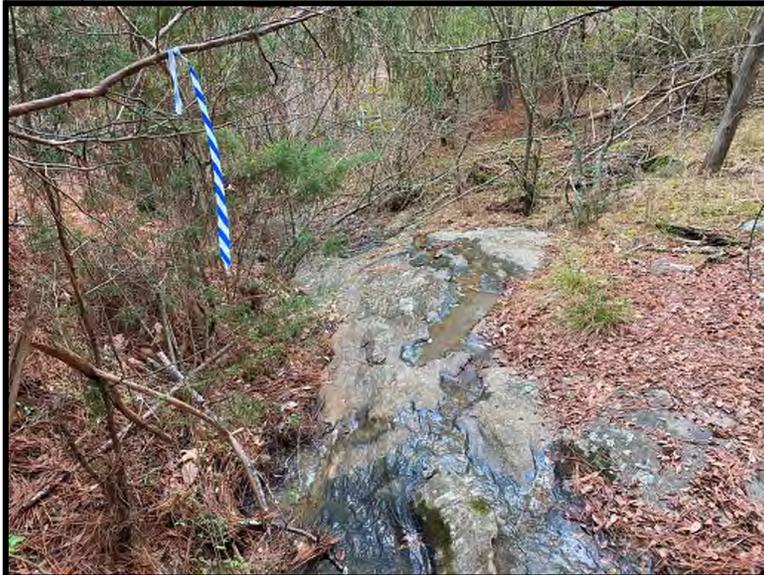
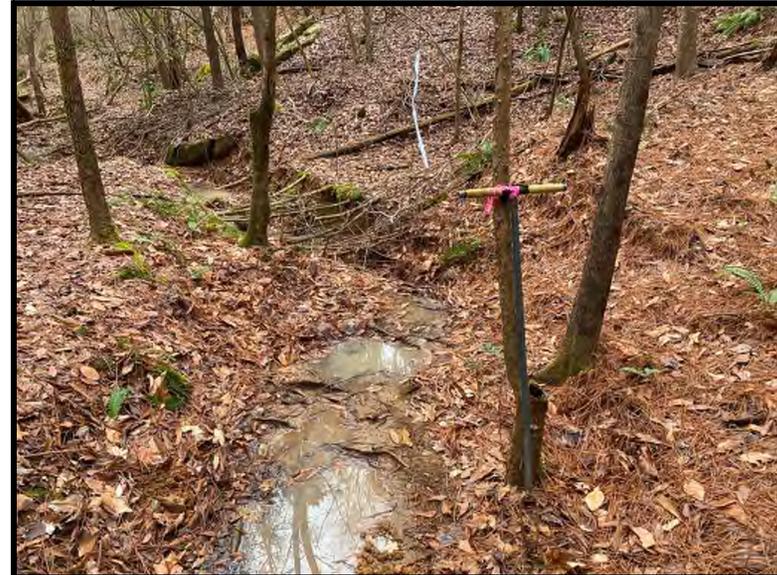
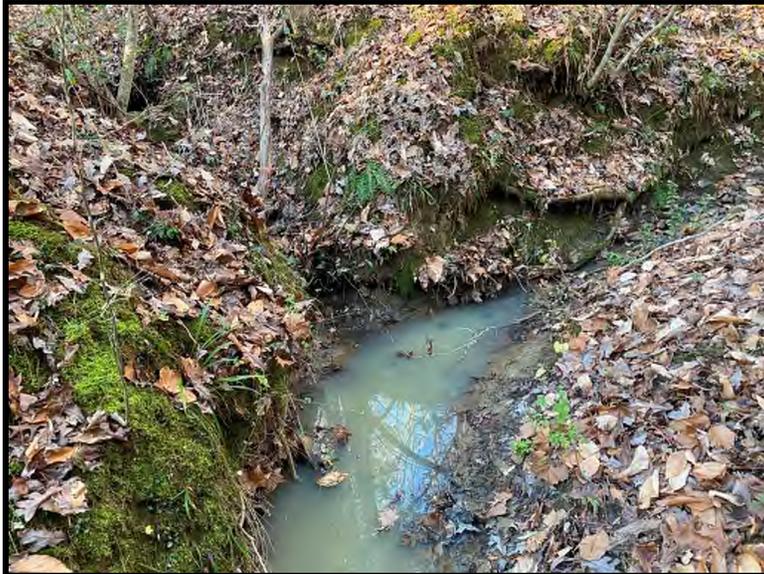
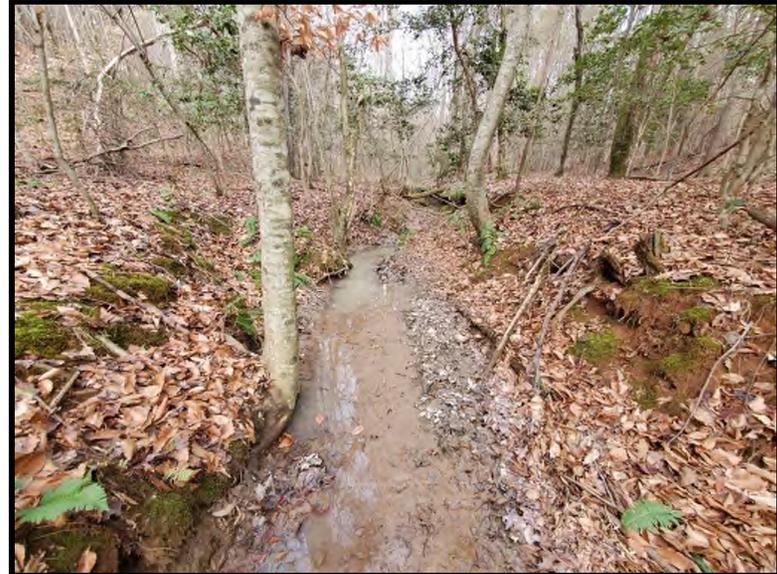
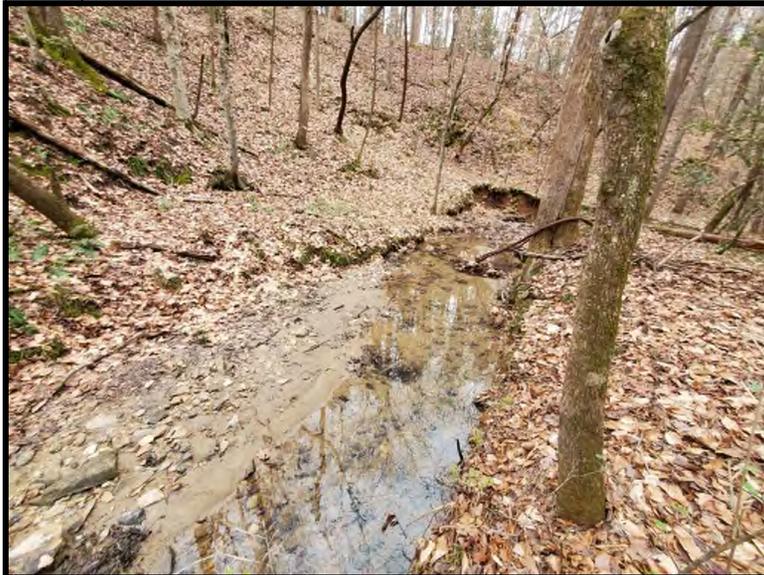
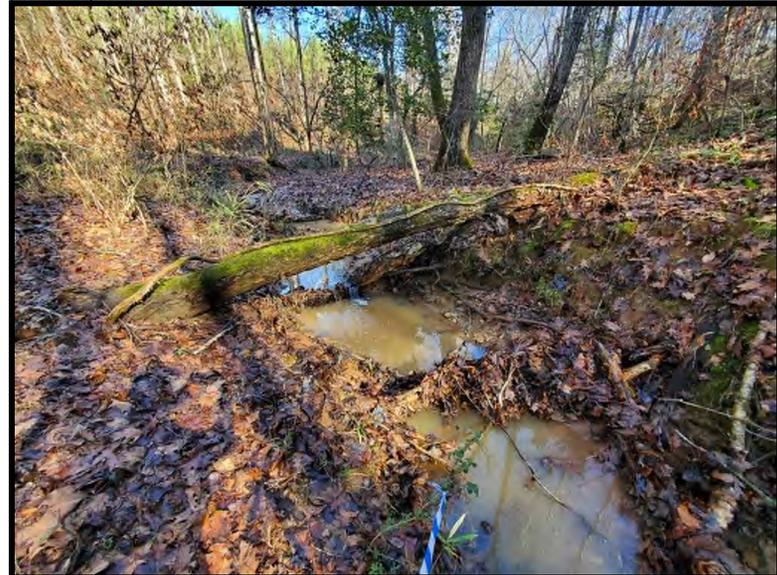
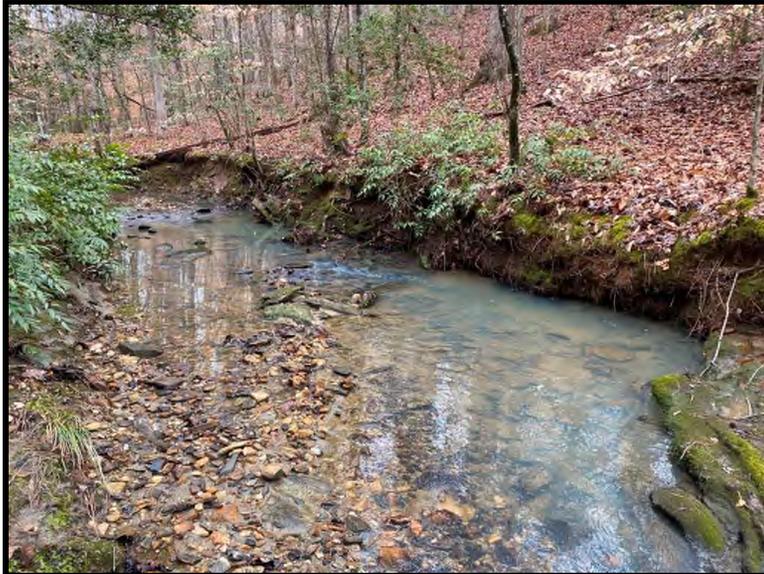
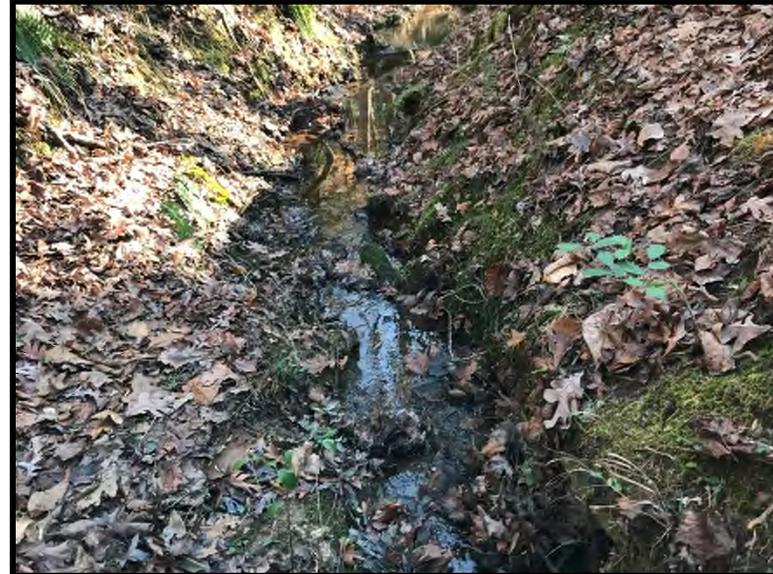
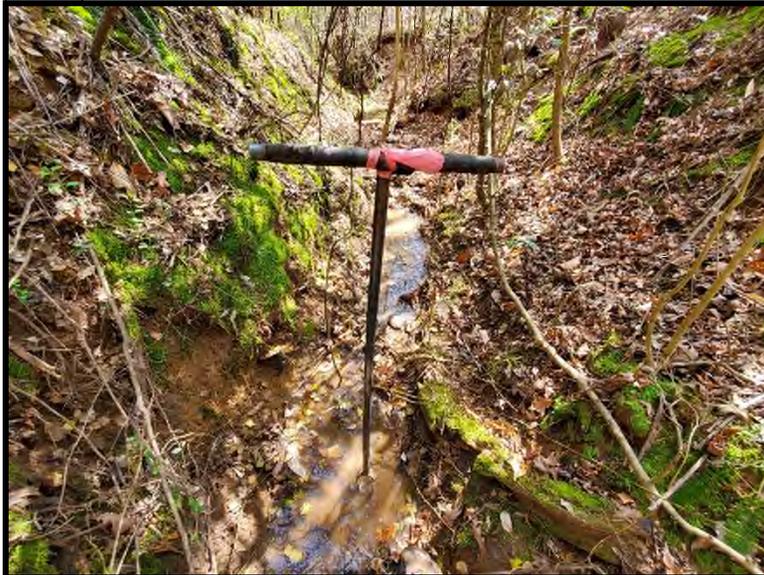
Twenty-seven (27) tributaries (31,290 linear feet (lf)/2.910 acres) were observed on the site (Photographs 11-20). The tributaries are classified as perennial and seasonal. The tributaries had varied widths (2-10 feet) and a mixture of sand, cobble, and boulder substrates.

11 NWW-1.

12 NWW-3.

13 NWW-5.

14 NWW-6.

15 NWW-12.

16 NWW-17.

17 NWW-21.

18 NWW-25.

19 NWW-27.

20 NWW-19.
