U.S. Army Corps of Engineers – Charleston District - Regulatory Division
REQUEST FOR CORPS JURISDICTIONAL DETERMINATION (JD) / DELINEATION
 (For Jurisdictional Status and Identifying Wetlands and Other Aquatic Resources)

Site Name: Pacolet Quarry Site Date: March 14, 2023
 City/Township/Parish: Spartanburg County: Spartanburg
 Latitude/Longitude: 34.9370N, -81.7681W Acreage: 782
 Tax Map Sequence (TMS) #(s): Multiple Spartanburg Co. TPNs (Appendix C)
 Property Address(es): Southwest and northeast of Hammett Grove Road

On December 6, 13, and 20, 2022, January 5 and 18, 2023, and March 9, 2023, S&ME Biologists Chris Daves, P.W.S., Chris Handley, and Will Trotter conducted the Wetland Delineation. The following features were observed (see **Appendix A** for mapping and representative site photographs and **Appendix B** for Summary Tables):

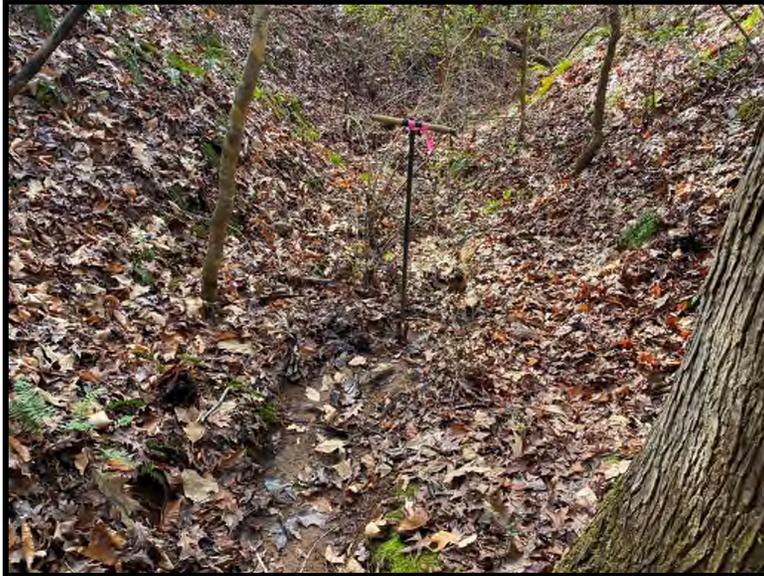
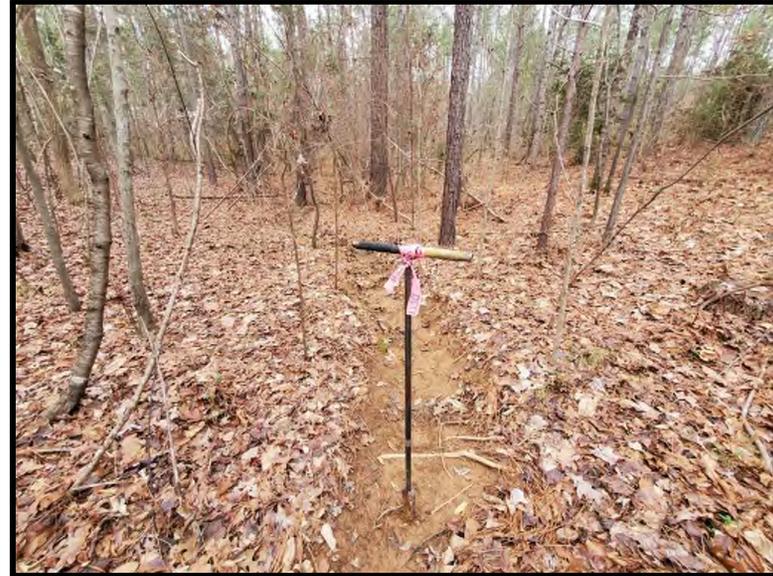
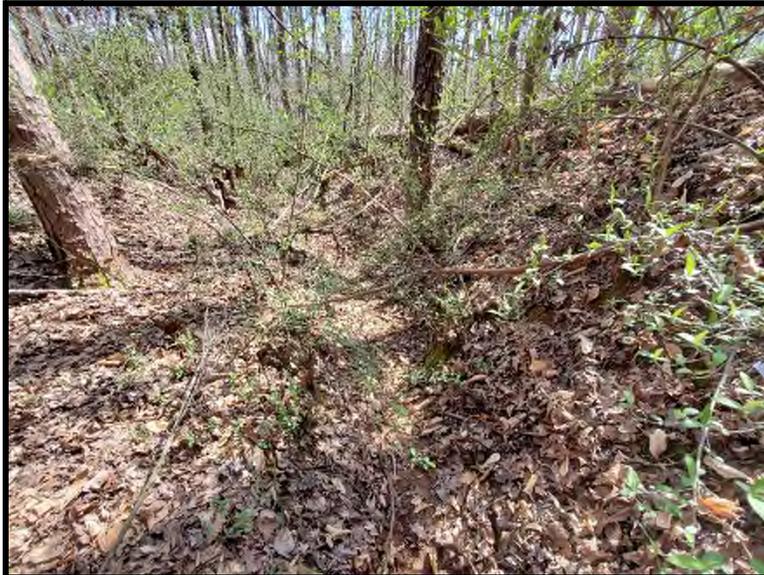
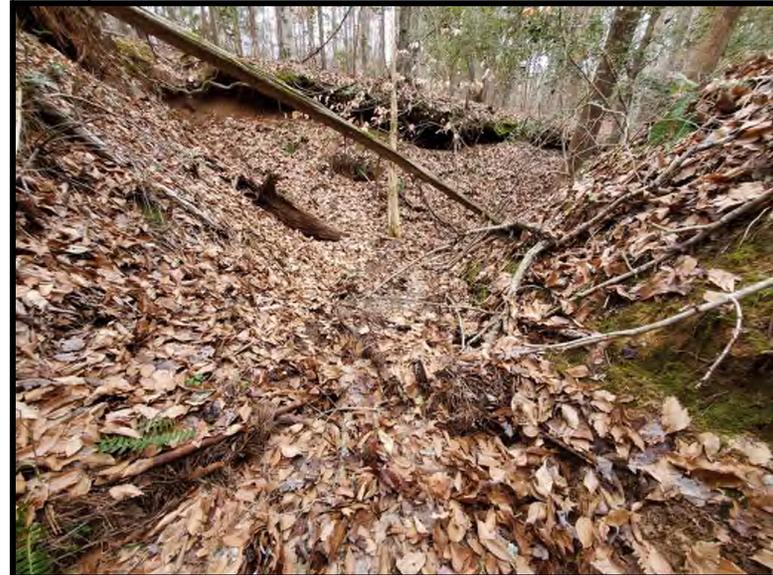
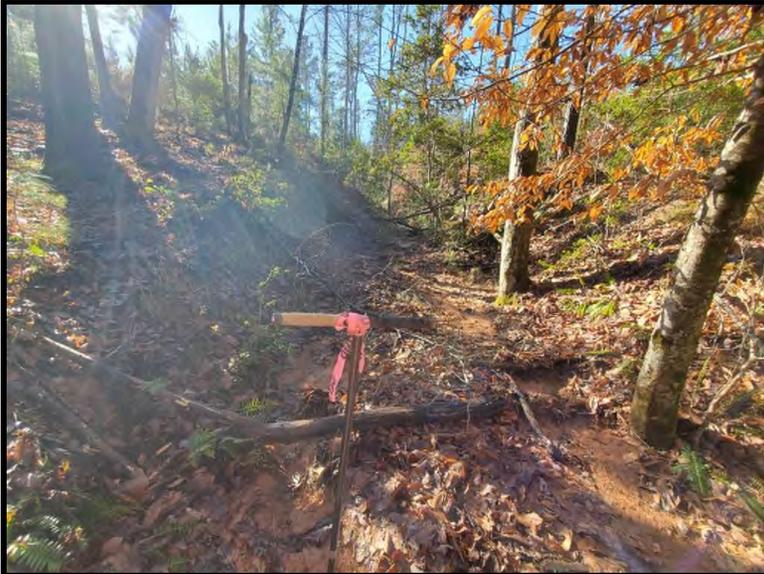
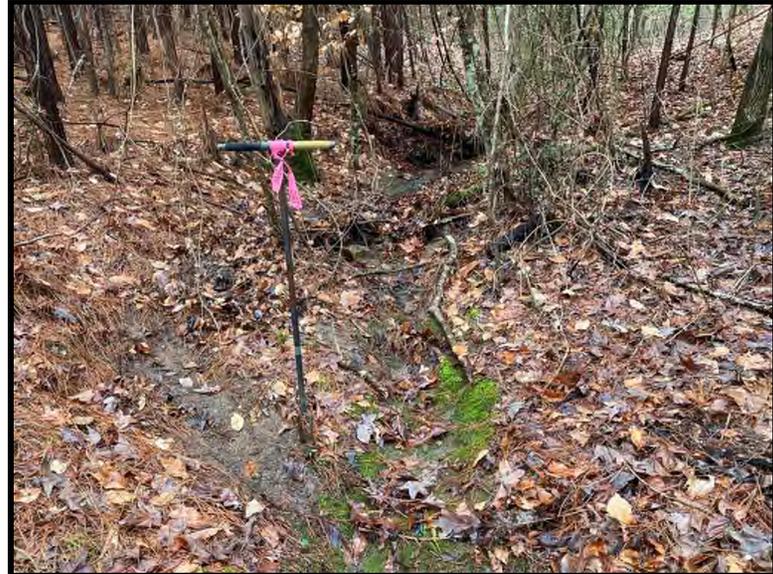
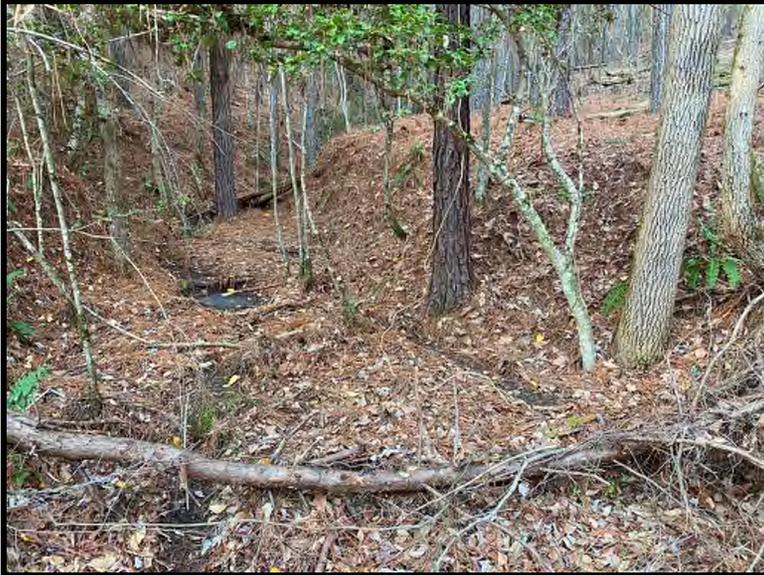
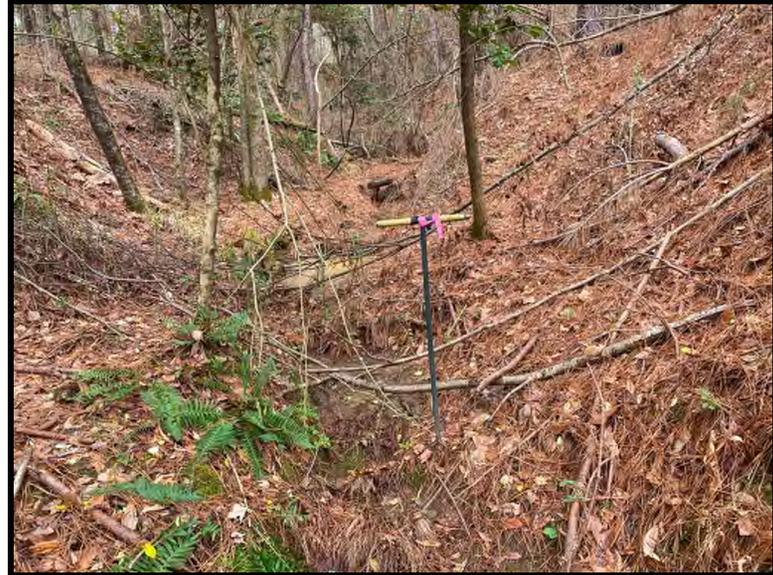
Sixty-two (62) ephemeral drainages/swales (23,463 lf) were observed on the site (Photographs 21-28). No evidence of hydrology or an Ordinary-High-Water-Mark (OHWM) were observed during site visits.

21 NAR-7.

22 NAR-14.

23 NAR-59.

24 NAR-39.

25 NAR-51.

26 NAR-58.

27 NAR-12.

28 NAR-22.
