South Carolina Department of Health and Environmental Control

# CSXT Bramlett Road MGP Site Update

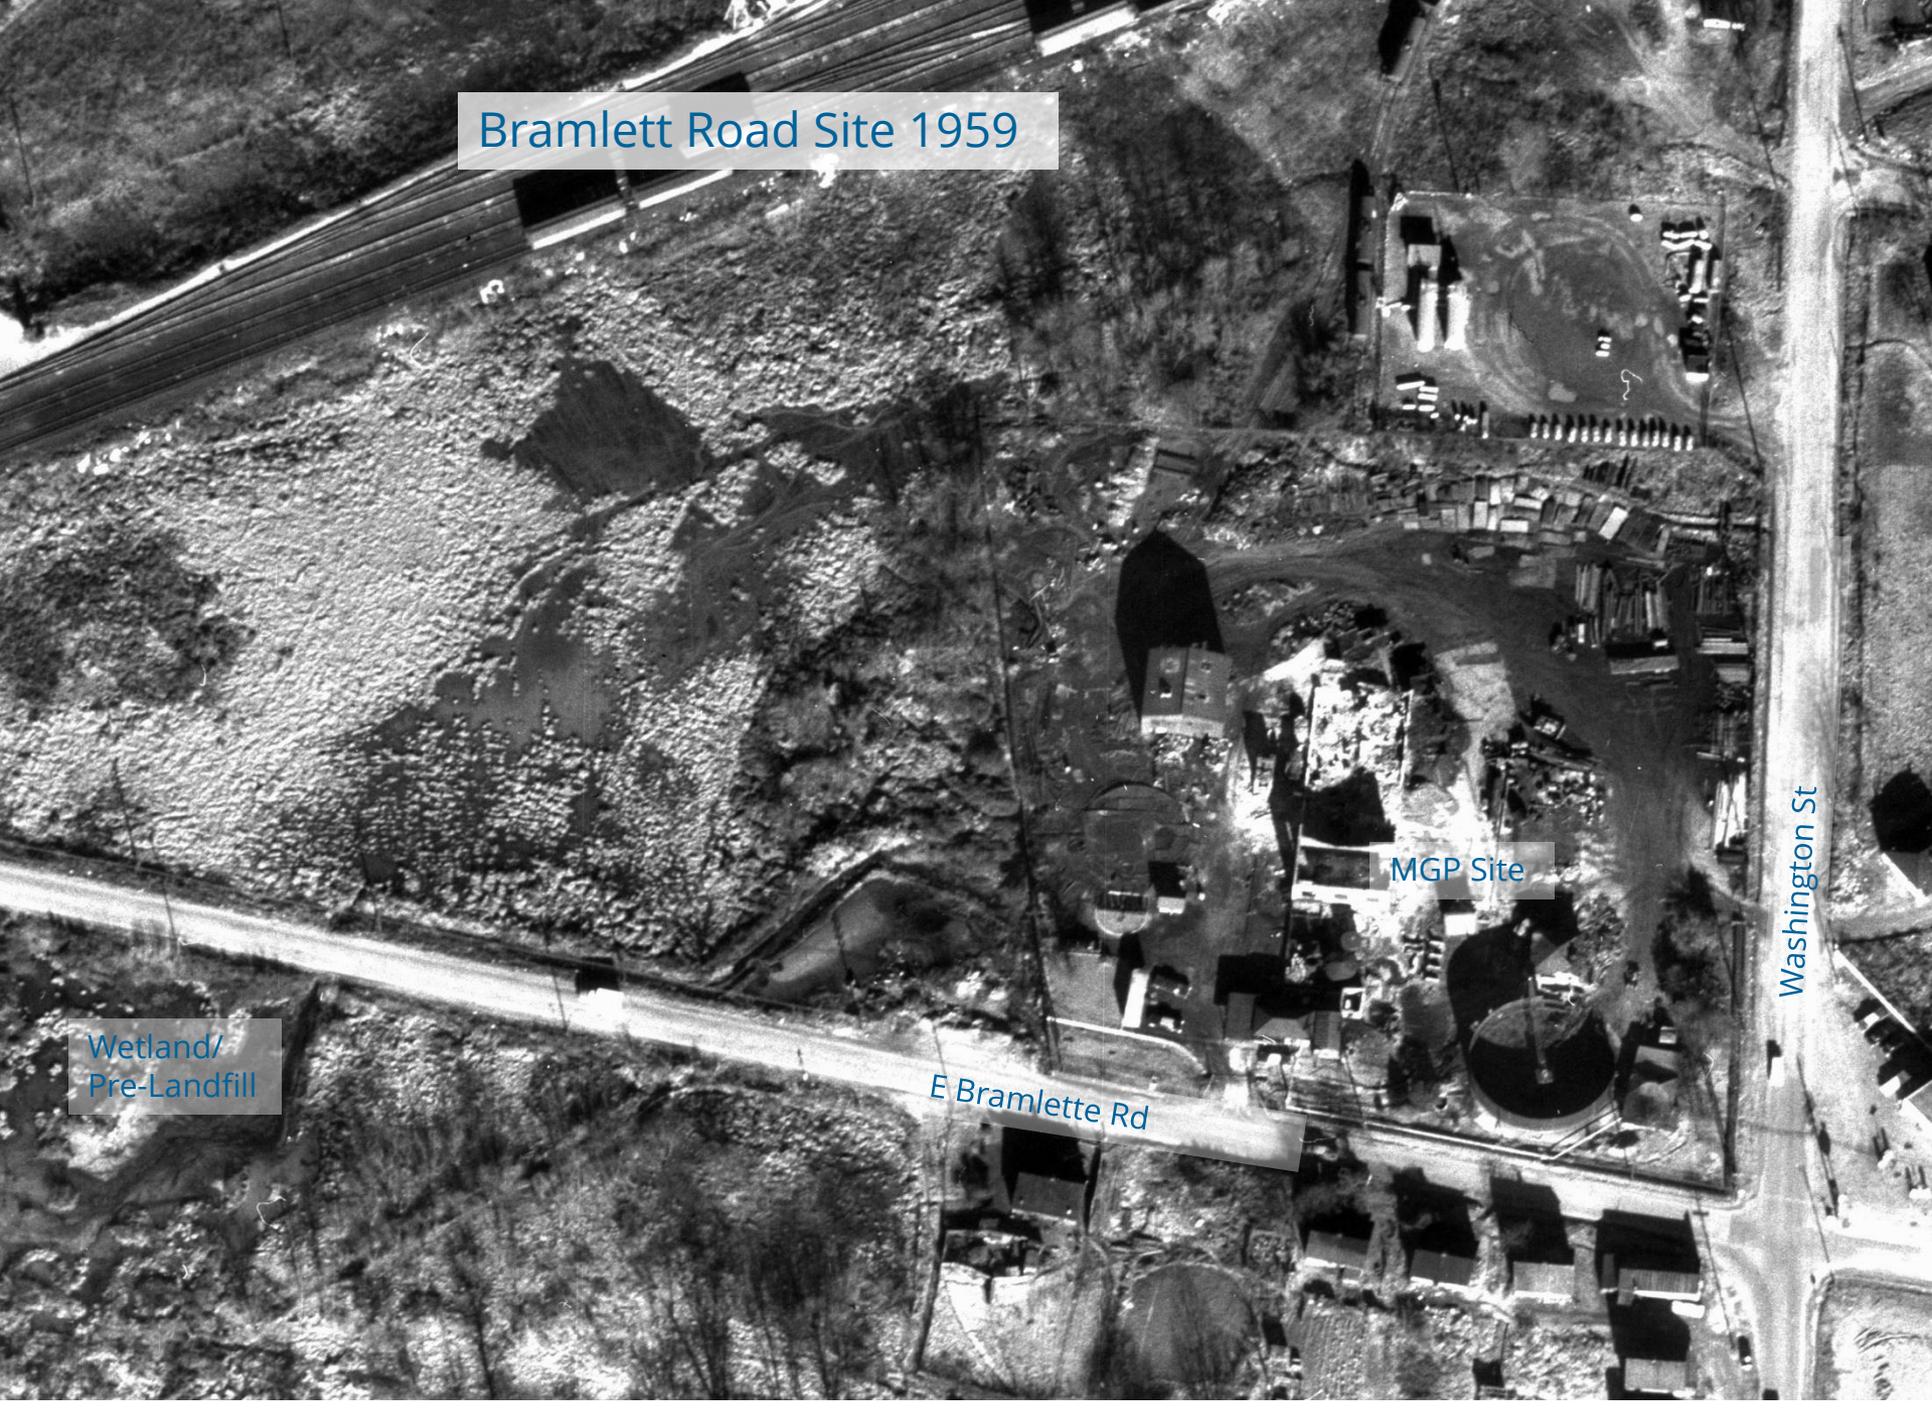
Bramlett Road Site 1959

Wetland/  
Pre-Landfill

MGP Site

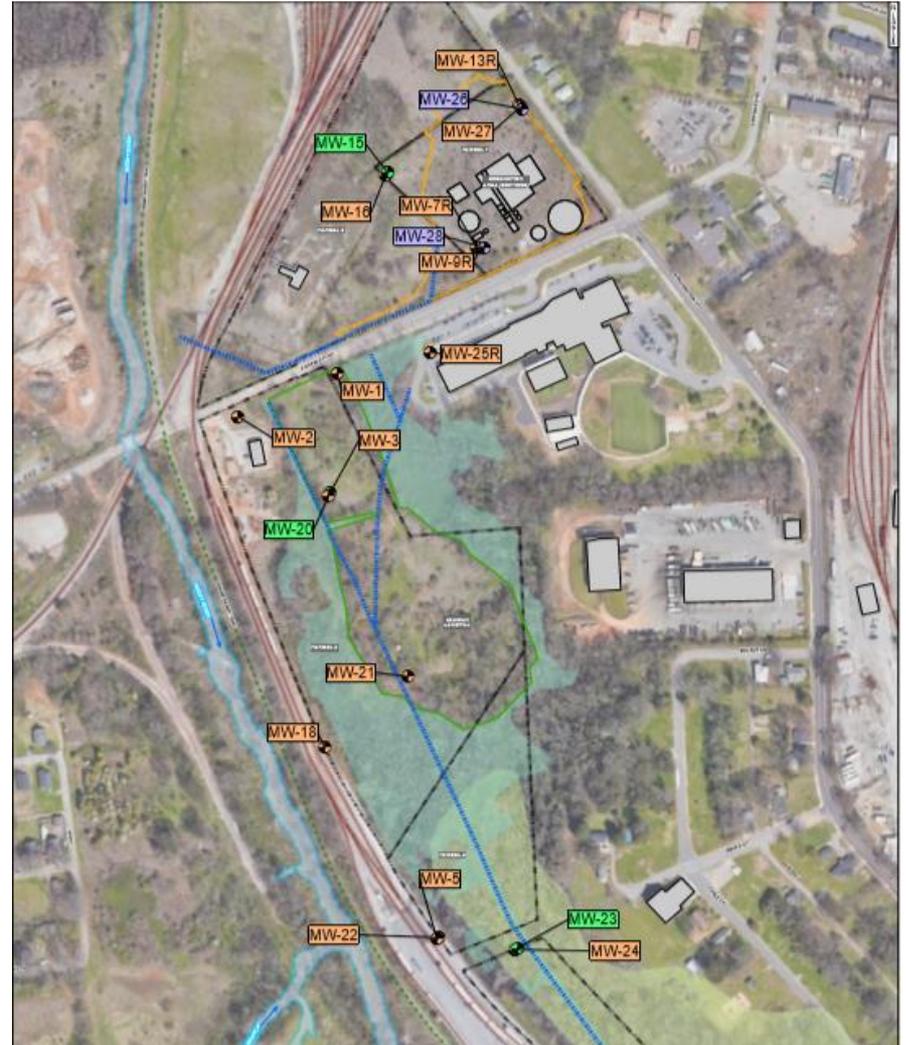
# Groundwater Remedial Investigation began in 2017

- Wells:
- 19

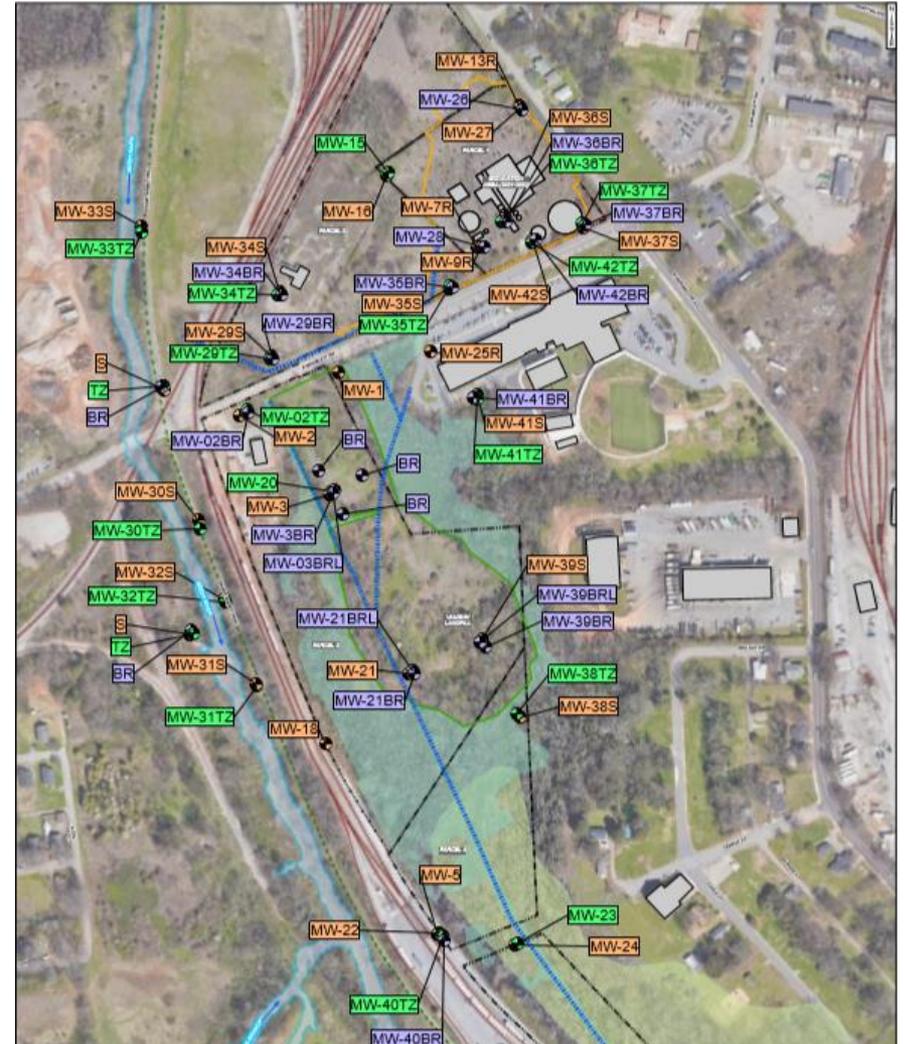
# Groundwater RI Work Conducted

Wells completed:

- 61

Total Wells Expected:

- 70

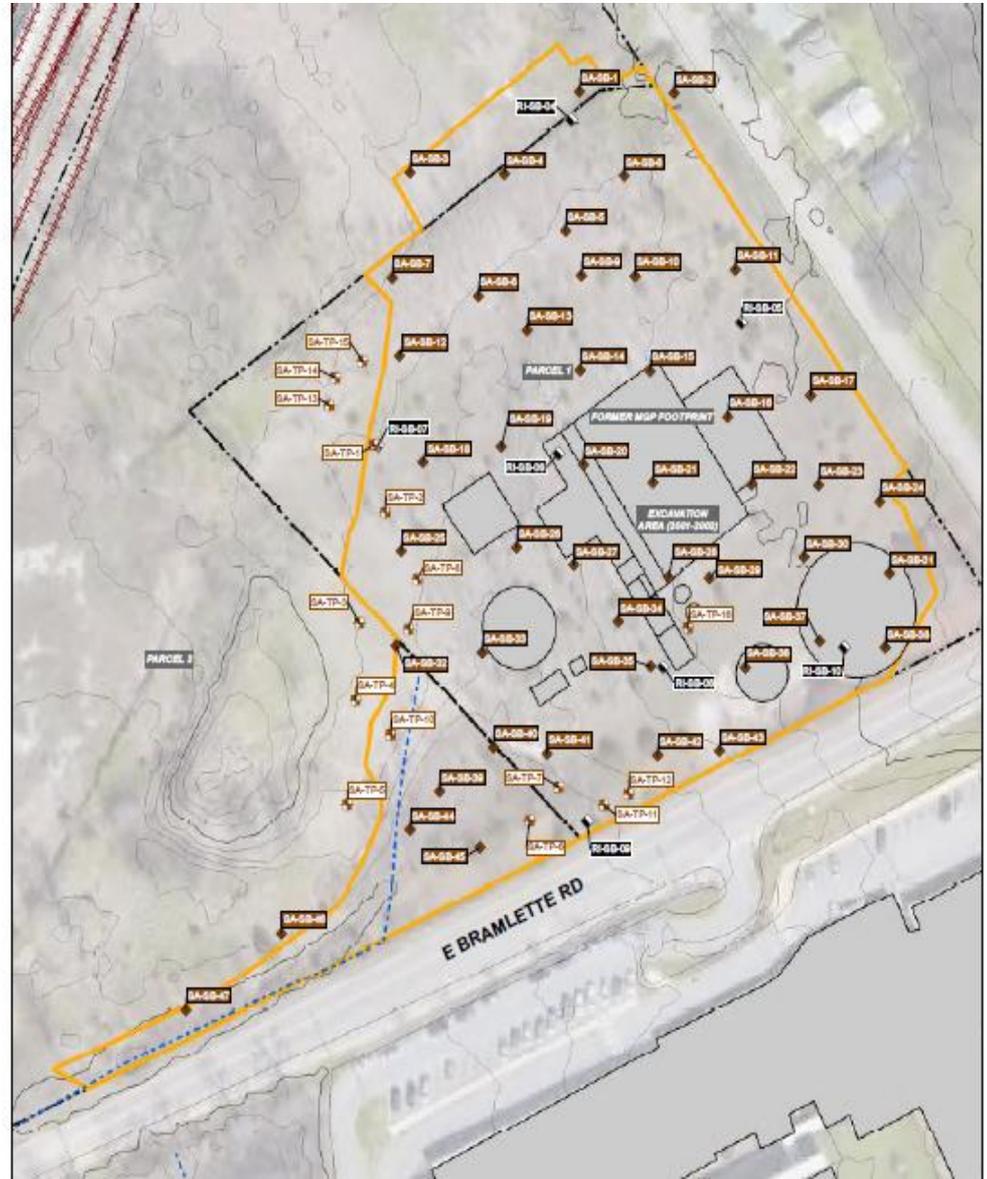
## RI Work Conducted

### Work in MGP Source Area:

- Completed subsurface geophysical survey
- Drilled 47 near surface soil borings
- 47 passive soil gas probes
- Excavated 16 test pits

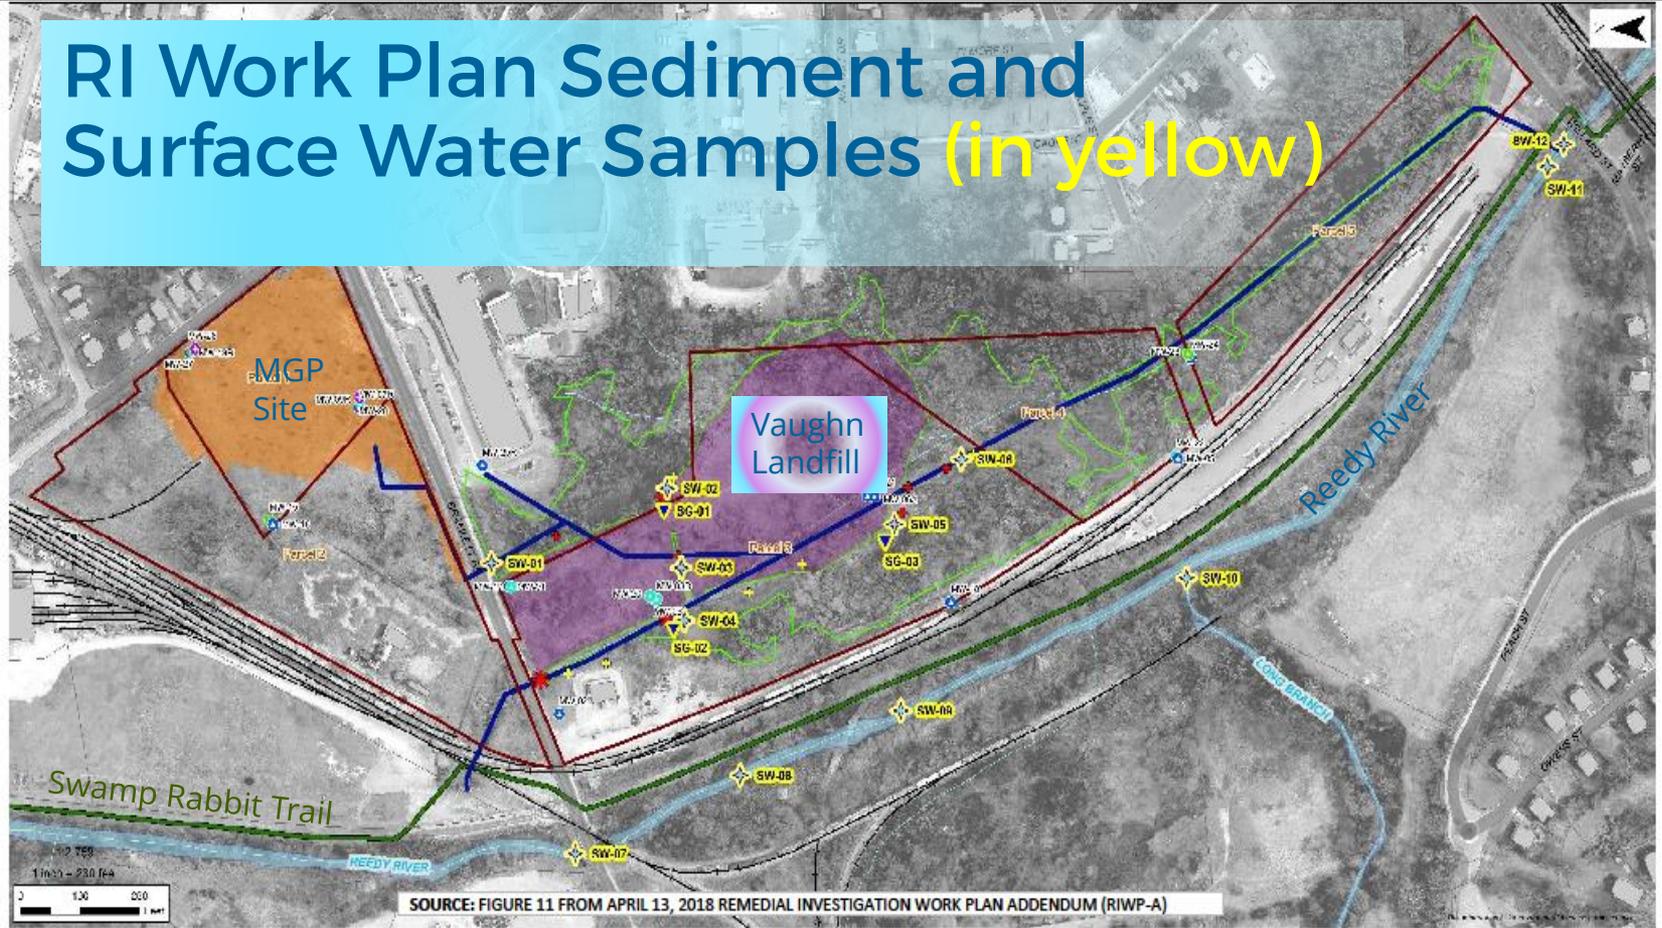
SOURCE: FIGURE 11 FROM APRIL 13, 2018 REMEDIAL INVESTIGATION WORK PLAN ADDENDUM (RIWP-A)

# RI Work Plan Sediment and Surface Water Samples (in yellow)

| Former Drainage Ditch | Surface water sheen (12/2017) | Surface Water / Sediment Samples | Shallow |
| Excavated Area (2001-2002) | 1995-1996 Sediment Sample | Stream Gauge | Mid Saprotite |
| Approximate Vaughn Landfill Boundary | 1995-1996 Sediment Sample with visible coal tar | | Deep Saprotite |
