# Evaluating Living Shorelines to Inform Regulatory Decision-Making in South Carolina

# South Carolina Oyster Restoration and Enhancement (SCORE) Program:

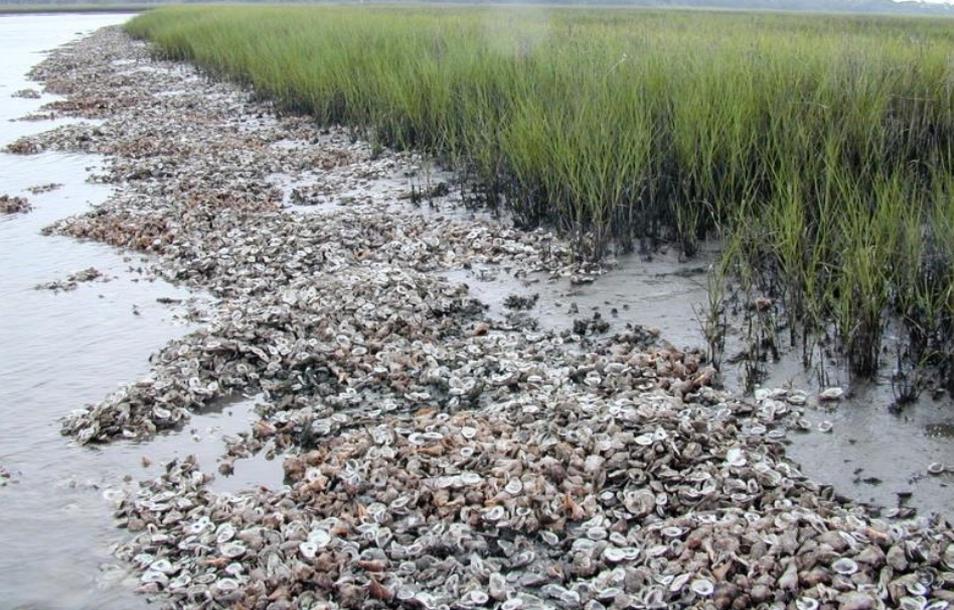
**Bagged oyster shell**

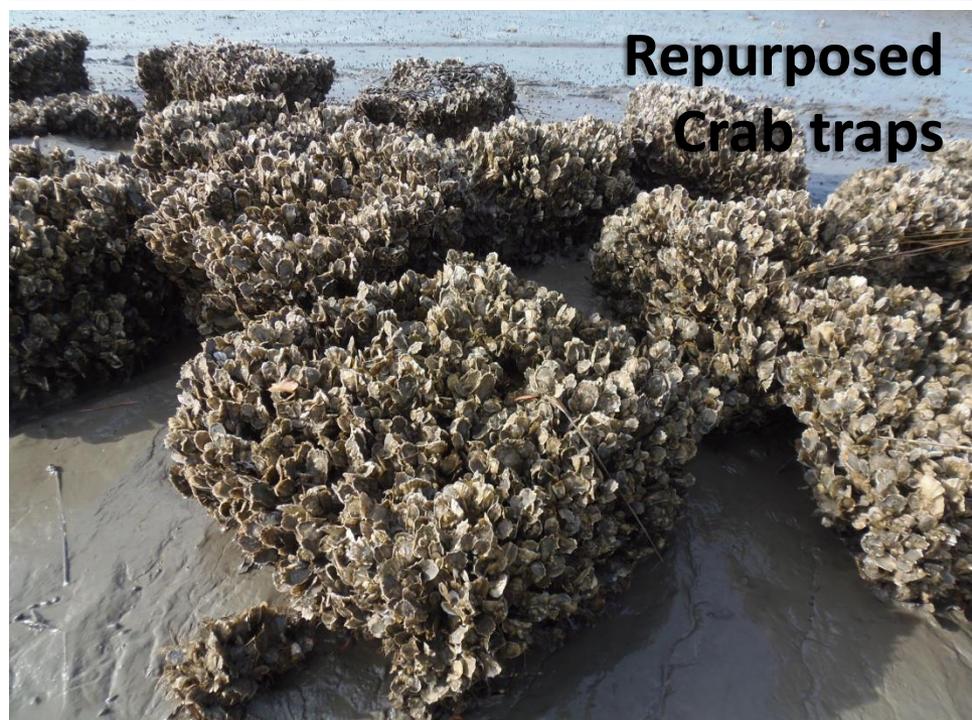
**Repurposed  
Crab traps**

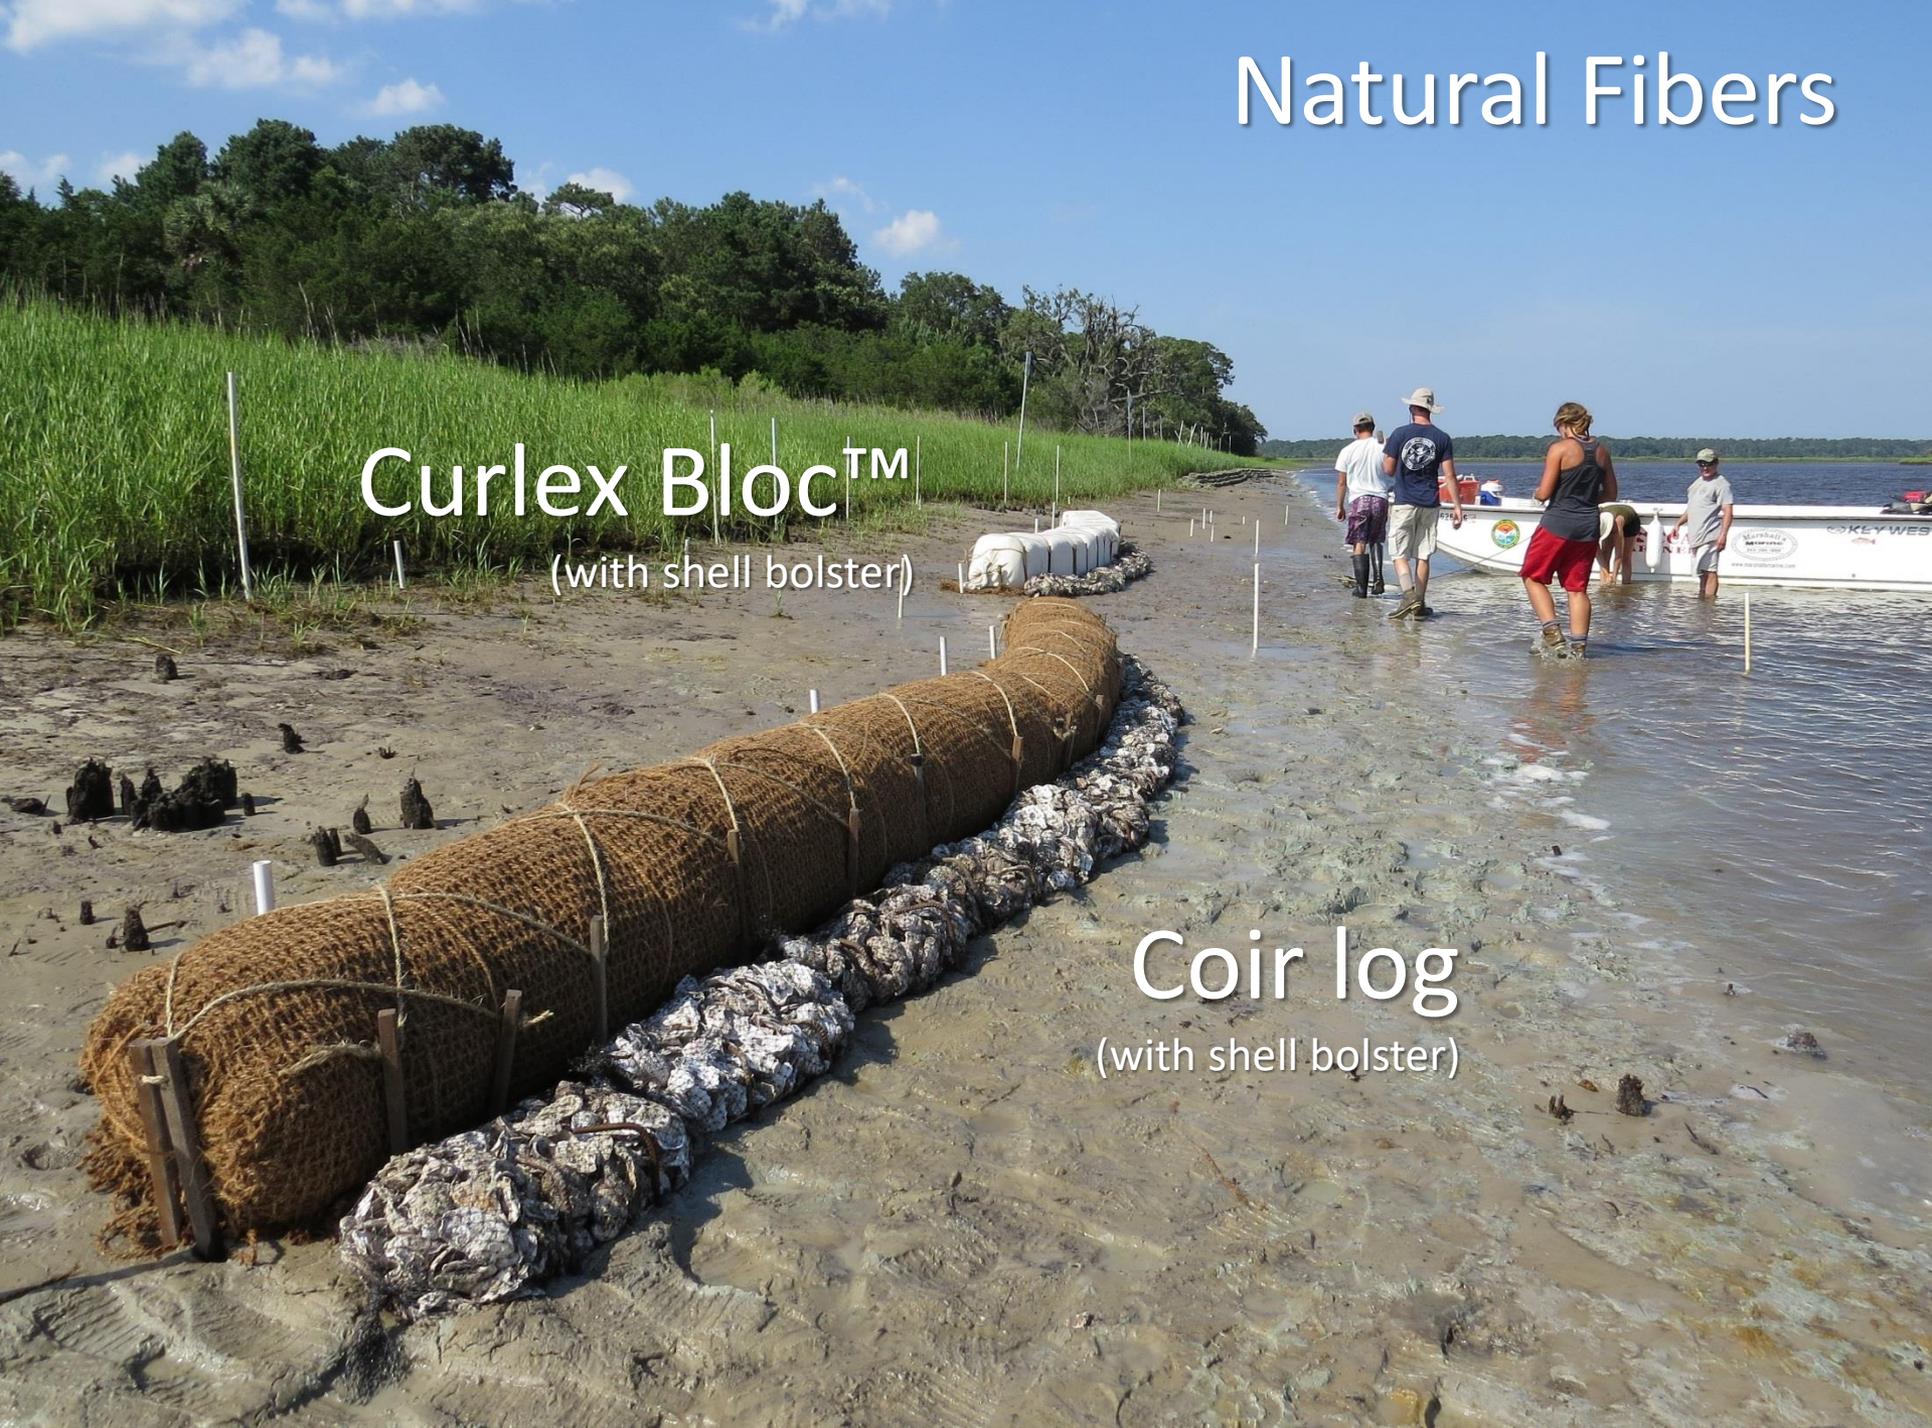
# Natural Fibers

Curlex Bloc™  
(with shell bolster)

Coir log  
(with shell bolster)

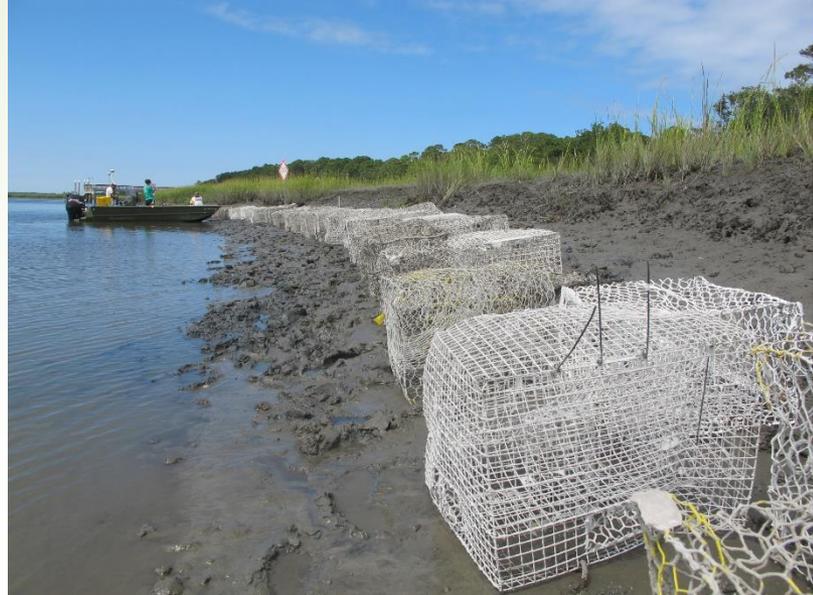
**Repurposed crab trap  
(RCT)**

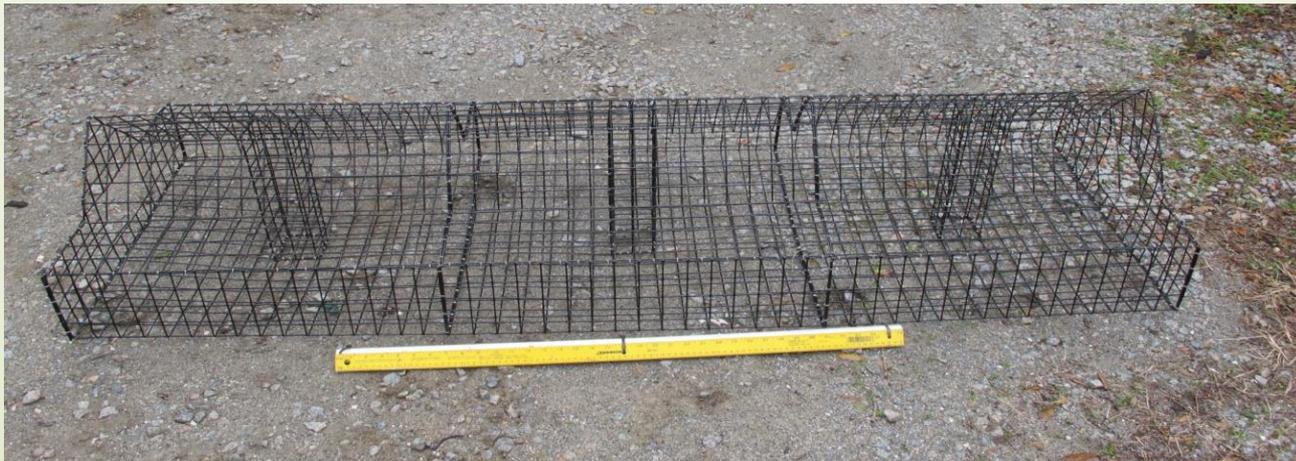
**Manufactured wire reef (MWR)**

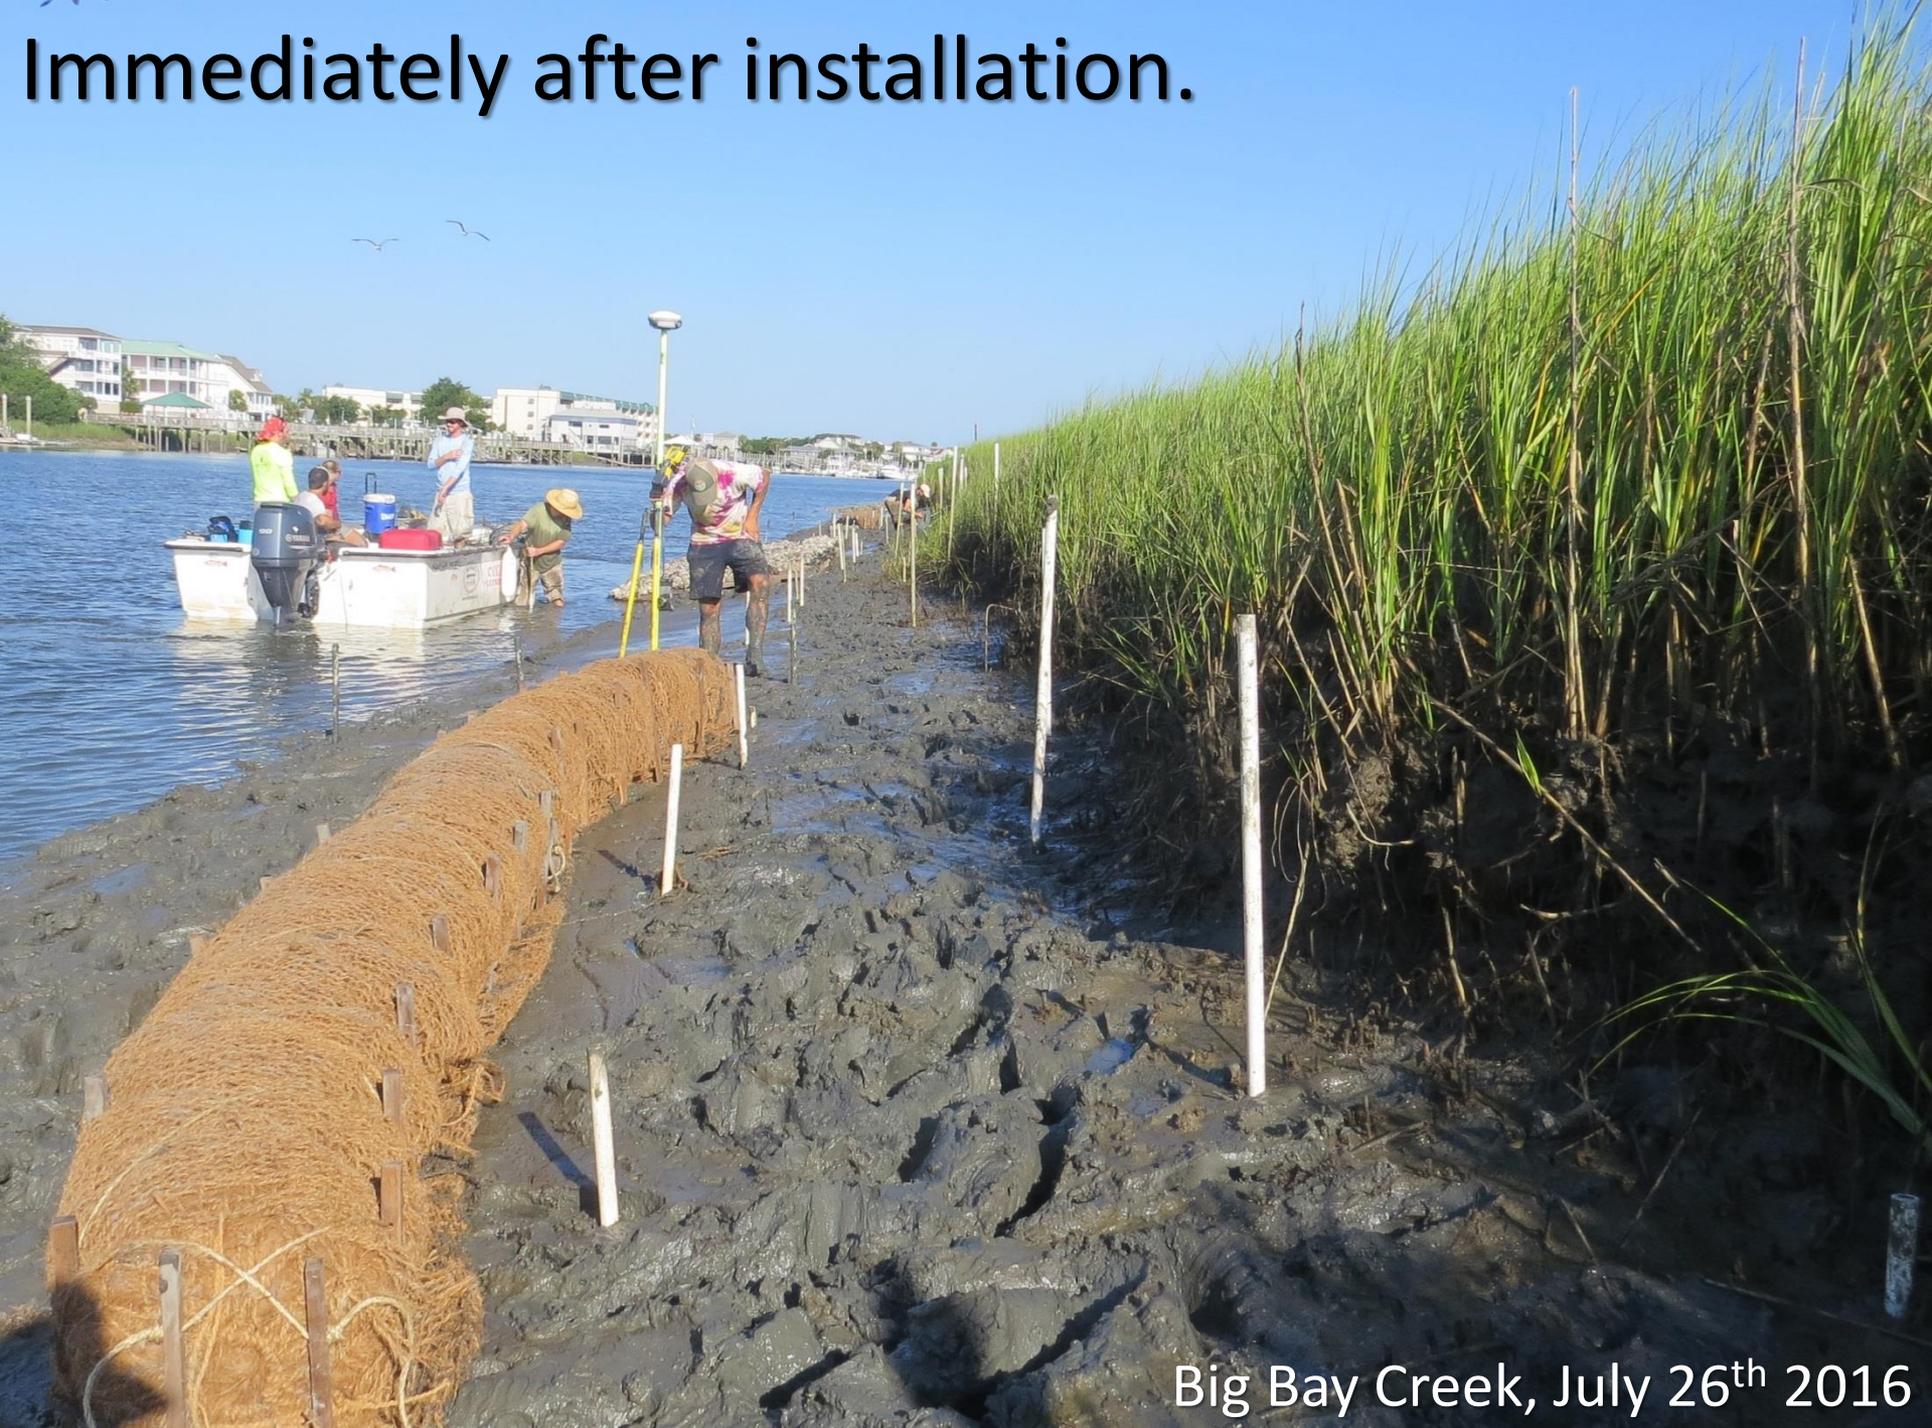
Big Bay Creek, July 26<sup>th</sup> 2016

Immediately after installation.

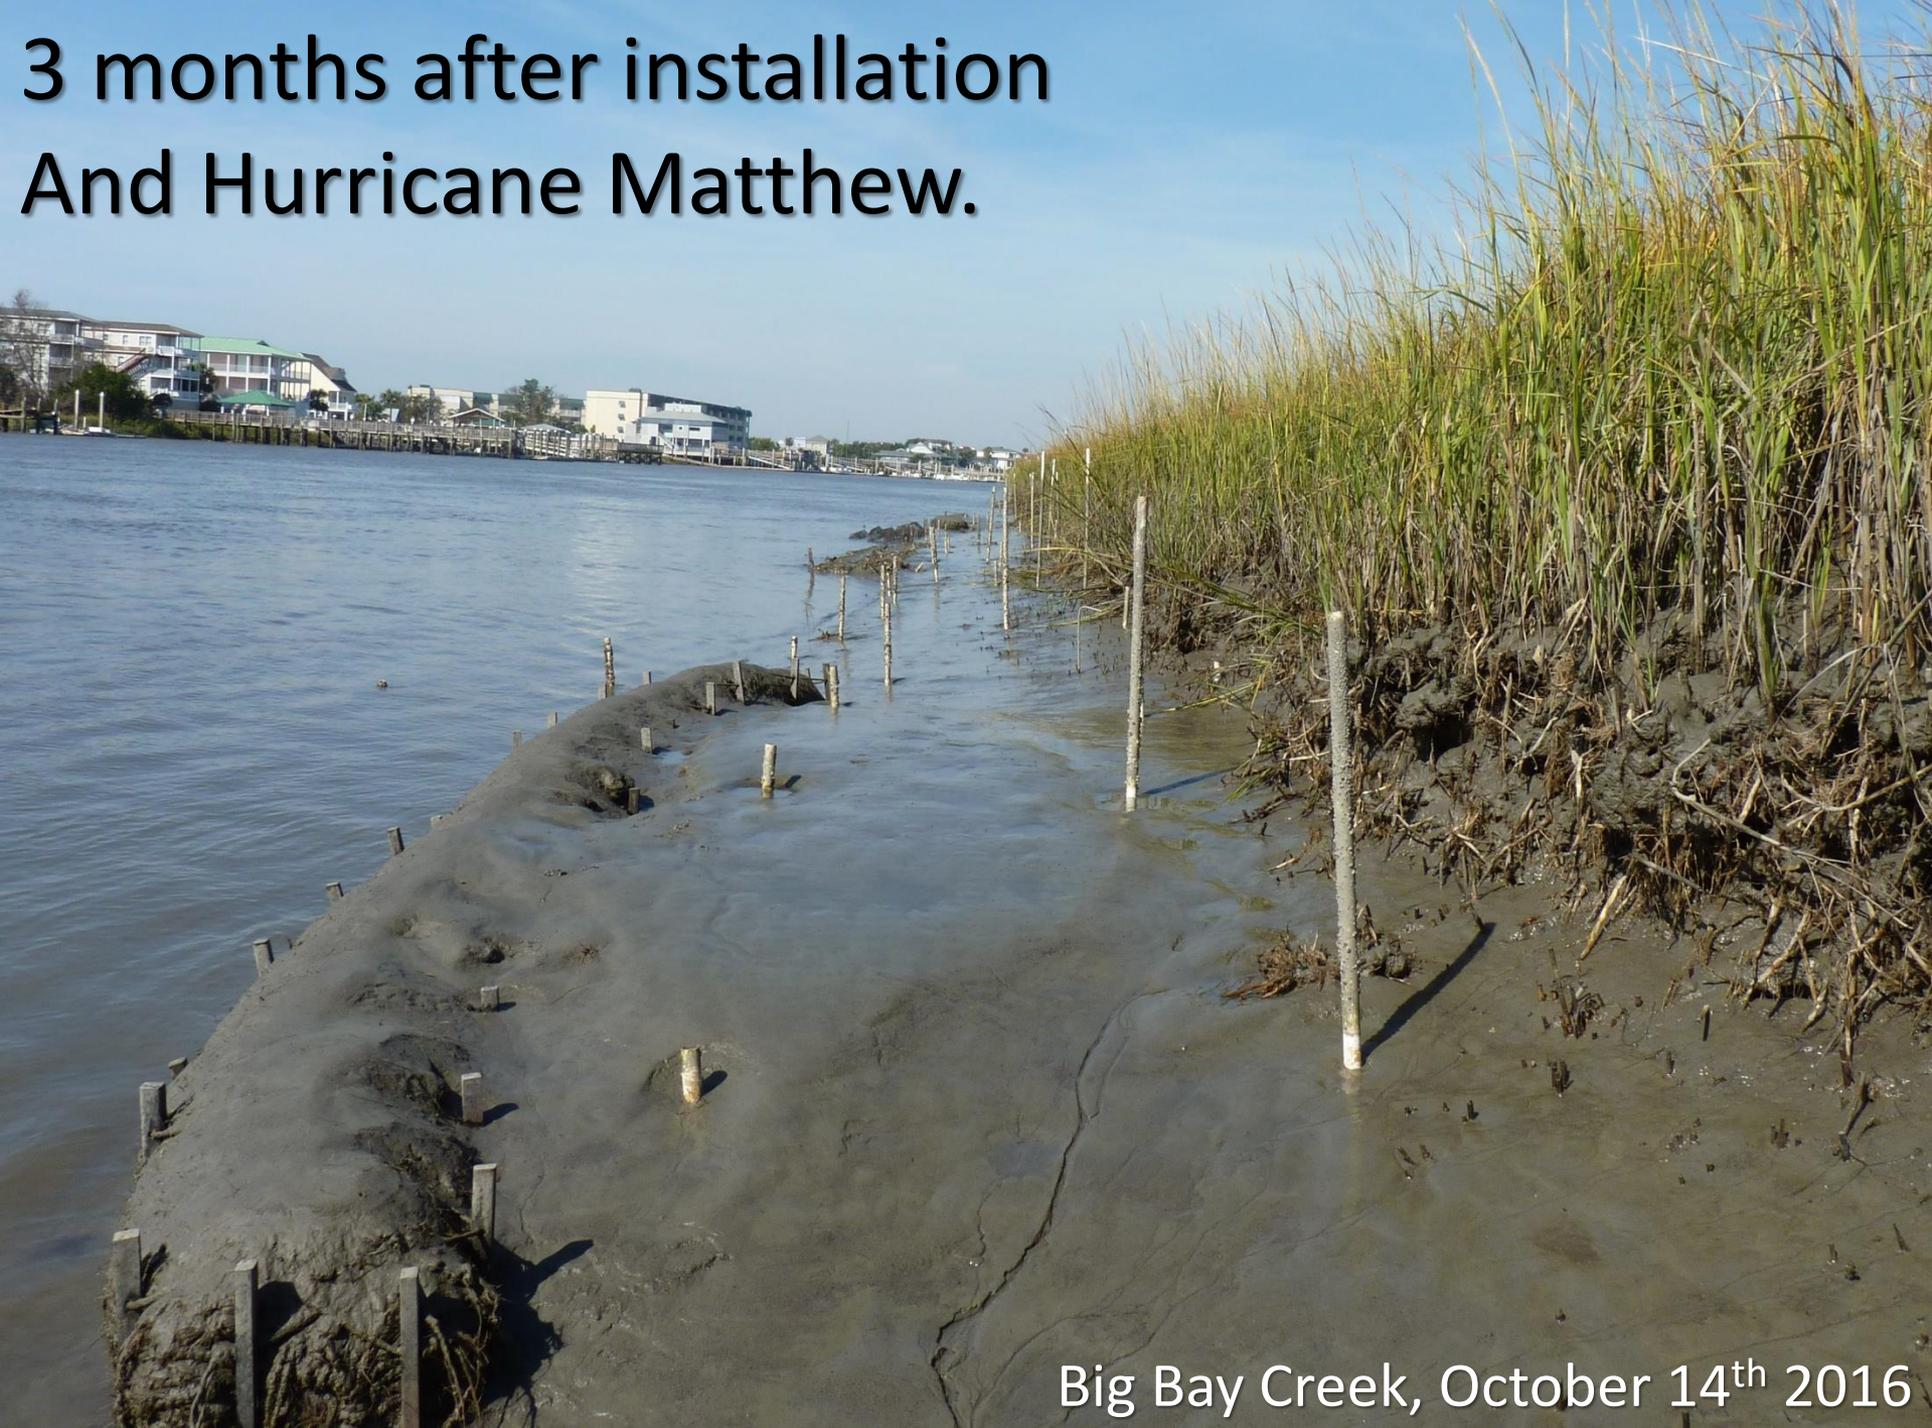
Big Bay Creek, October 14<sup>th</sup> 2016

# 3 months after installation And Hurricane Matthew.

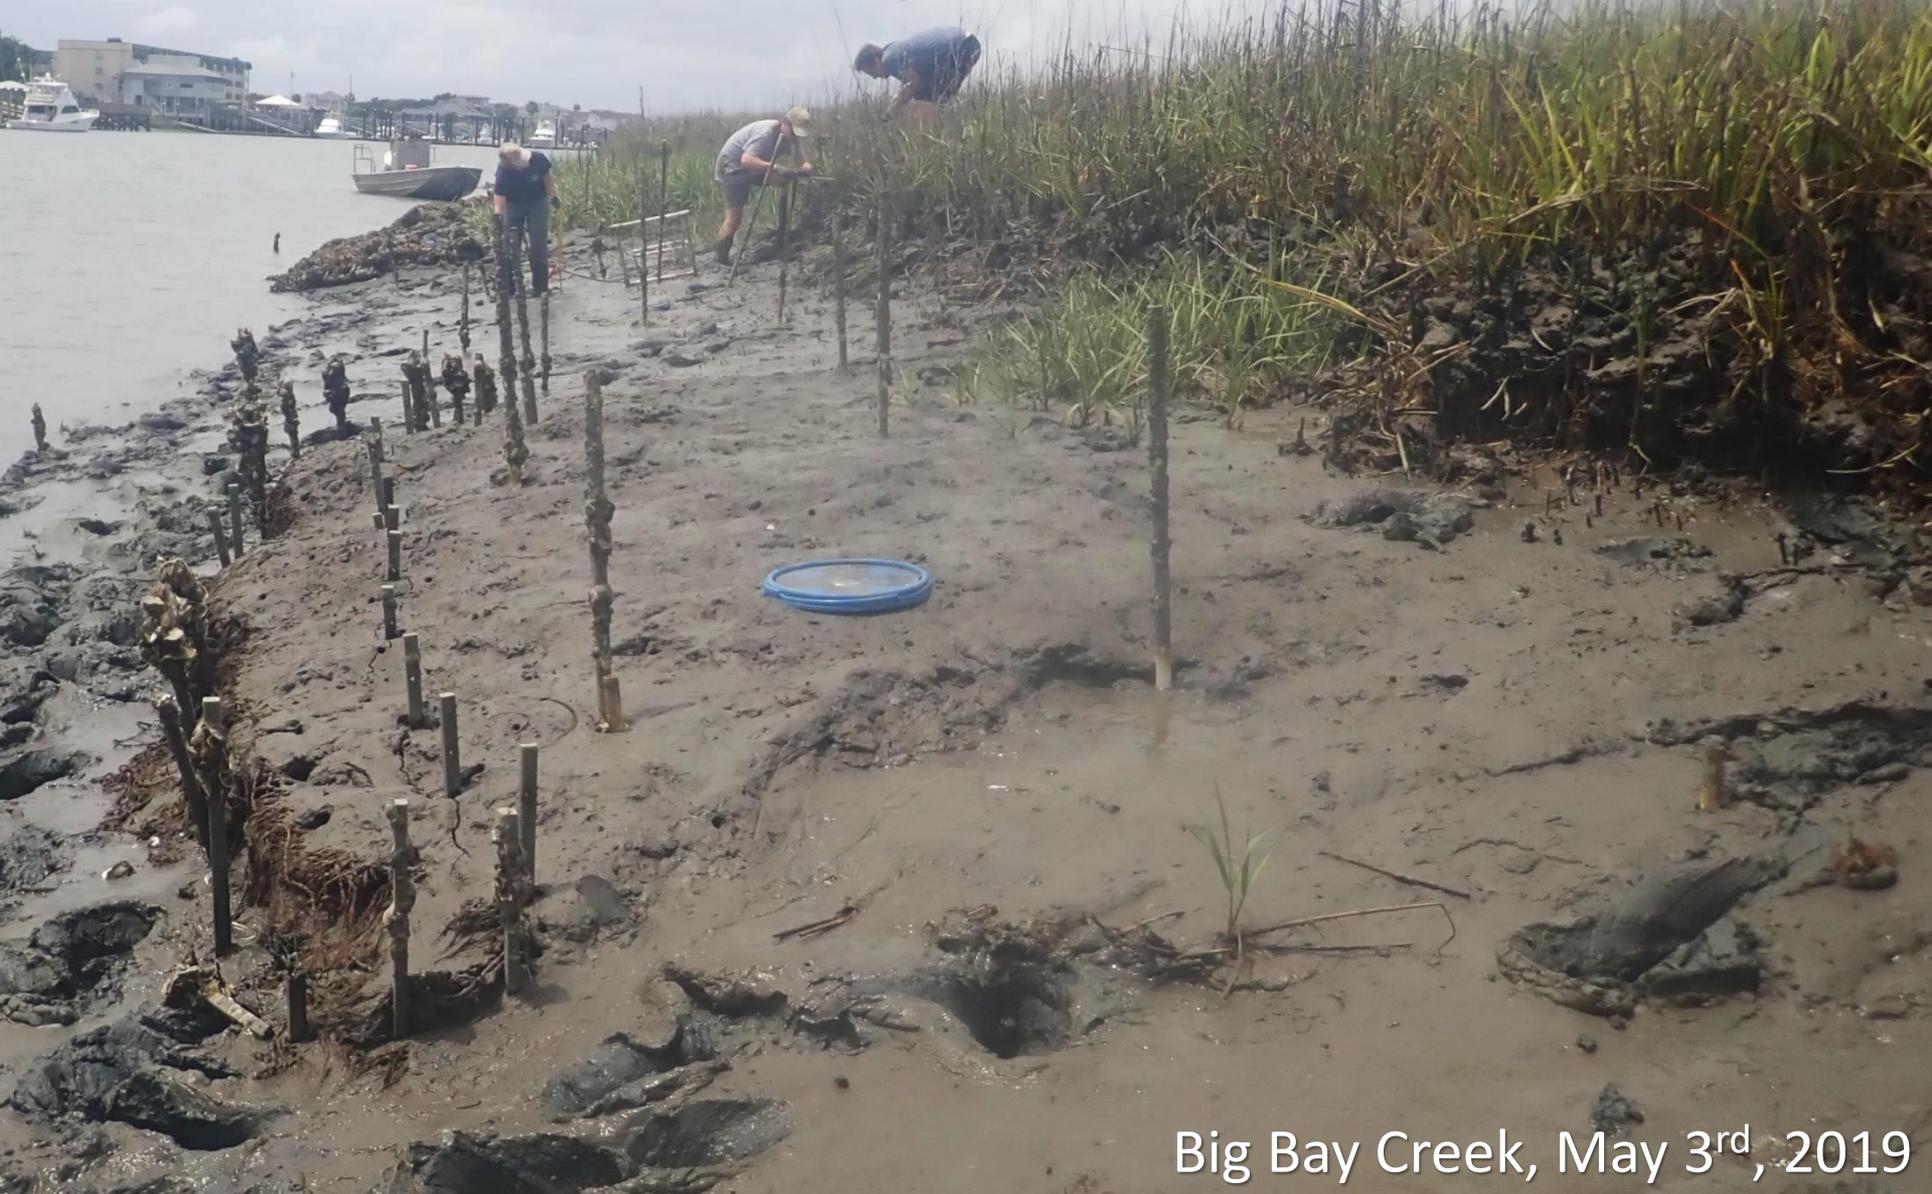
Big Bay Creek, May 3<sup>rd</sup>, 2019

# Coir logs, 32 mo. post-install (after 2 hurricanes)

## Note natural marsh expansion

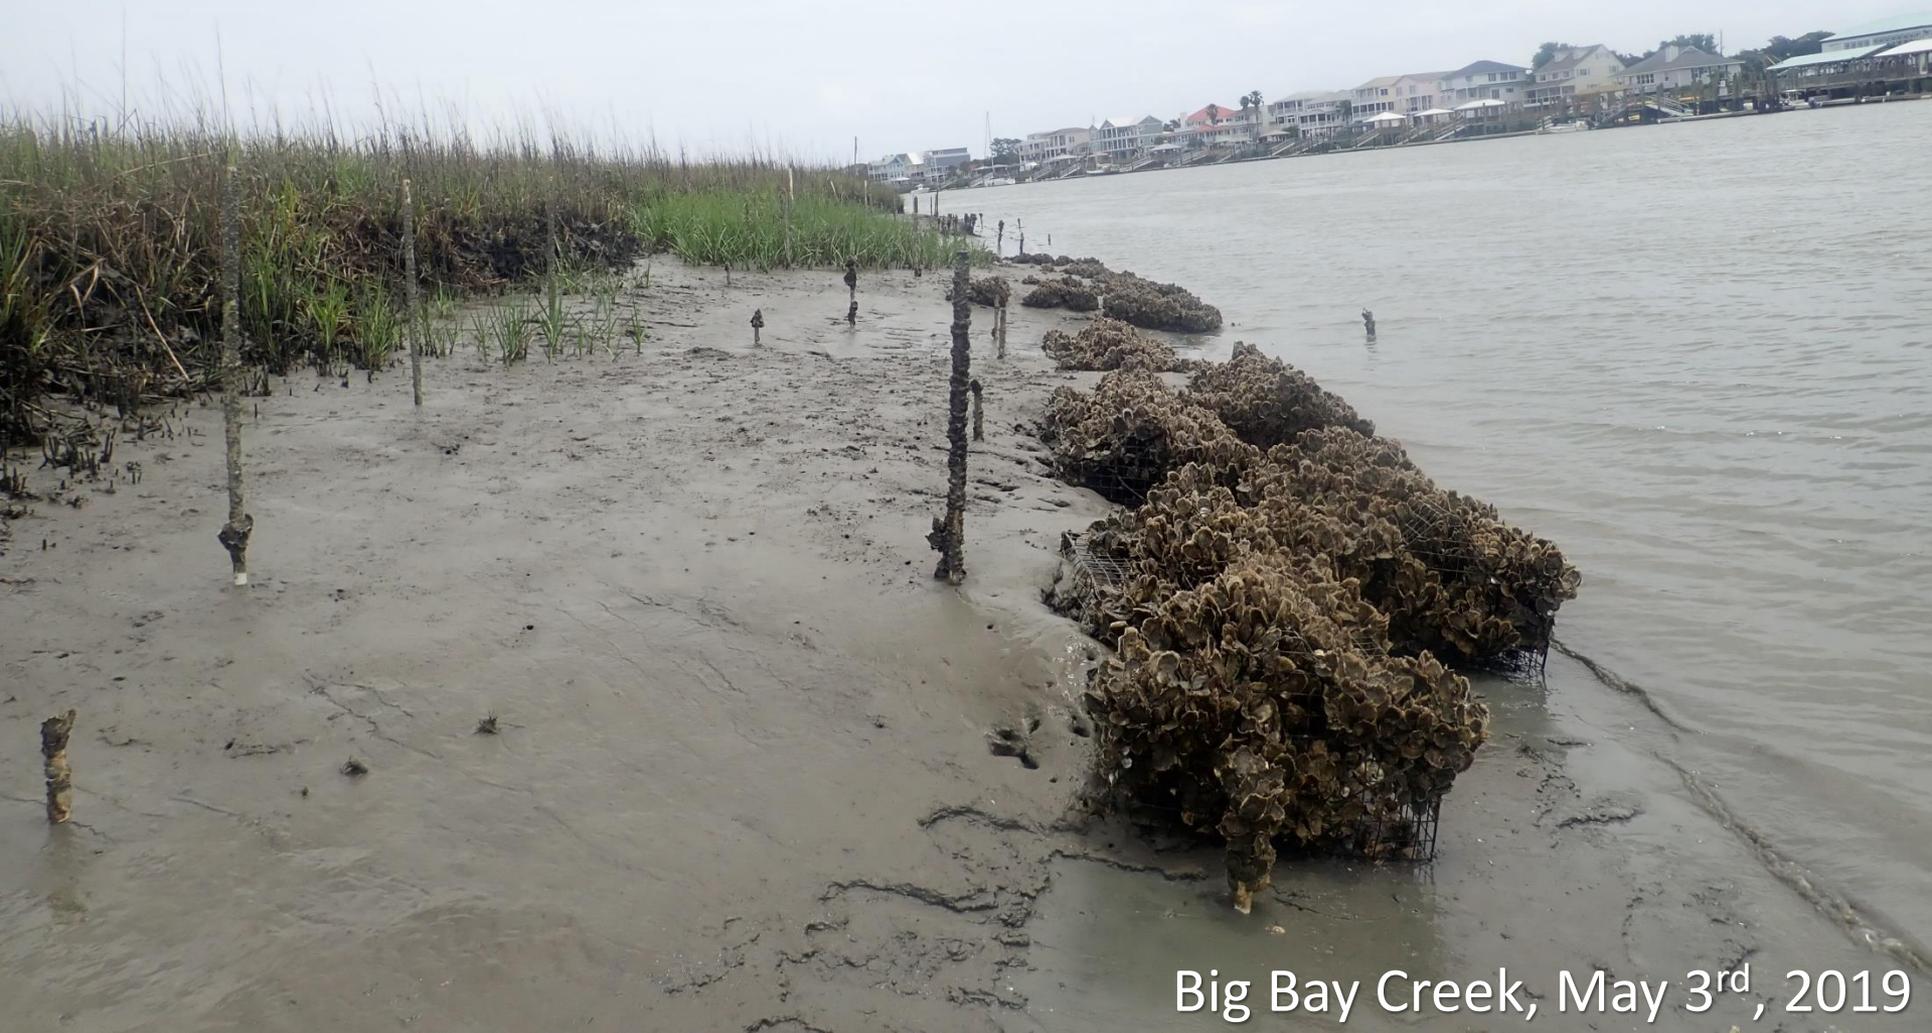
Big Bay Creek, May 3<sup>rd</sup>, 2019

# MWR, 32 months after installation

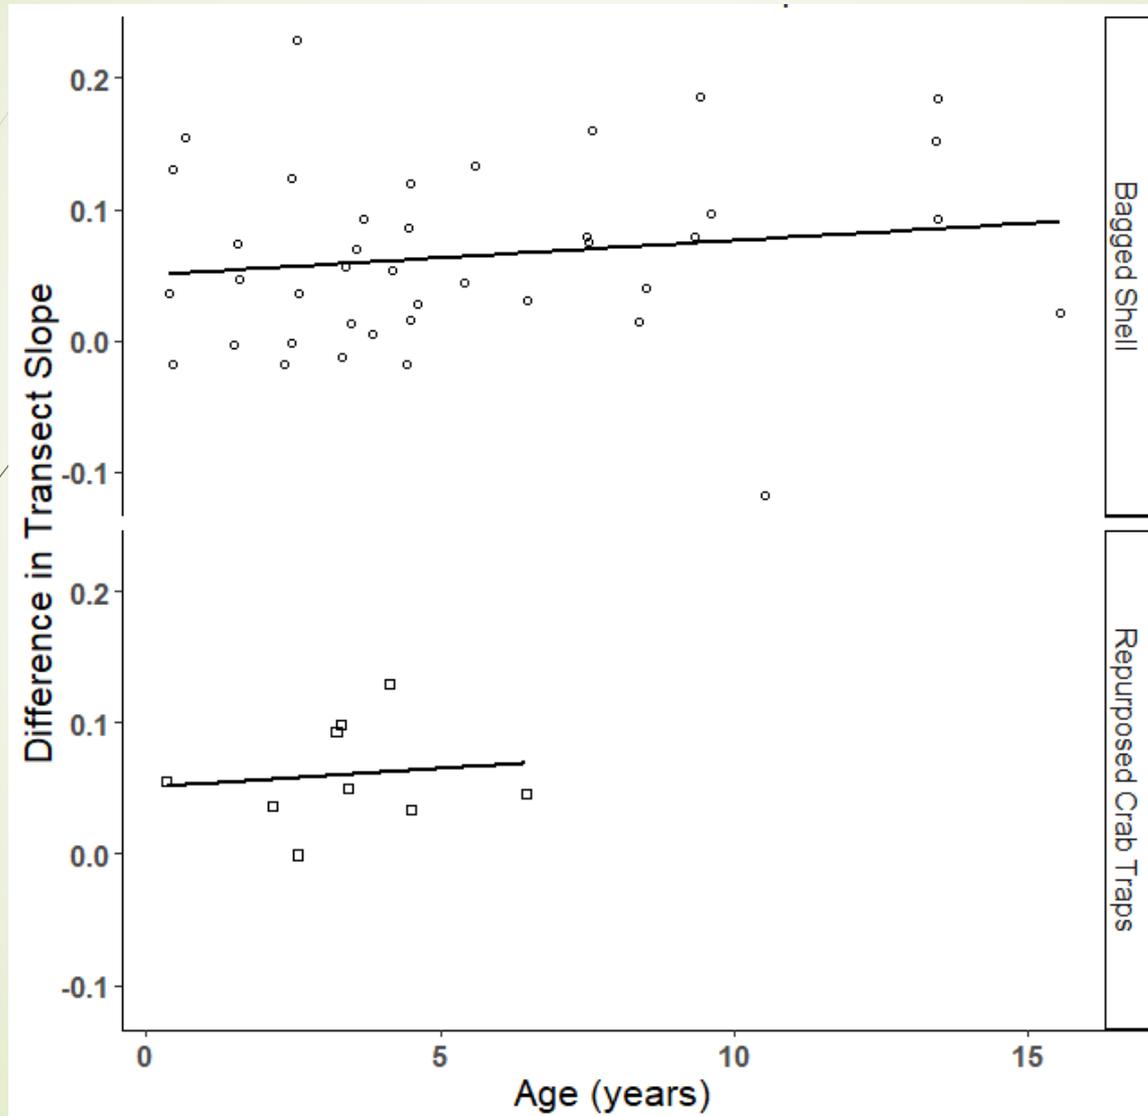
# Results: difference in slope Existing

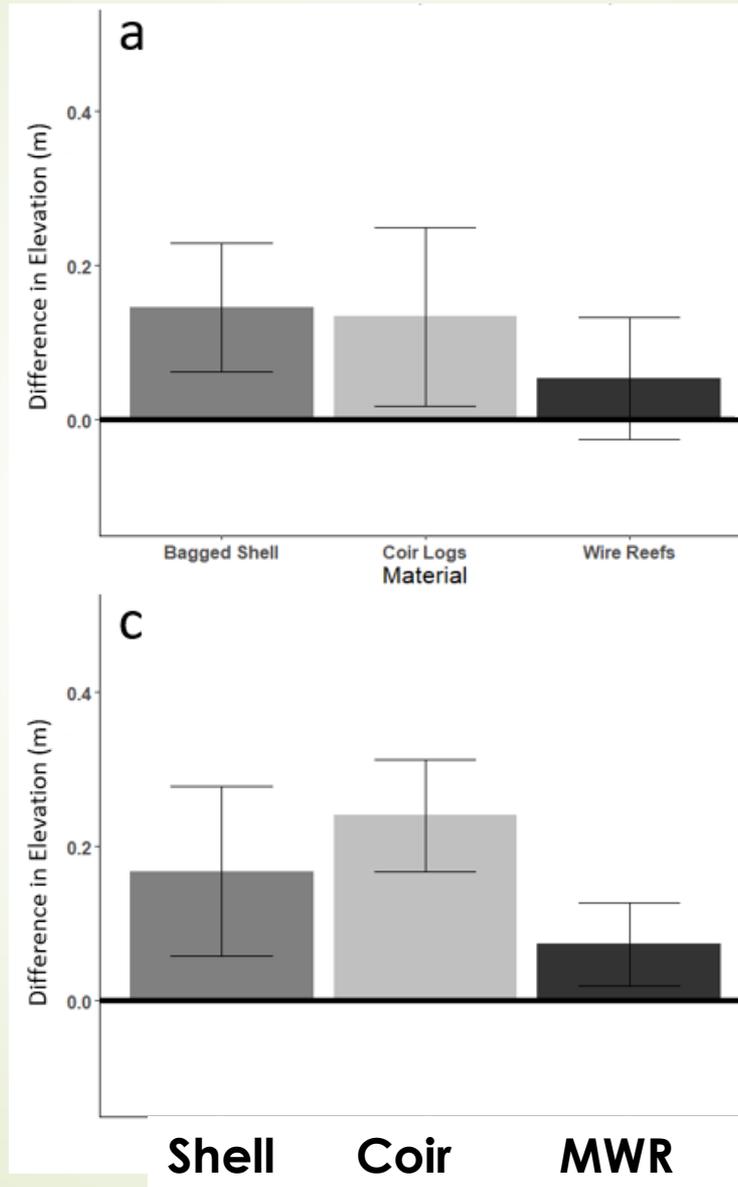
# Results: difference in accretion

## New builds

1 yr: BS=CL>MWR

2 yr: CL>MWR

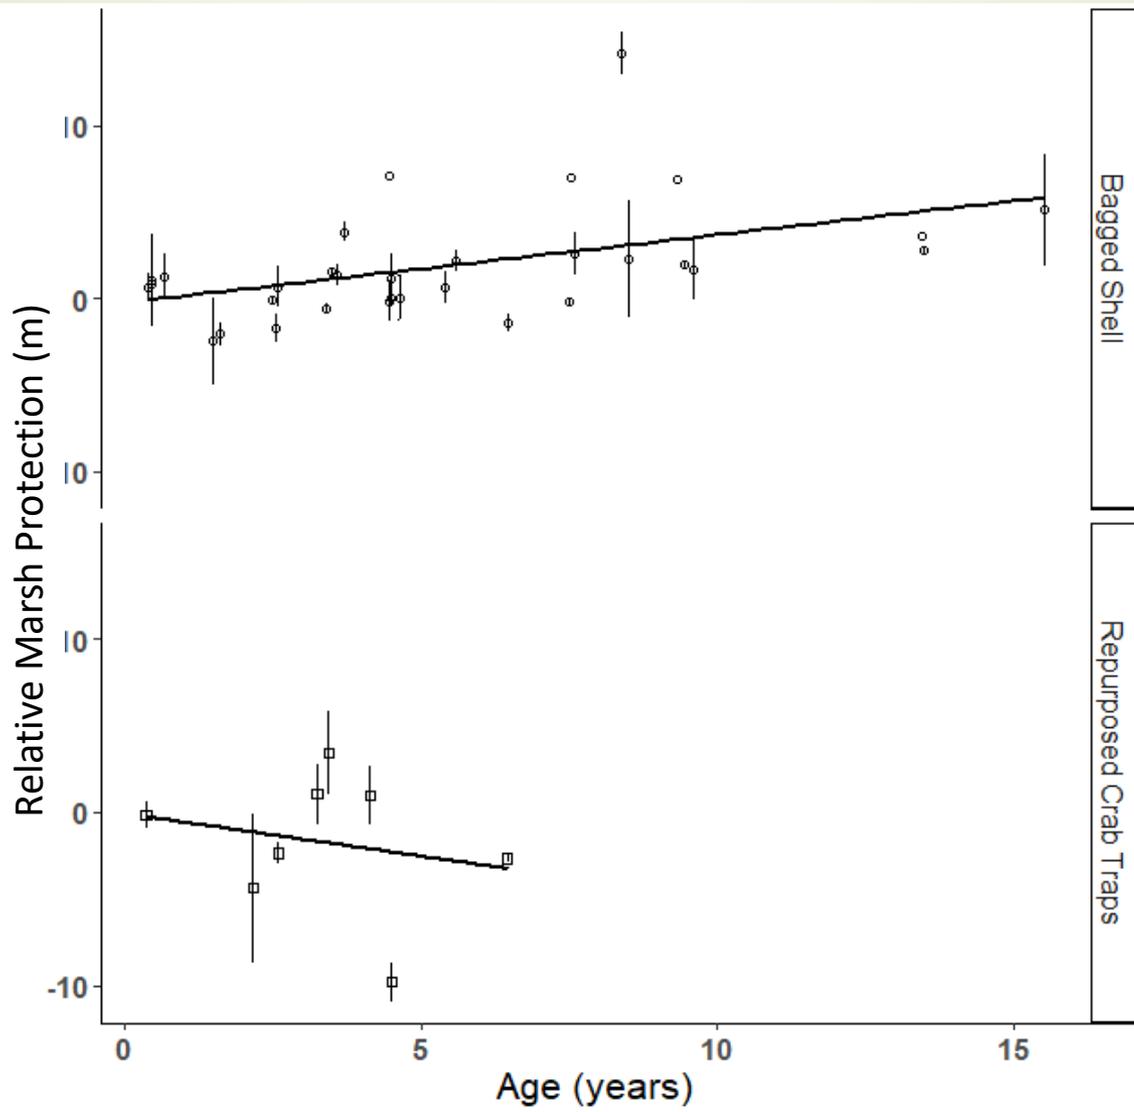
# Results: difference in marsh edge Existing

$p = 0.004$   
Slope = 40 cm/yr

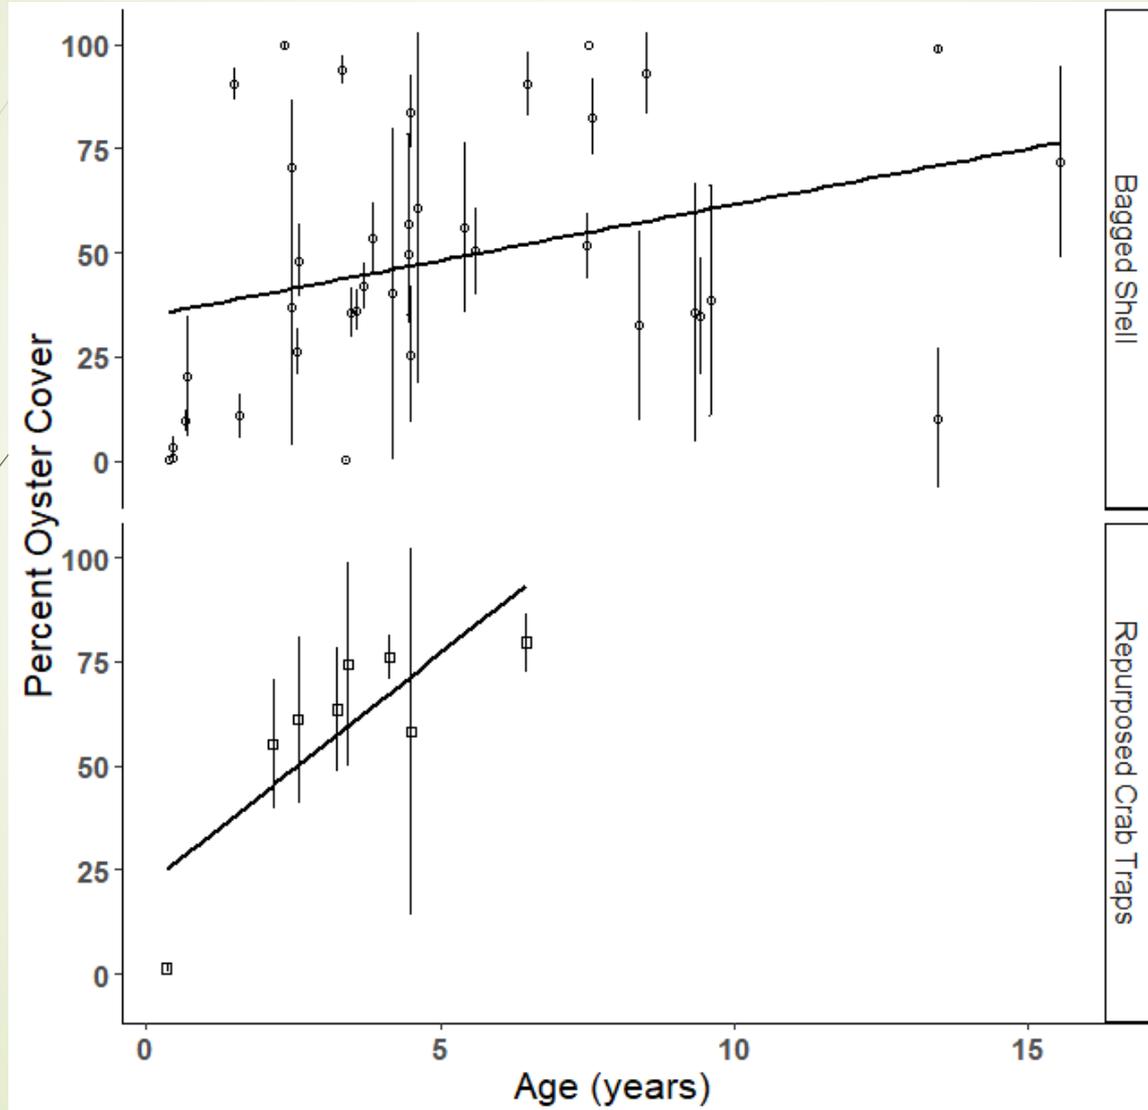
# Results: difference in oyster cover Existing

Bagged Shell

$p = 0.02$   
Slope = 3%/yr

Repurposed Crab Traps

$p = 0.01$   
Slope = 11%/yr

But lack of older data likely biases rate

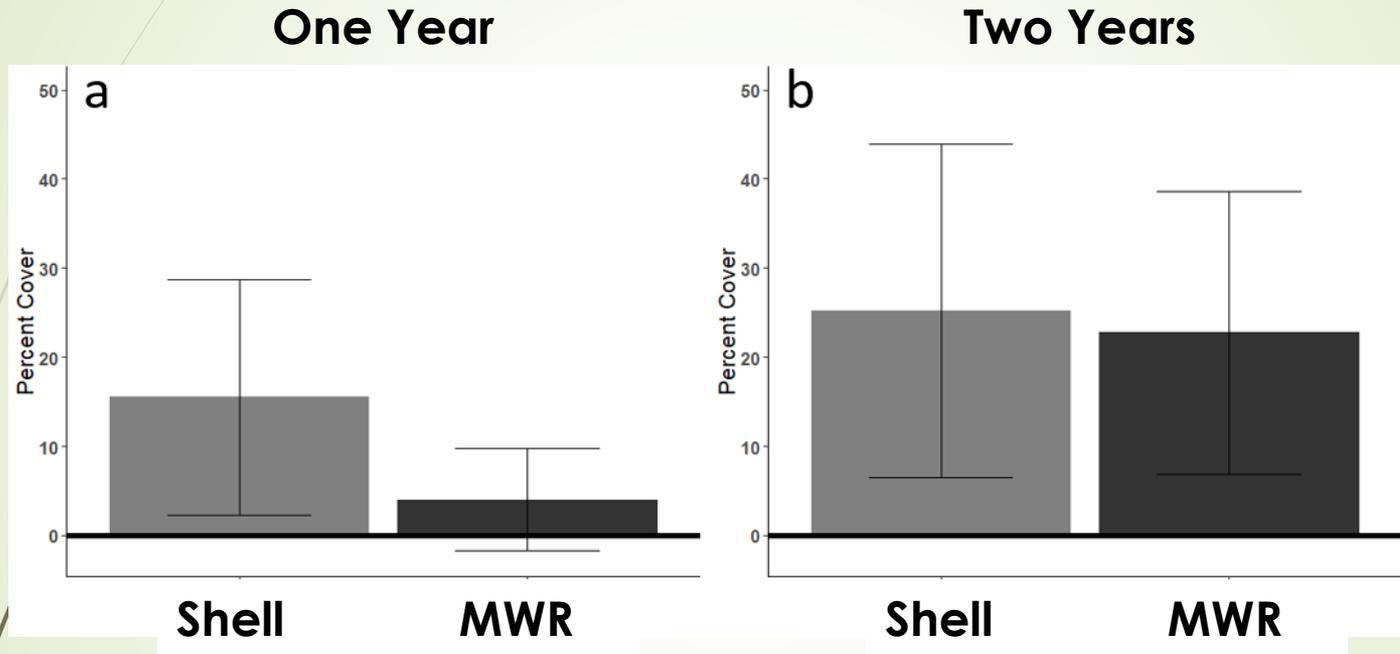
# Results: difference in oyster cover

1 yr: BS>MWR

2 yr: BS=MWR
