# Evaluating Living Shorelines to Inform Regulatory Decision-Making in South Carolina

# South Carolina Oyster Restoration and Enhancement (SCORE) Program:

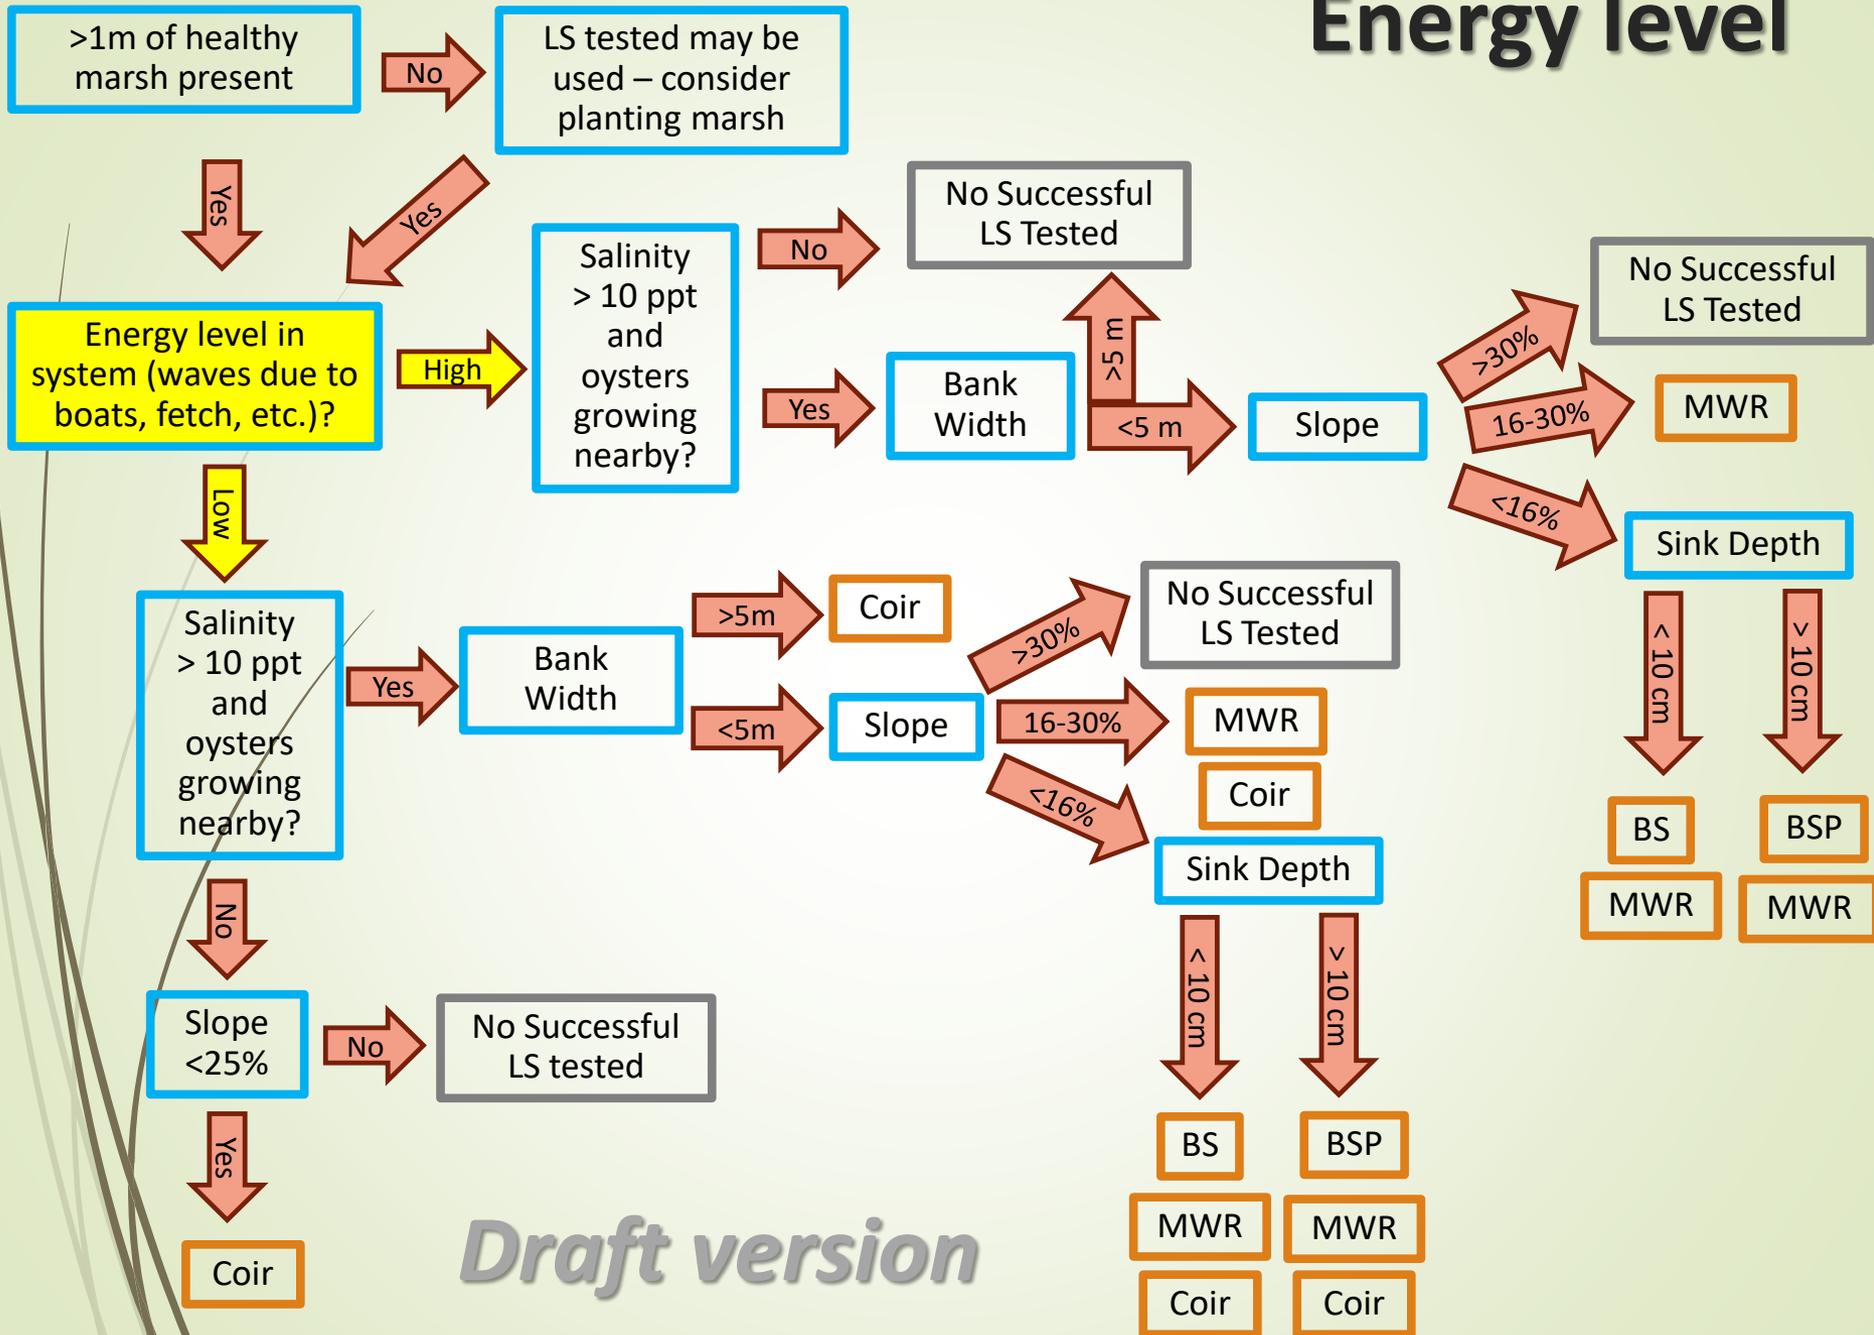
# Energy level

- Coir logs did not perform well at high energy sites (dredged/ICW, outside bend, open bay)
  - 71% failure rate
- High energy sites also tended to be higher salinity sites
- Recommend extra staking for bagged shell or MWR treatments in high energy areas
- Some treatments exhibited reduced sediment accumulation in high energy areas

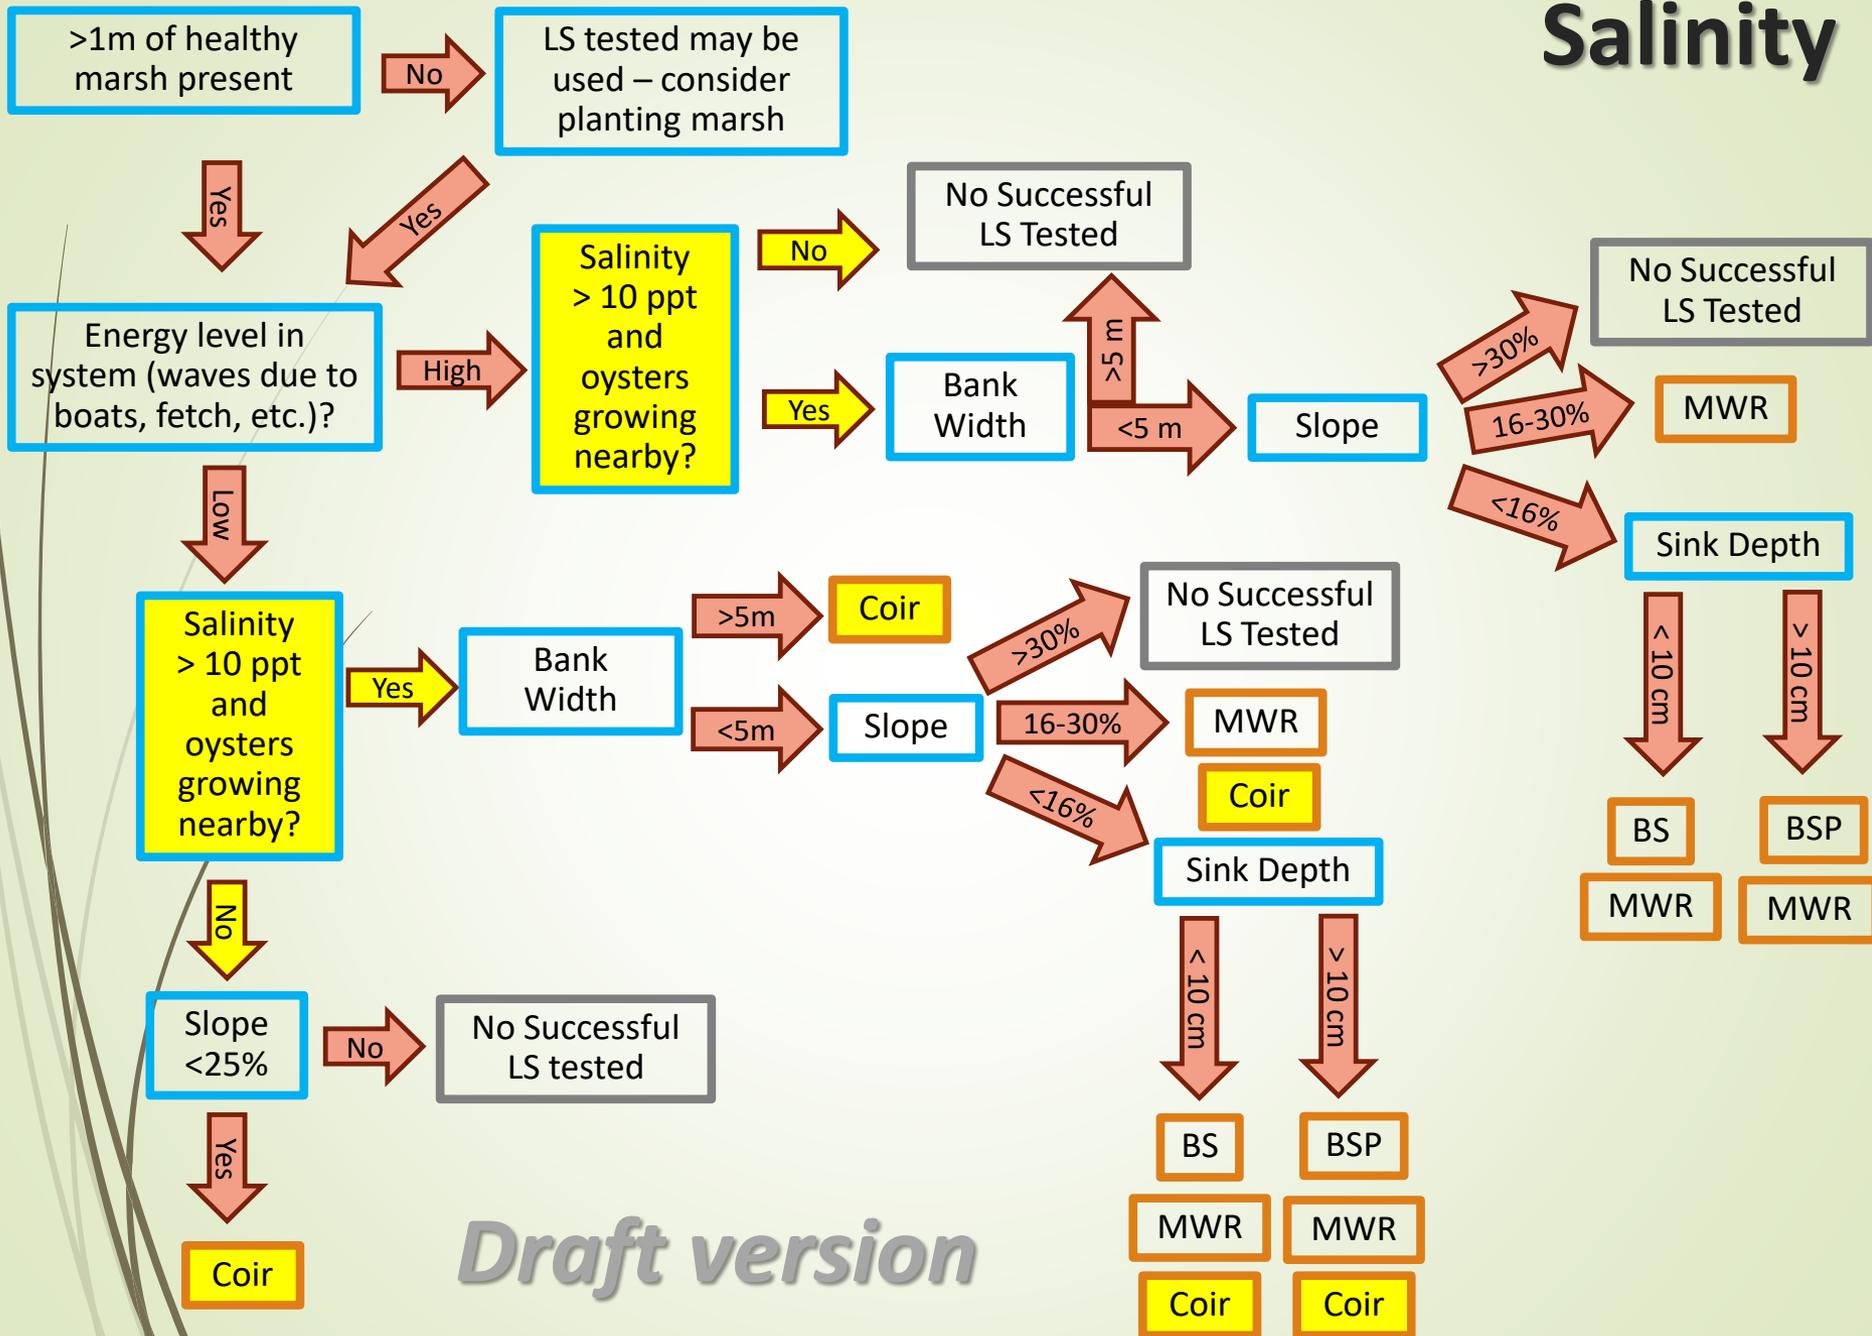
# Salinity

- **Low salinity options tested included coir logs and Curlex Bloc**
- **Curlex Bloc failed in 100% of deployments**
- **Coir log was often successful in low energy high salinity areas along with oyster-based methods**
- **Recommend checking adjacent shoreline for oysters. Lowest salinity tested here ~18 ppt**
- **May work as low as 10-15 ppt**

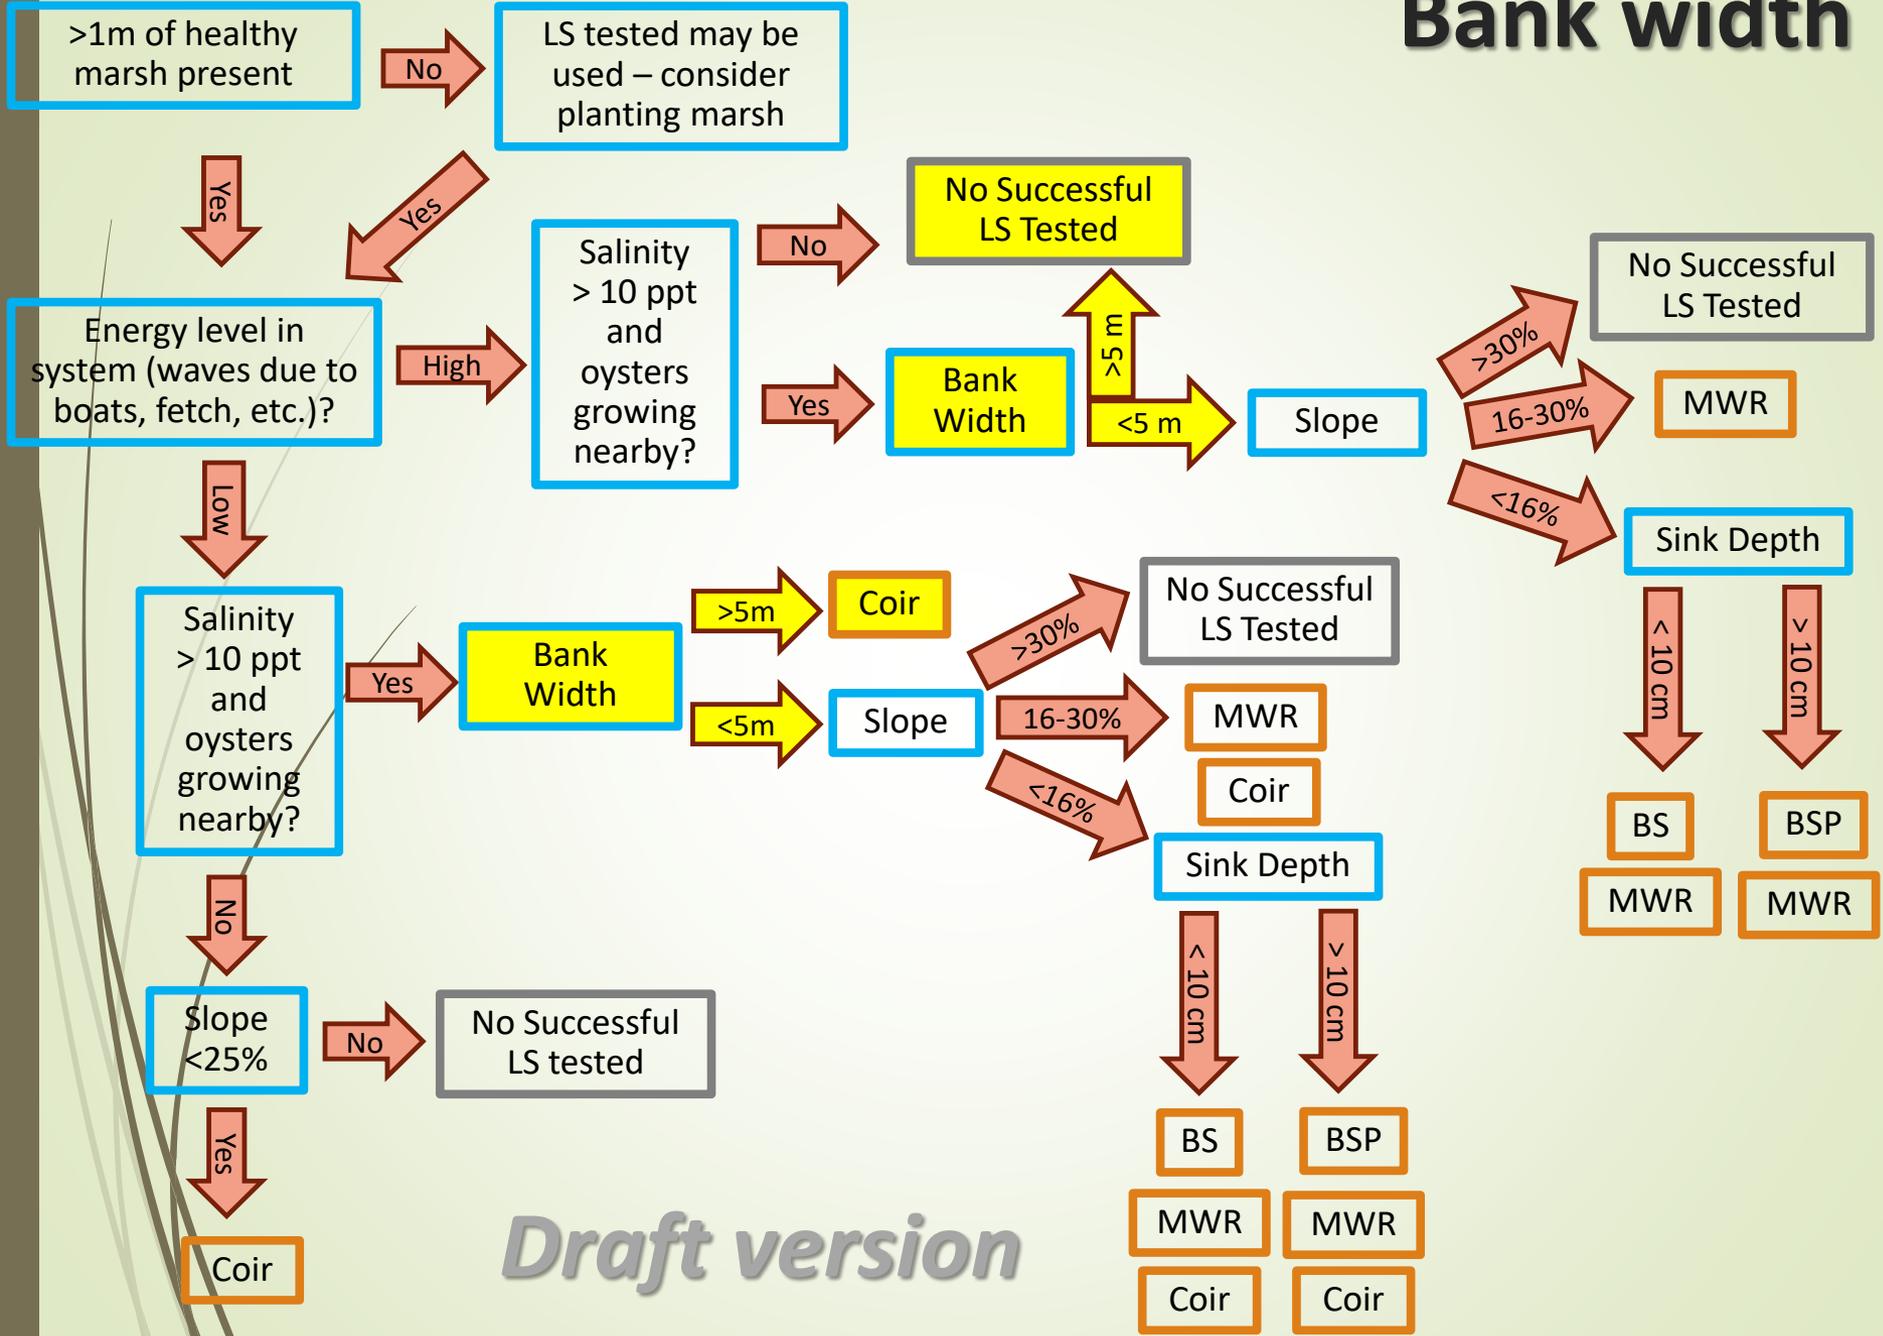
# Bank width

- Most sites exhibited bank widths  $< 8$  m, but a few very wide banks tested (15+ m)
- Bank widths  $< 5$  m exhibited:
  - Greater silt/clay change (all)
  - Greater sediment accumulation (all)
  - Greatest potential for marsh protection (BS)
  - Greatest oyster coverage after 2 yr (BS/MWR)
  - Consider placement higher in tidal frame/closer to marsh in wide areas

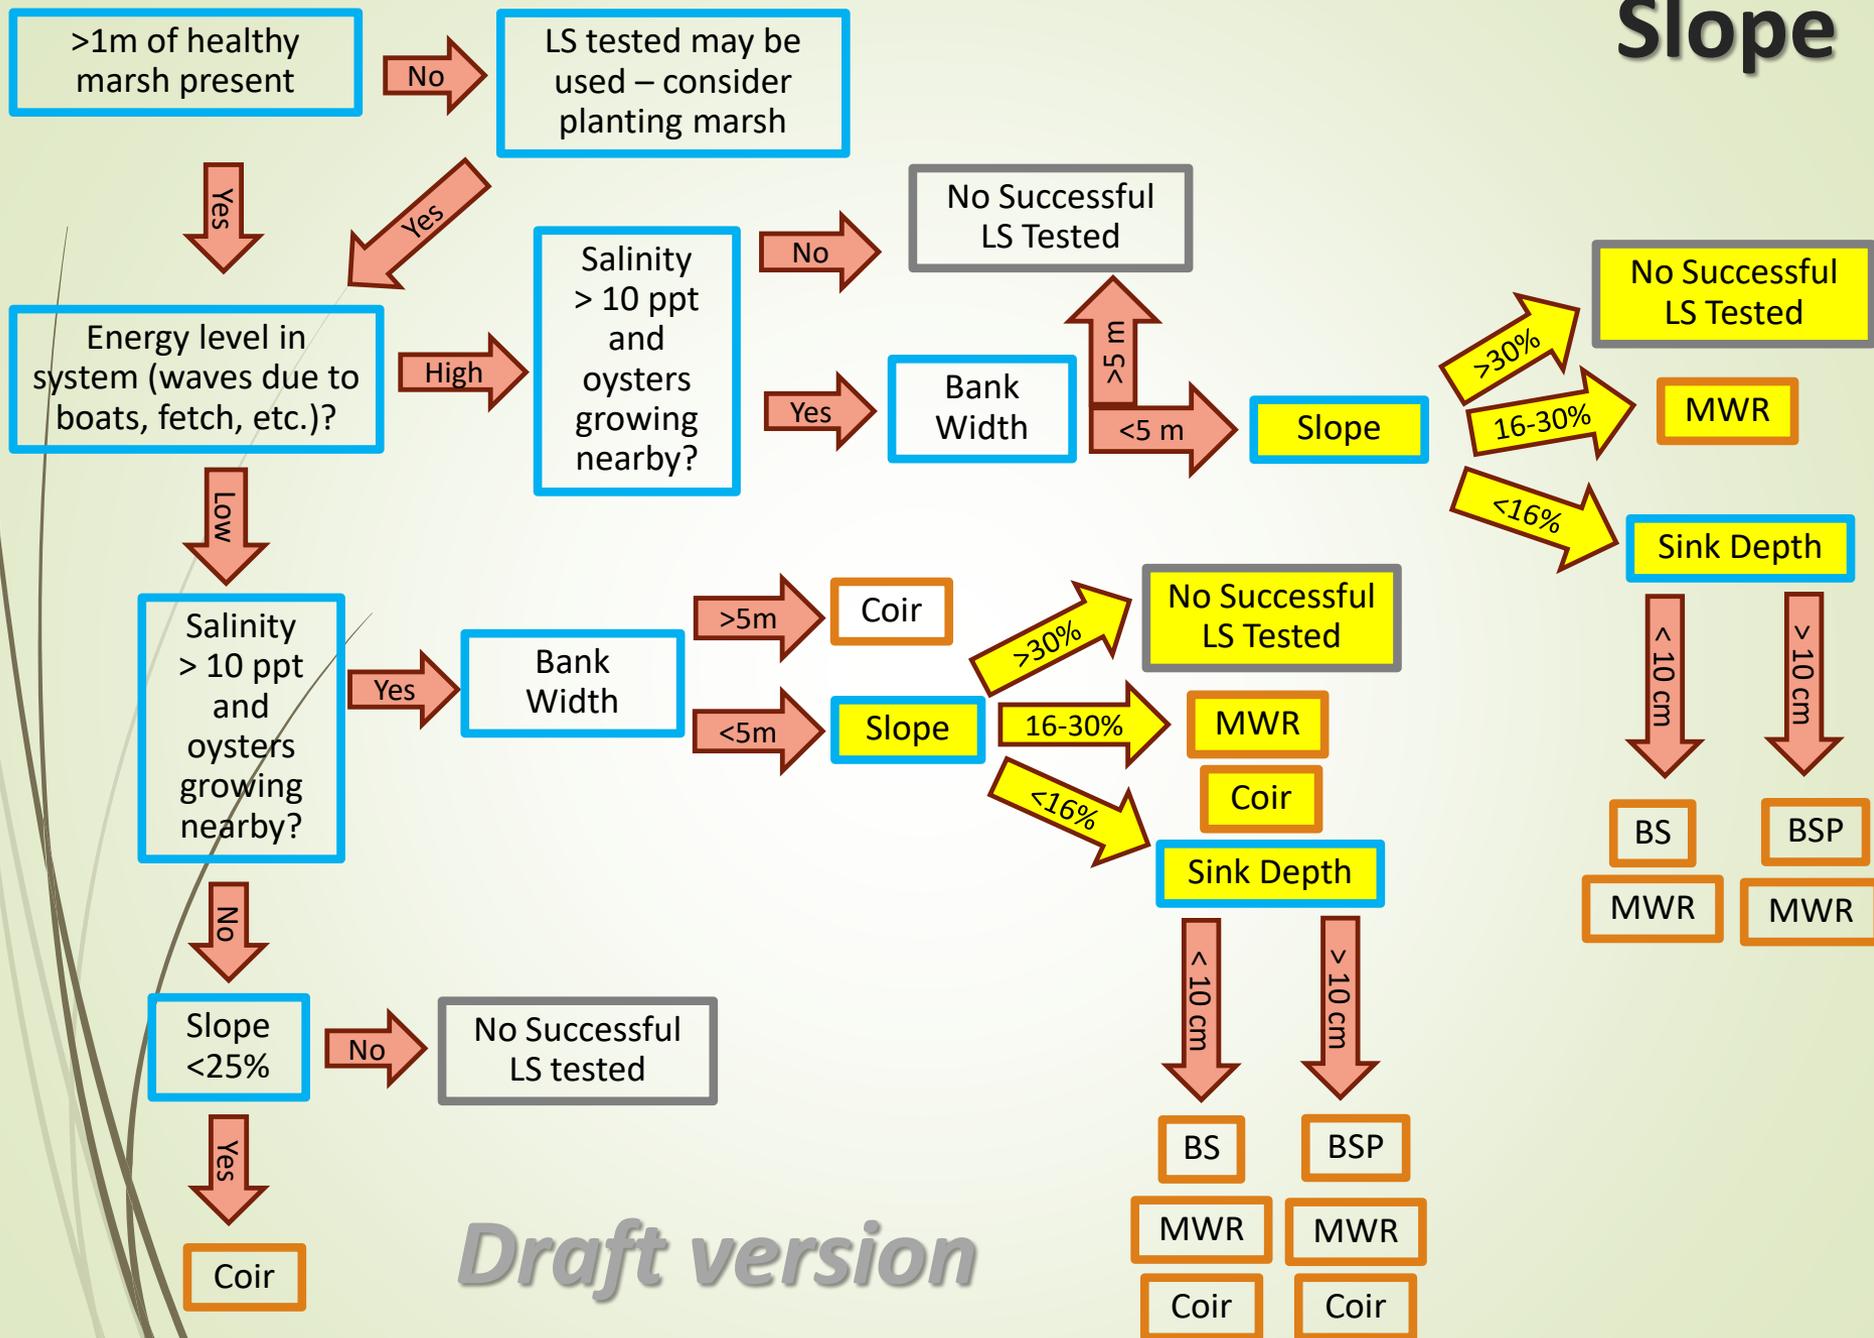
# Slope

- Treatment sliding is a concern in soft substrates, recommend extra staking at higher slopes
  - MWR is a lightweight option, easy to adjust
- Higher slopes exhibited greatest elevation gains and shift to fine sediments (BS/coir)
  - Especially with lower placement of treatment in tidal frame
- Higher placement may provide better marsh protection but less oyster growth

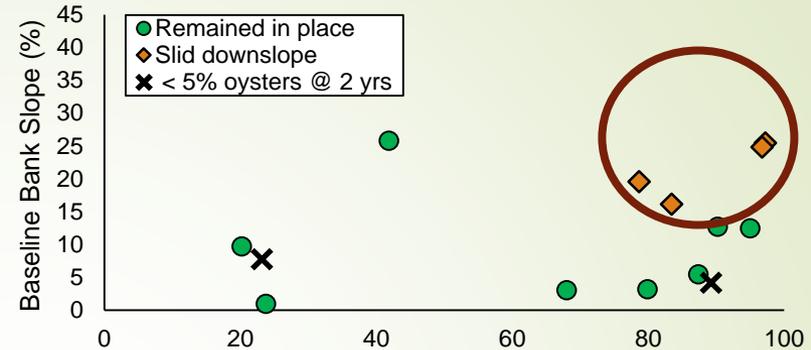
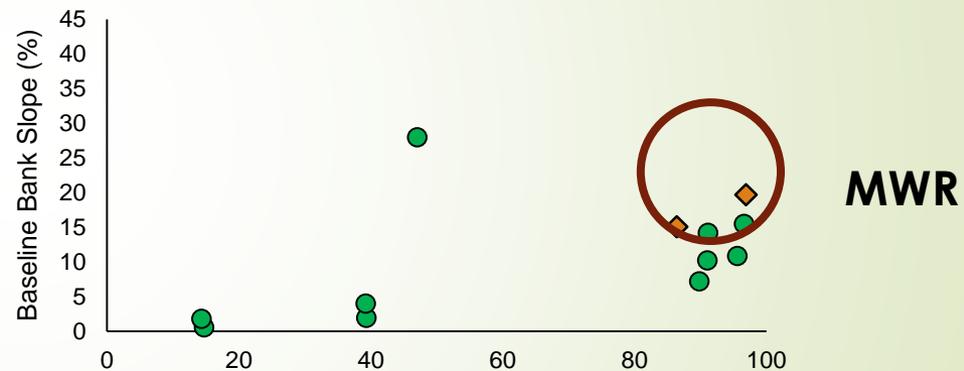
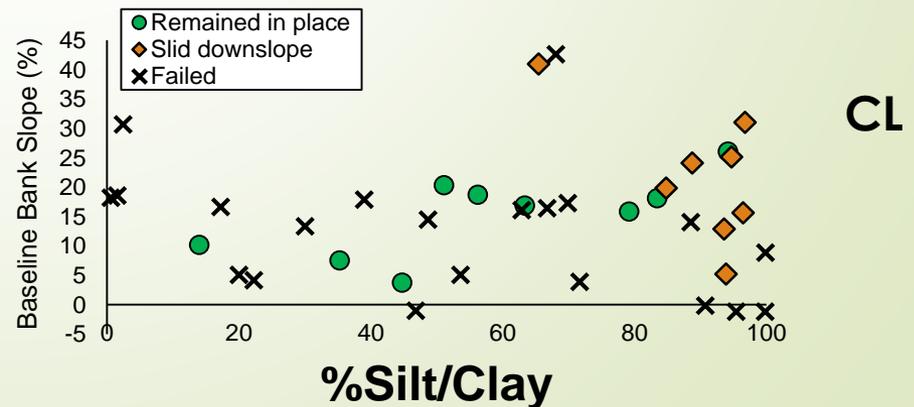
For bagged shell and manufactured wire reefs, movement appears to be a function of slope **and** substrate type

Coir logs exhibited failure in many cases and did not fit this trend.

71% of failures were at high energy sites

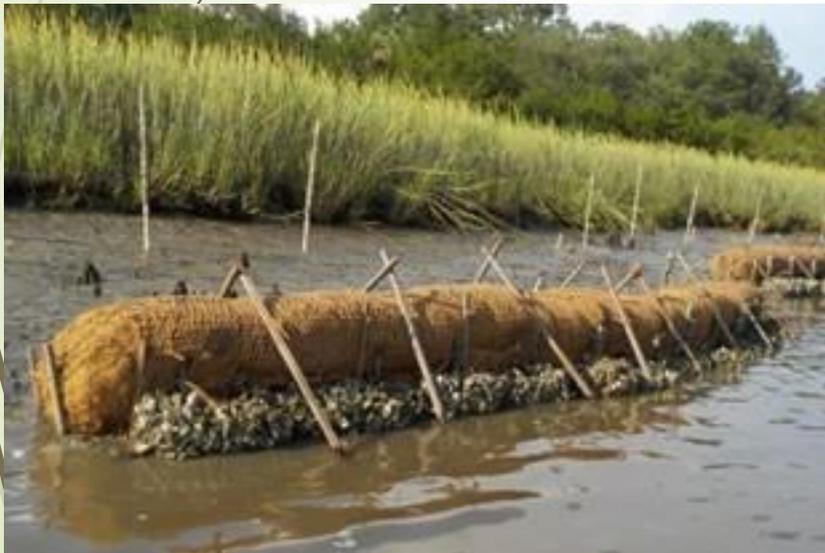
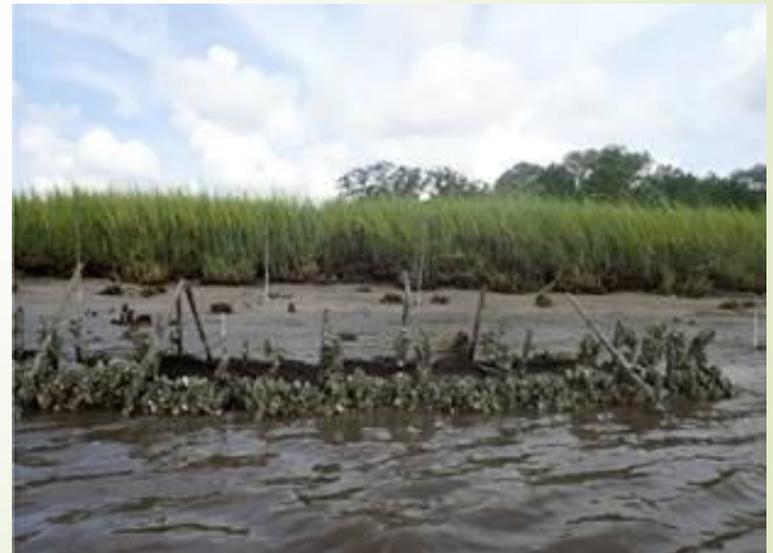
**Coosaw Cut (after two successive failures)**

INTEGRITY FAIL	No	Yes (%)
Bagged Shell	13	1 (7)
Coir Logs	17	21 (55)
MWRs	12*	
Curlex Bloc		14 (100)

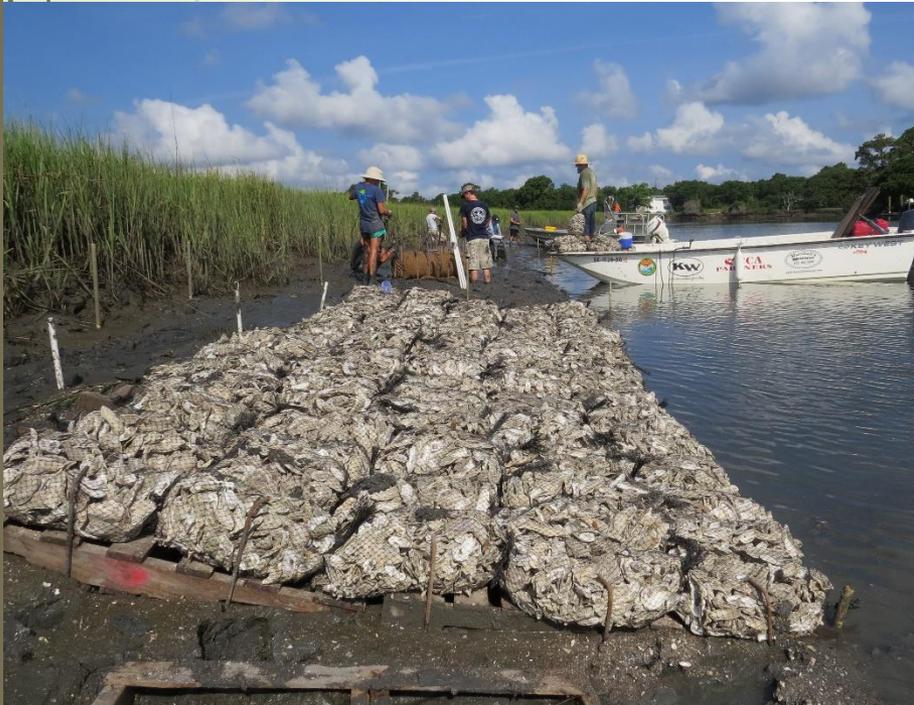
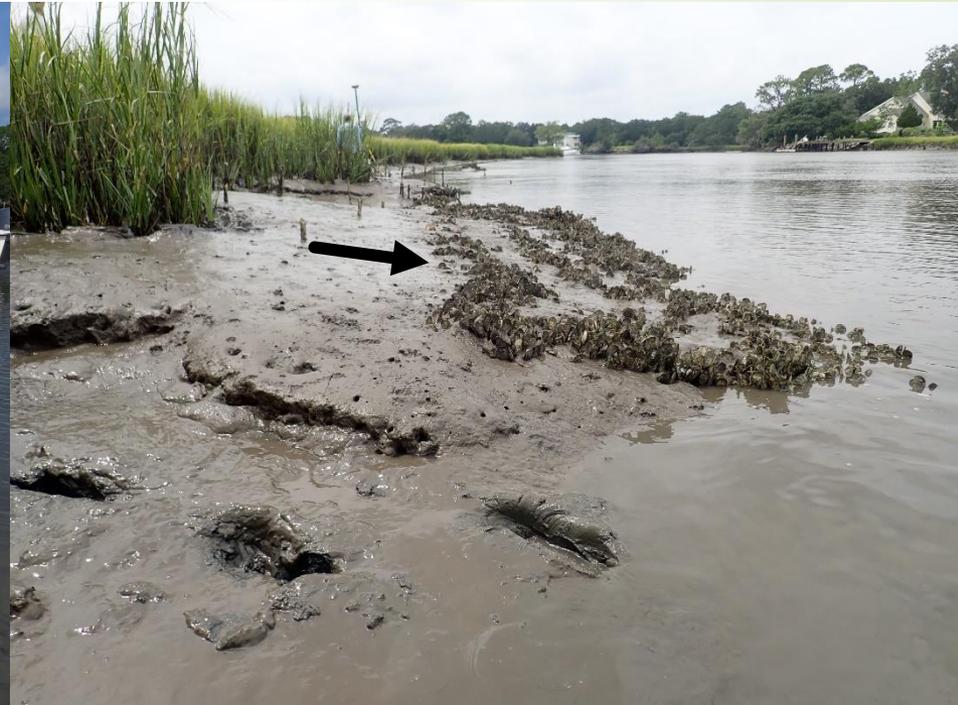
Abbapoola bagged shell movement

TREATMENT MOVEMENT	No	Yes (%)
Bagged Shell	9	4 (31)
Coir Logs	9	8 (47)
MWRs	10	2 (17)
Curlex Bloc	n.a	n.a.
