Westinghouse Fuel Fabrication Facility July 25, 2019

Hopkins, South Carolina

Overview

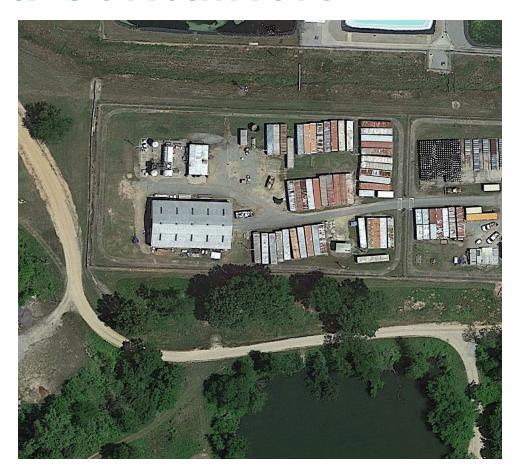
- Inspection by Westinghouse on 5/31/19 found one with hole in its roof
- Some drums inside were in poor condition. They are filled with materials containing Uranium for recovery – rags mops, etc.
- Inspected all other containers

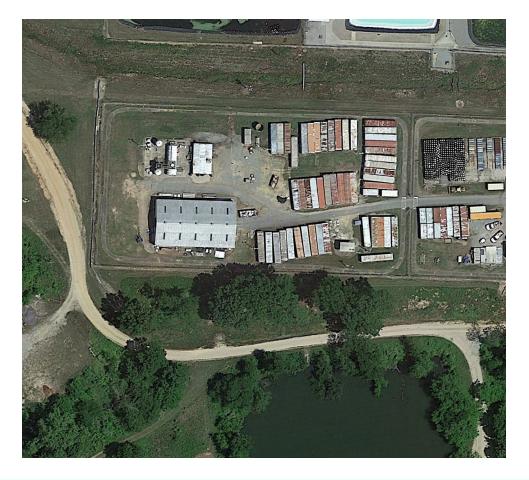
- As the Sea Land containers are emptied, the soil beneath them will be sampled.
- This Area is part of the Southern Storage Area included for investigation under the Consent Agreement.

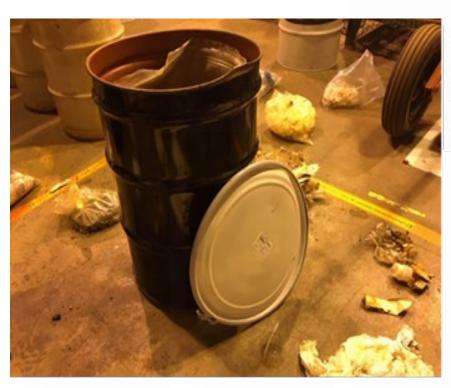
Pictured at left is the drum containing the items that self-ignited. Material on the floor was removed for inspection as part of the analysis of the incident.
