SC DEPARTMENT of  
**ENVIRONMENTAL  
SERVICES**

The South Carolina Department of Environmental Services (the Department/SCDES) inspected your dam on April 22, 2026 and the report of that inspection is enclosed. Please review it closely. Dam Safety Program staff are available to discuss the results of the inspection with you. A summary of the inspection report is as follows:

# UPPER SUNNY HILL POND DAM

## Dams Preliminary Inspection Form

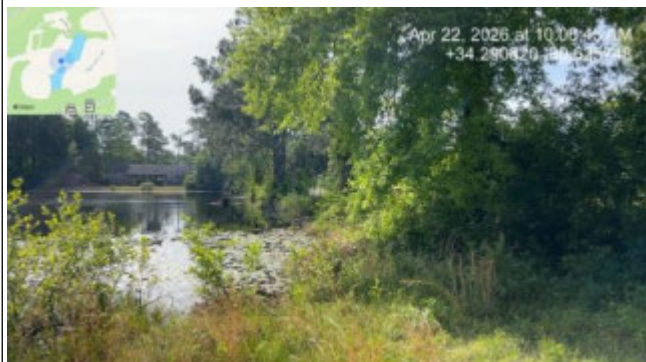
Photo Taken: 04/22/2026 10:06:00 AM  
GPS Latitude: 34.29073055555555  
GPS Longitude: -80.62569444444443  
GPS Altitude: 84.75 meters  
GPS Orientation: 1 degrees

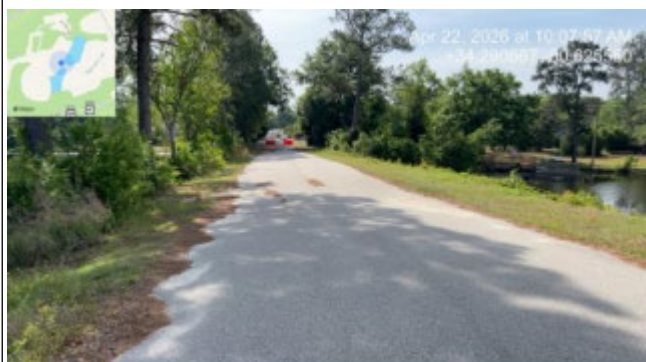
Photo Taken: 04/22/2026 10:07:00 AM  
GPS Latitude: 34.29073055555555  
GPS Longitude: -80.62569444444443  
GPS Altitude: 84.75 meters  
GPS Orientation: 1 degrees
