SC DEPARTMENT of  
**ENVIRONMENTAL  
SERVICES**

**Subject: Inspection of UPPER SUNNY HILL POND DAM, D2523, Kershaw County, High Hazard Class**

# UPPER SUNNY HILL POND DAM : D2523

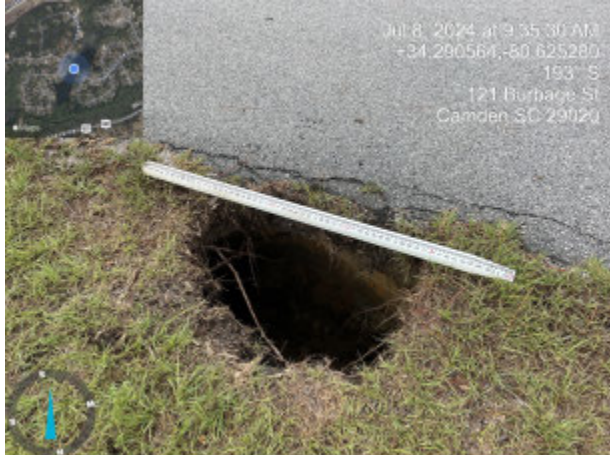
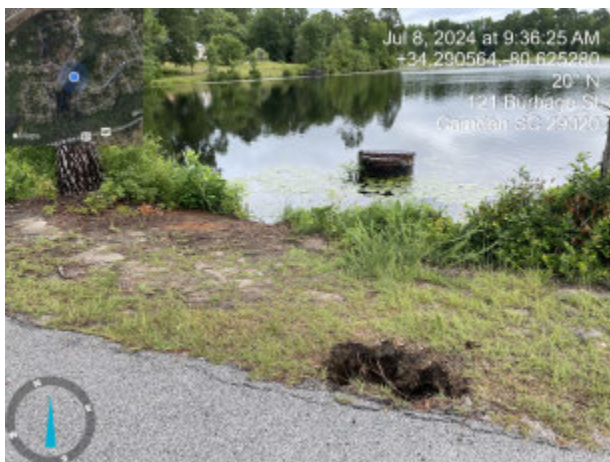
### Embankment: Crest

Needs Permitted  
Repair(s)

Engage a Professional Engineer to evaluate the stability of the crest around the sinkhole and develop a permit application for repairs and stabilization of the embankment.

Monitor for worsening cracking along the pavement.

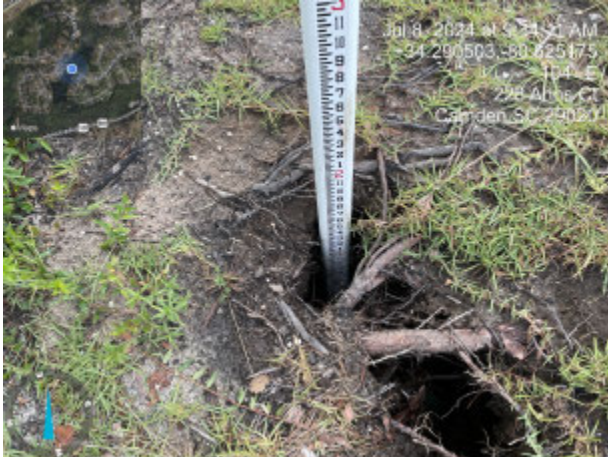
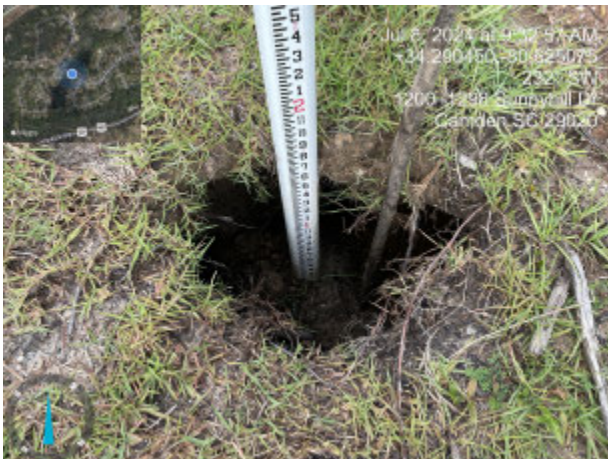
### Embankment: Upstream Slope

Dense brush and woody vegetation less than 4 inches in diameter observed along the upstream slope, mainly along the water line.

Numerous trees greater than 4 inches in diameter observed, including dead trees and decaying stumps.

Numerous voids/subsided areas observed within the upstream slope. Depths vary, but all are greater than 12 inches in depth. Standing water was observed within one of the voids. Some of the voids appear to have formed around tree roots.

Minor scarping observed on the upstream slope near the right side of the dam. Less than 12 inches.

Regular Monitoring  
Necessary, Needs  
Maintenance, Needs  
Permitted Repair(s)

Engage a Professional Engineer to evaluate the condition and stability of the upstream slope, especially around areas with voids. Engineer should develop a permit application for repairs and stabilization of the upstream slope.

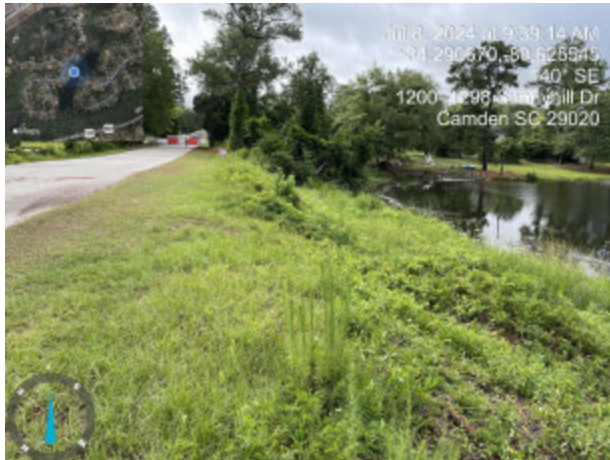
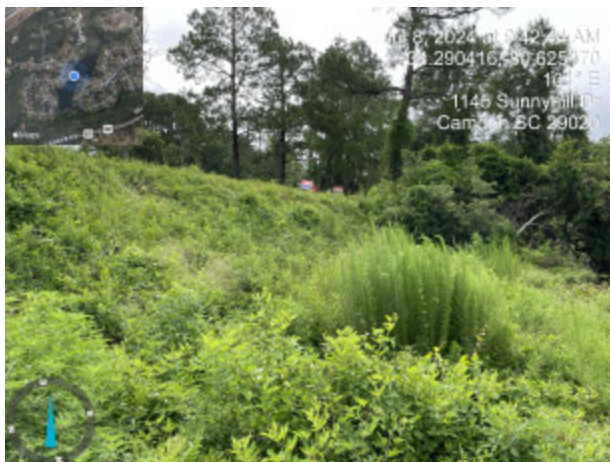
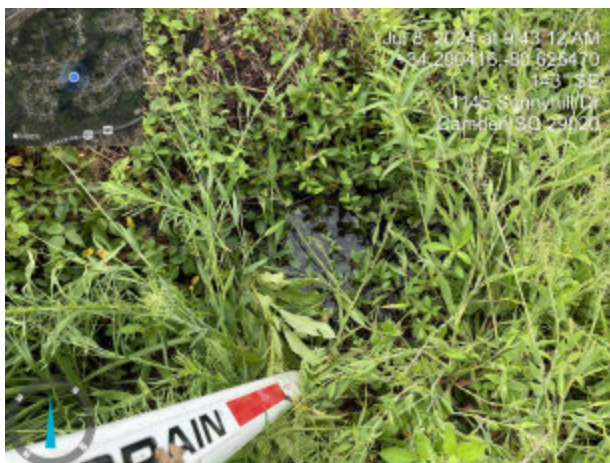
Decaying tree stumps observed.

Dense brush and woody vegetation observed in the groins of the downstream slope.

Multiple voids observed within the downstream slope, potentially around tree roots and stumps. Depths greater than 2 feet observed in some areas.

Puddles observed along the downstream slope, potentially due to recent rainfall.

Regular Monitoring  
Necessary, Needs  
Maintenance, Needs  
Permitted Repair(s),  
Condition Prevented  
Full Inspection

Engage a Professional Engineer to evaluate the stability and condition of the downstream slope, especially around decaying tree stumps. Engineer should develop a permit application for repairs of the voids and eroded sections of the downstream slope.

Engage a Professional Engineer to evaluate the area of the downstream slope experiencing scarping and to develop a permit application for slope repair and stabilization.
