# PRO DISPOSAL USA (BARNWELL RESOURCES) CLASS 2 LANDFILL

P1TJ-QJAP-426

| <b>Solid Waste - Class 2 Landfill</b> | |
| <b>Date of Inspection</b> | 10/22/2025 |

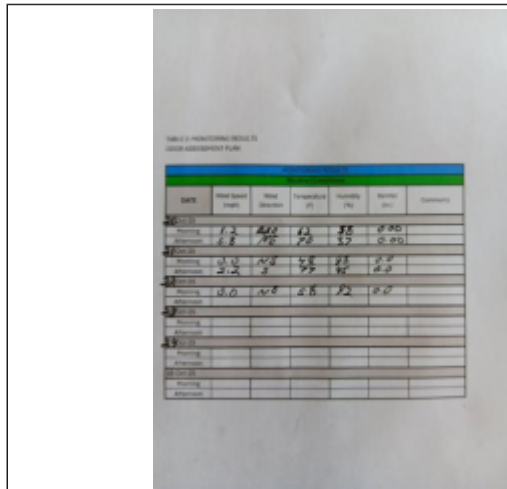
Photo Uploaded: 10/23/2025

Facility has already started implementing their Odor Assessment Plan.  
Facility management planning to be onsite next week to develop additional plans to address the odors and water management within the site.
