Preliminary Inspection Report for South Carolina Regulated Dams and Impoundment Structures Regulations R.72-1 through R.72-9

A. Dam Number: D 0005 & Hazard Class c1 B. Name of Dam: Big Creek WCD Dam 2
C. Inspection Date (12/02/2013) & Time: 0930 D. Date of Last Inspection: (12/19/2011)
E. Location-County/City: Anderson / williamston F. EQC Regional Office: Anderson
G. Inspector's Name: Hannah Vinson
H. Owner's Name: Al Rentz (first phone #) and Paul Williams (second phone #)
I. Contact Person (if different from above): Al Rentz, present at time of inspection, phone number below
J. Dam Owner's or Contact Person's Phone Numbers: Home (864) 940 - 7418 Office (864) 847 - 1157 Other () - - - -
K. Dam Owner's or Contact Person's mailing address: Address 1 223 Walton Drive (Rentz) 124 P Williams Road (Williams) Address 2 (optional) City Williamston, State sc Zip Code 29697 - - - -

Re: WS Lee Steam Station Primary Ash Basin (D 4887) Preliminary Inspection Results
High Hazard, Anderson County

February 24, 2014 Preliminary Inspection for WS Lee Primary Ash Basin

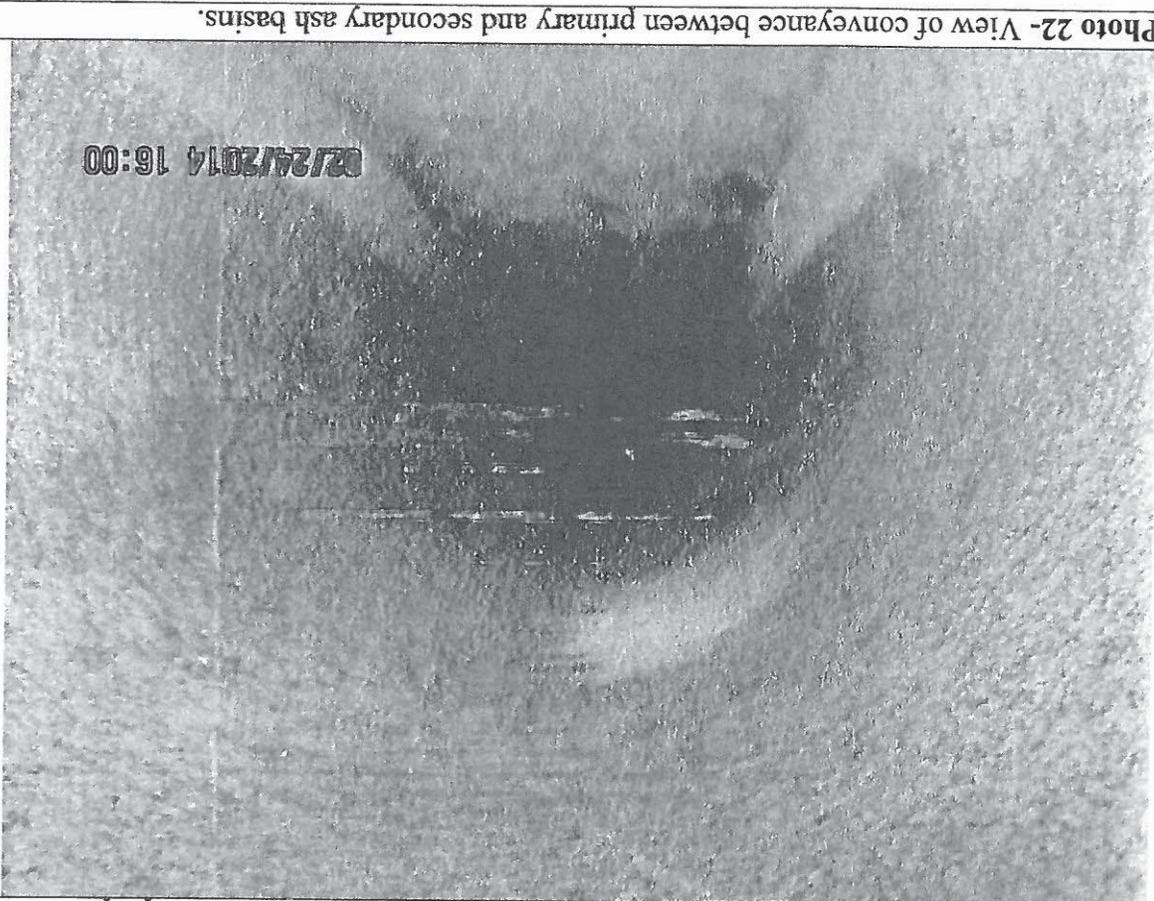
Photo 22 - View of conveyance between primary and secondary ash basins.

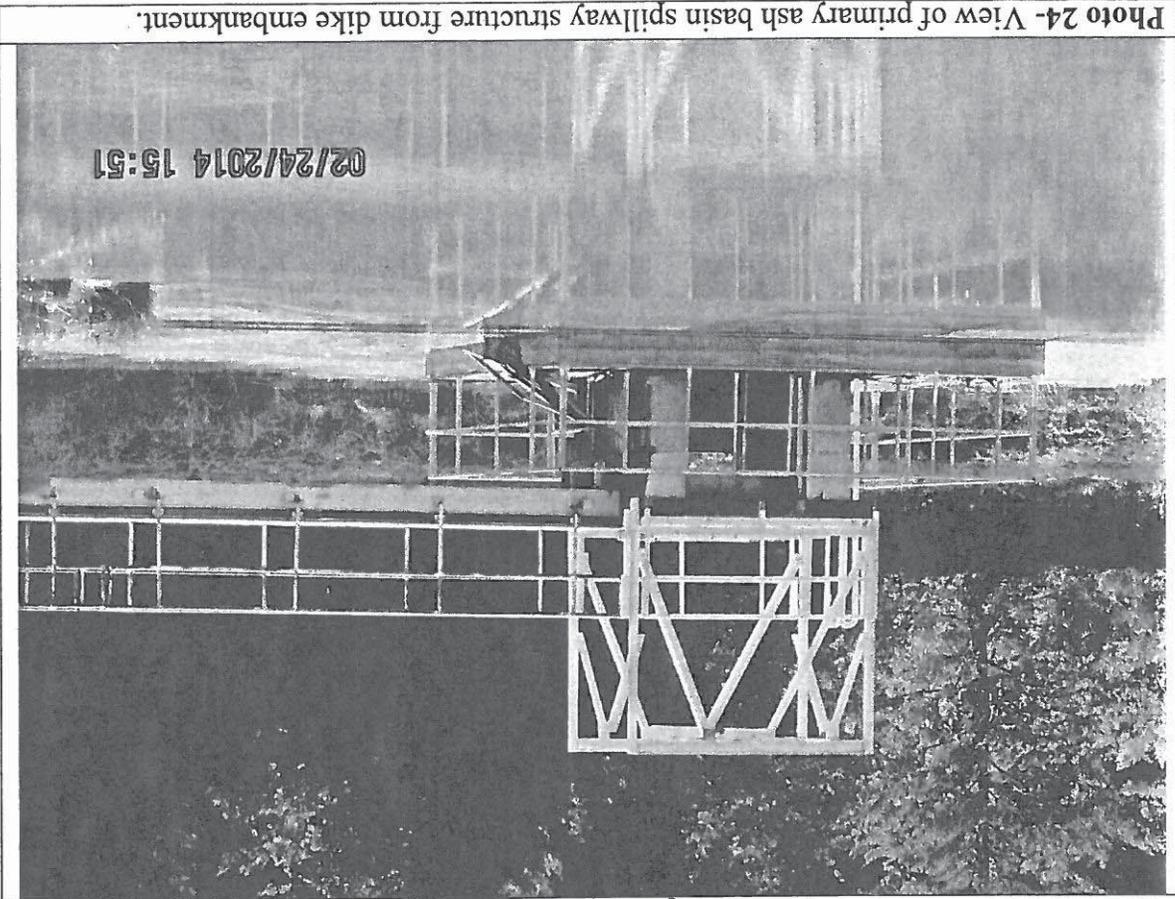
ii. Is there an obvious need to repair or replace trash rack? No, the structure had a floating deck that blocked most trash

from reaching the spillway. See photo 24.

Photo 24- View of primary ash basin spillway structure from dike embankment.

- 1. Complete form 2606 and return it to DHEC. 2. Remove dead vegetation from rip rapped areas.
- 3. Remove debris from spillway structure. 4. Monitor the condition of the spillway to ensure its structural integrity.

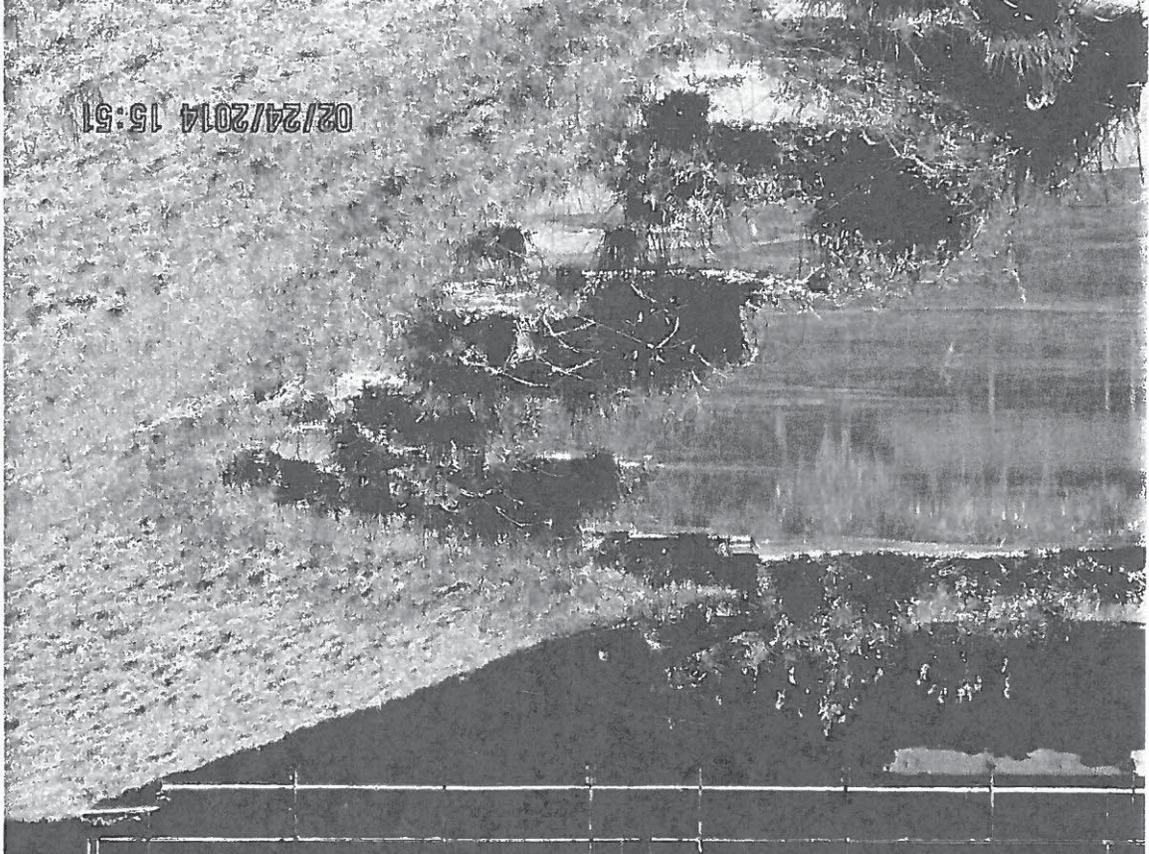
Photo 27- Upstream shoreline of dike embankment.

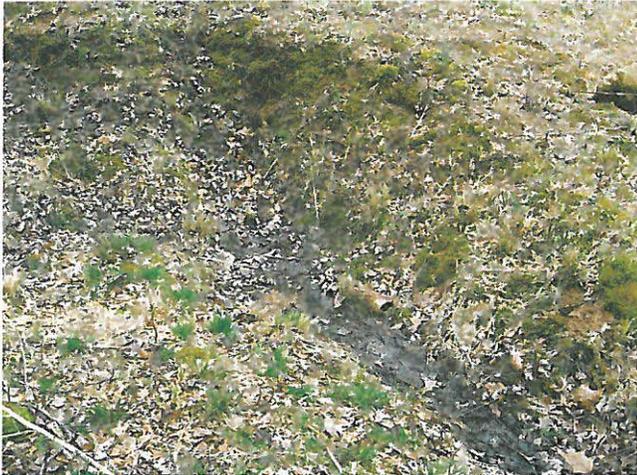
13. Possible spring on back side of dam.

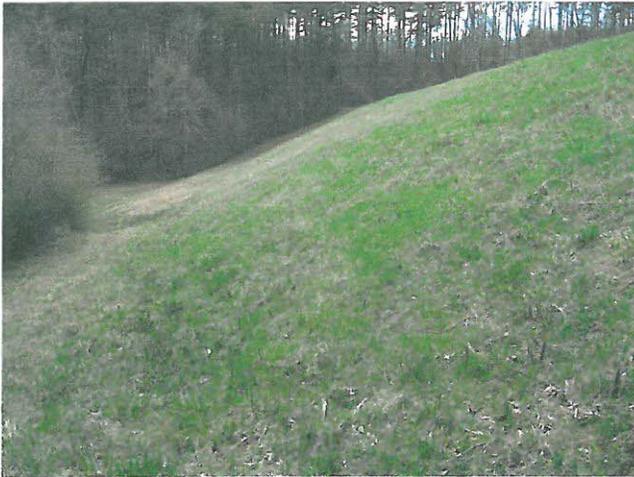
19. Back slope of dam.

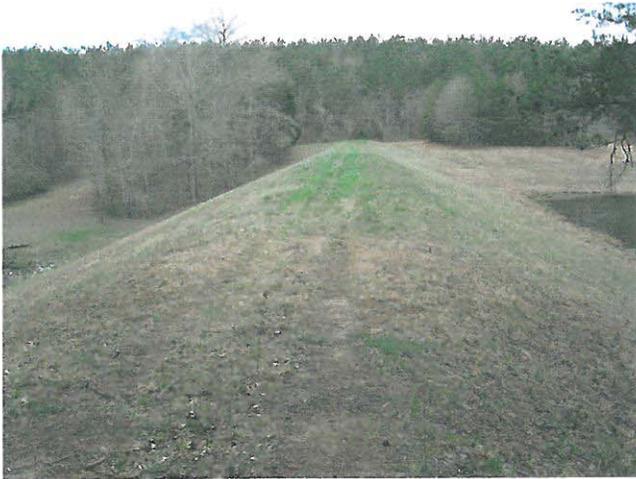
1. Crest of dam.

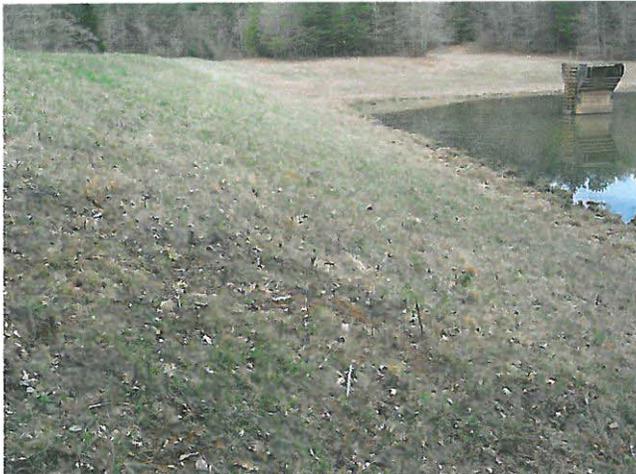
3. Front slope of dam.

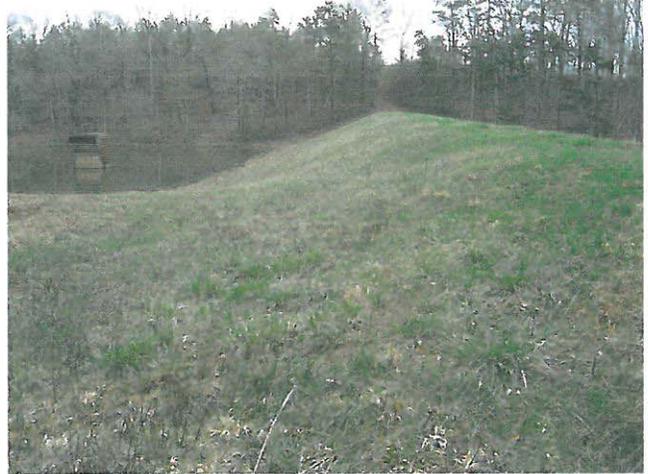
4. Front slope of dam.

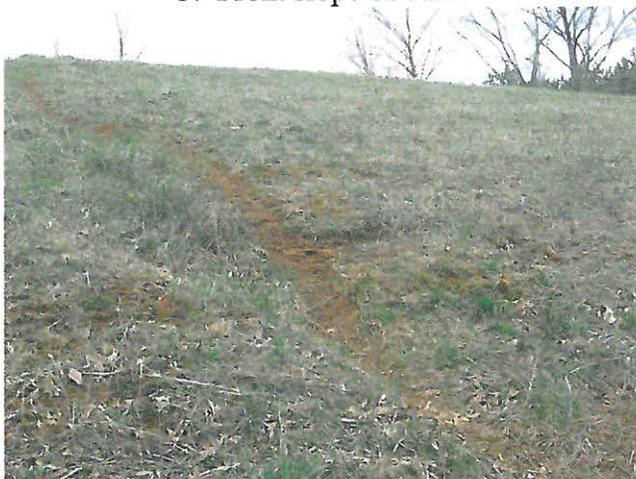
- i. Vegetation (grass, trees weeds)? Grass
- ii. Animal activity observed? Animal trail (possibly raccoon?) in center of slope. Wild hog activity on right side of slope. Monitor and repair as necessary to avoid erosion.
- iii. Any obvious alterations or repairs made? None observed
- iv. Erosion observed on upstream slope? None observed
- v. Settlement or cracks visible in slope? Possible crack in center near animal trail. Monitor and repair as necessary to prevent further damage to slope.

5. Trail on front slope of dam.

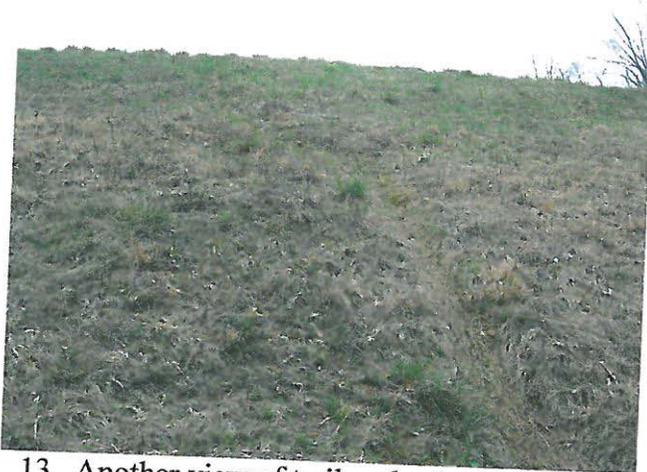
- i. Vegetation (grass, trees weeds)? Grass
- ii. Animal activity observed? Wild hog activity on right side. Animal trail (possibly raccoon?) in center of slope. Monitor and repair as necessary to prevent eroision.
- iii. Any obvious alterations or repairs made? None observed
- iv. Erosion observed on down stream slope? None observed
- v. Settlement or cracks visible in slope? None observed
- vi. Toe drains flowing? Yes
- vii. Any seepage observed? If so, describe location, flow rate, and any turbidity or color within the flow: None observed

13. Another view of trail on back side of dam.

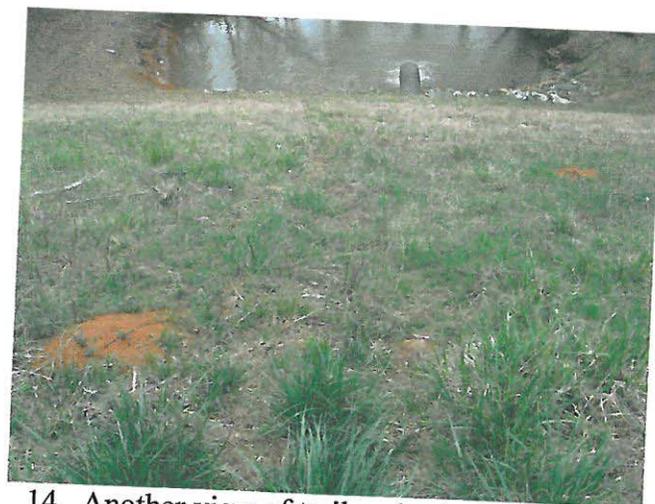
14. Another view of trail on back side of dam.
